Closure Completion Notification for Closure by Removal

Mountaineer Plant

Bottom Ash Pond Complex

AEP Mountaineer Plant Bottom Ash Complex

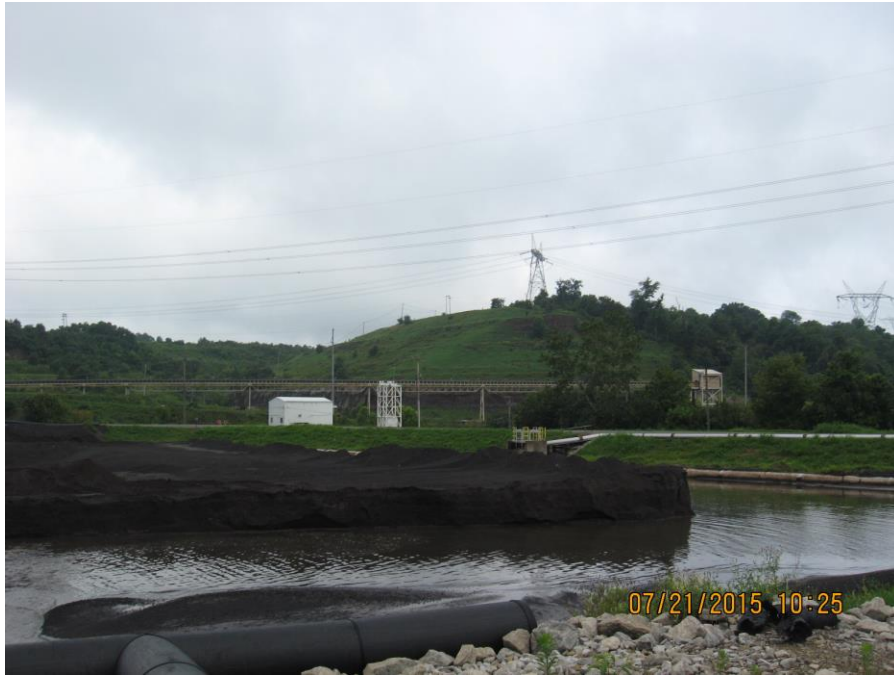
Photo 1: West Bottom Ash Pond, north dike.

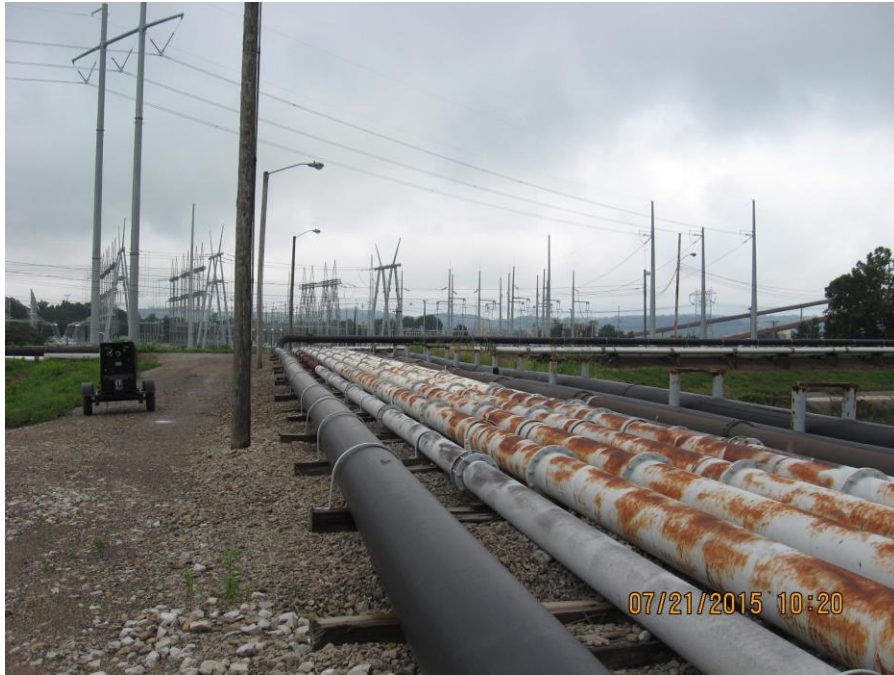
Photo 3: Bottom Ash Ponds, splitter dike: bottom ash inlet pipes.

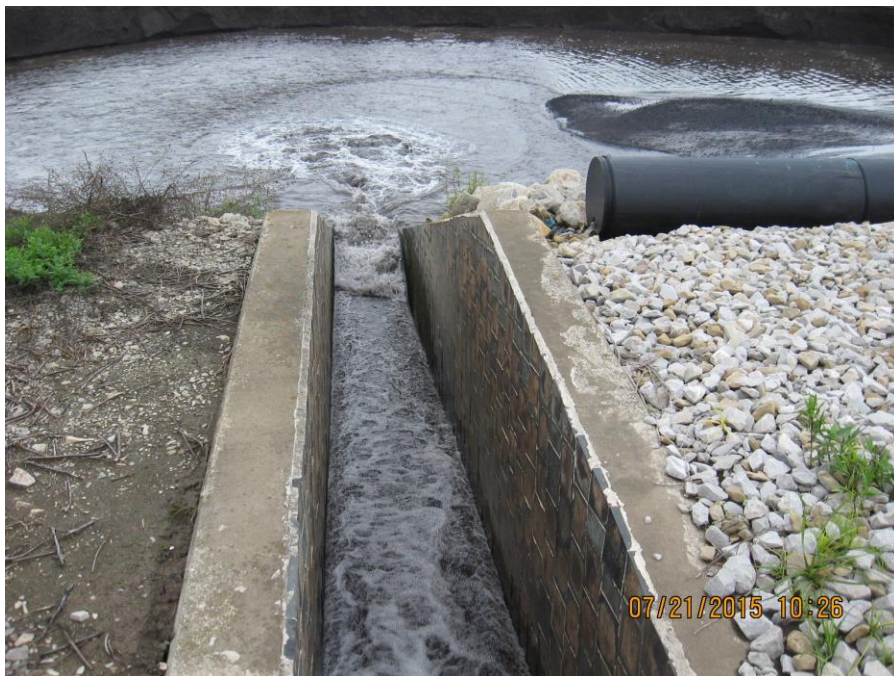
Photo 6: West Bottom Ash Pond: inlet structure.

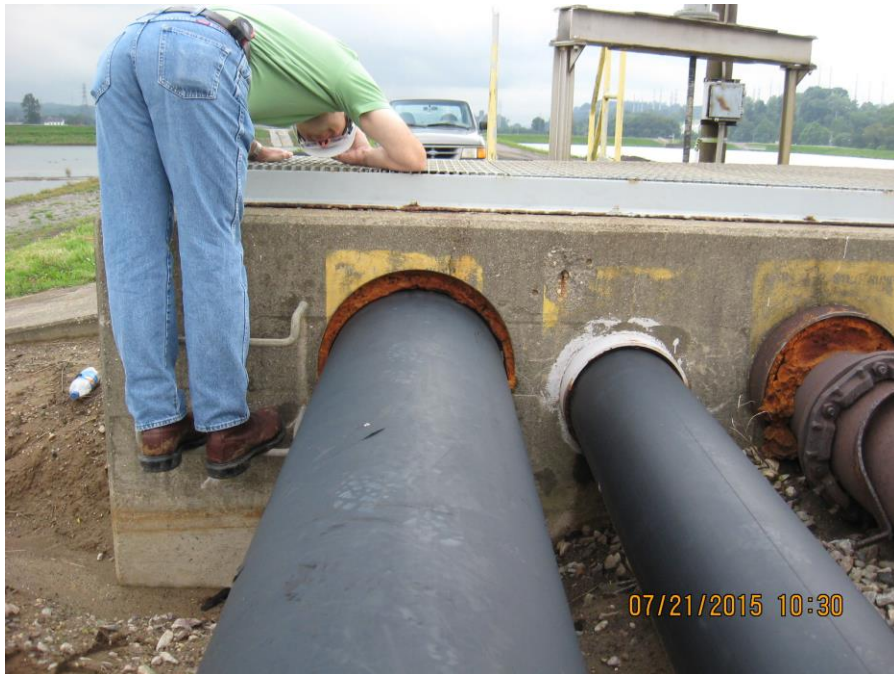
Photo 8: Bottom Ash Ponds: bottom ash inlet pipes and inlet structure.

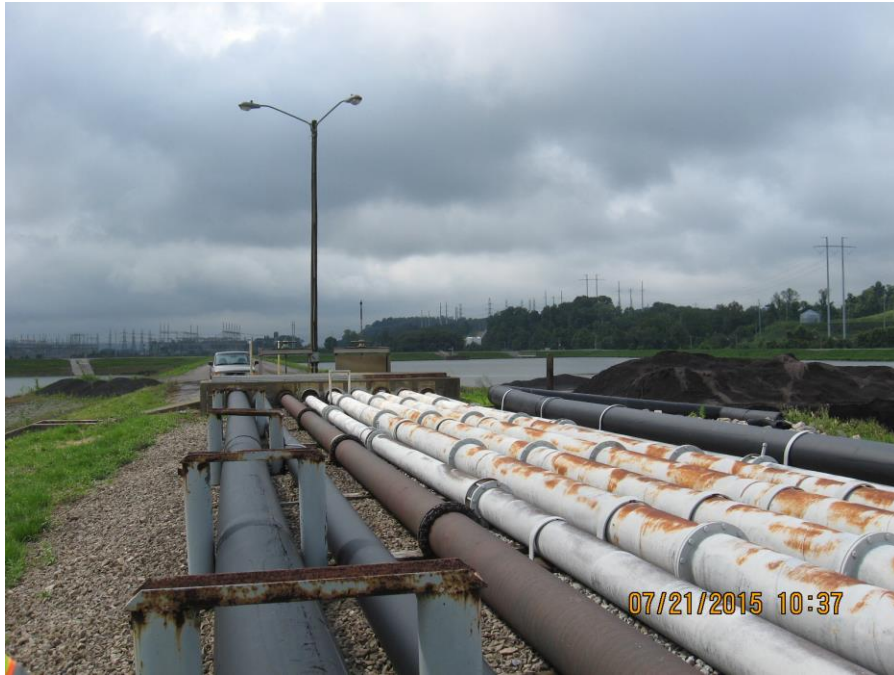
Photo 11: Bottom Ash Ponds, splitter dike: bottom ash inlet pipes.

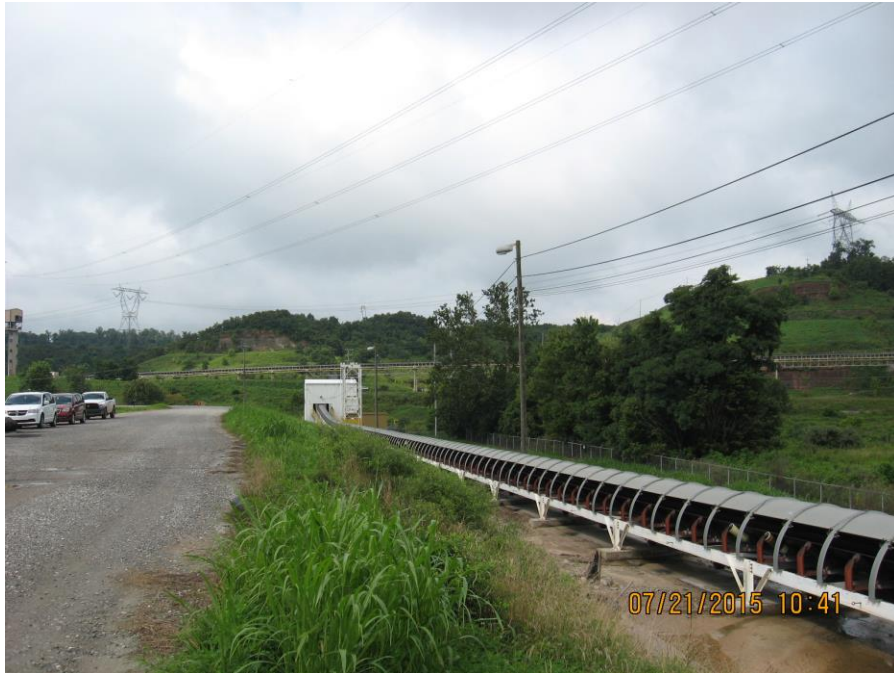
Photo 13: Bottom Ash Ponds, north dike: gypsum conveyor.

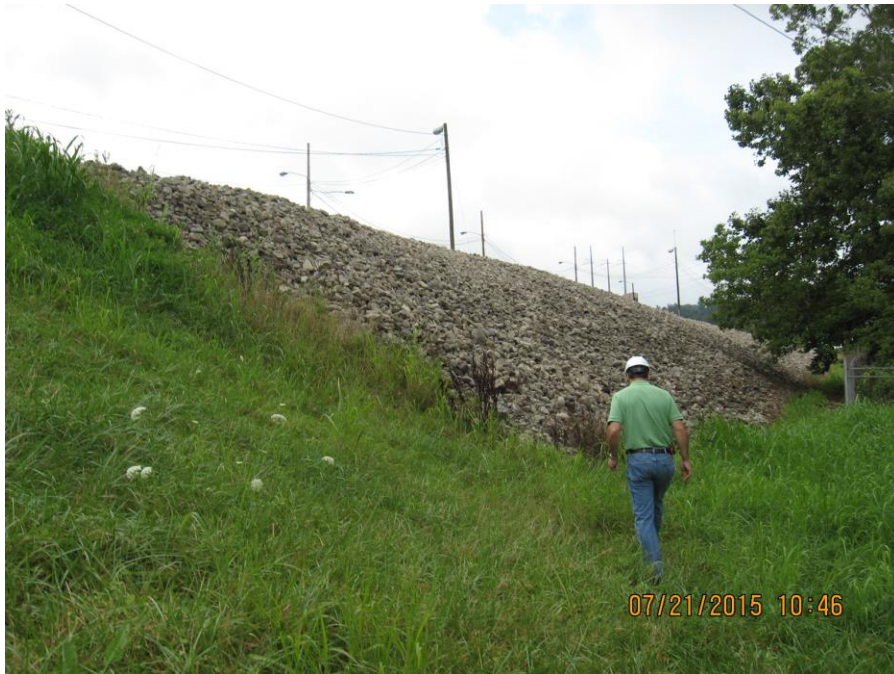
Photo 14: Bottom Ash Ponds, north dike: exterior slope.

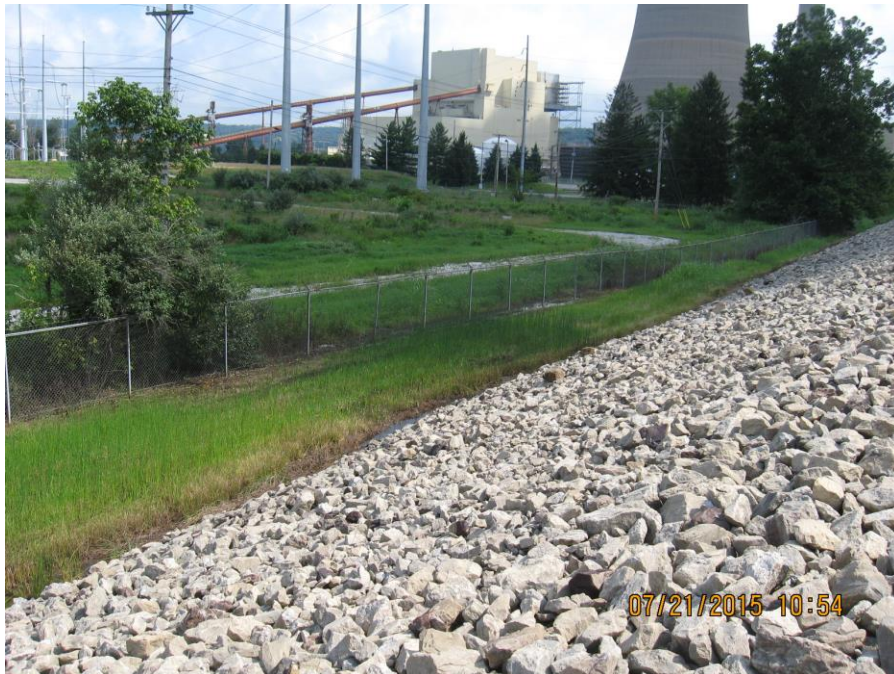
Photo 20: Bottom Ash Ponds, north dike: exterior slope.

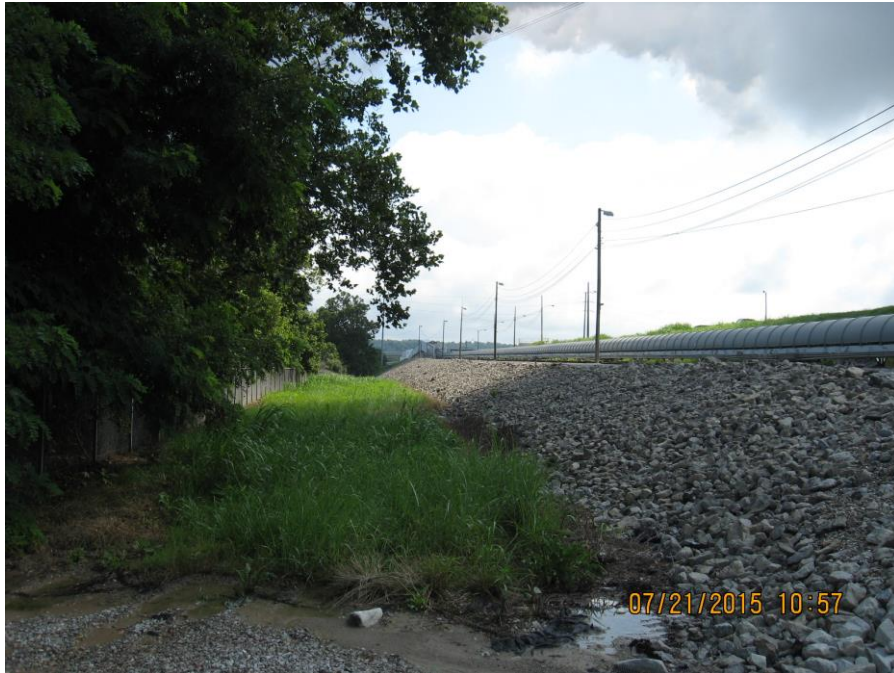
Photo 21: Bottom Ash Ponds, north dike: exterior slope.

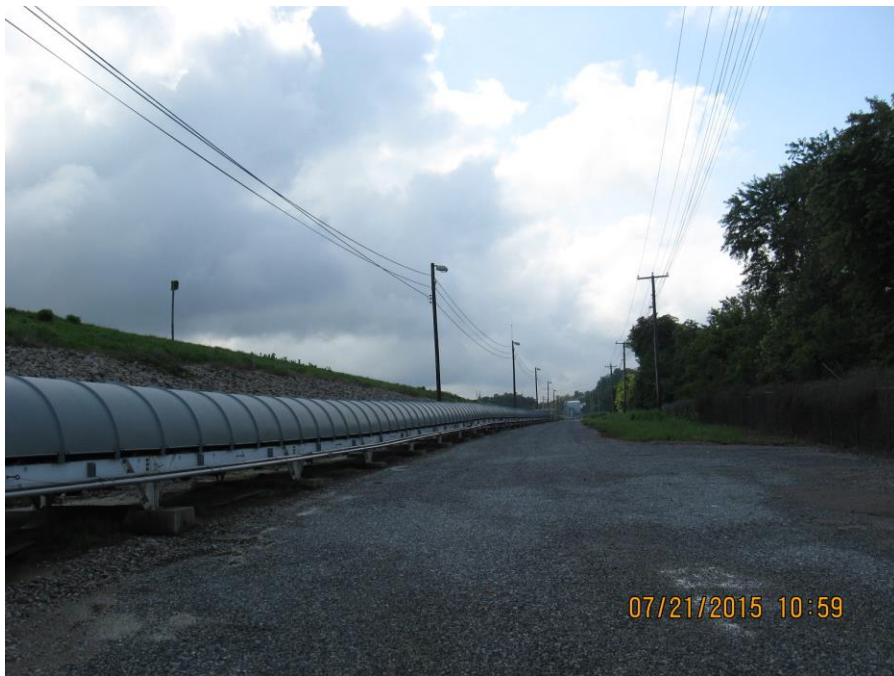
Photo 22: West Bottom Ash Pond, west dike: exterior slope.

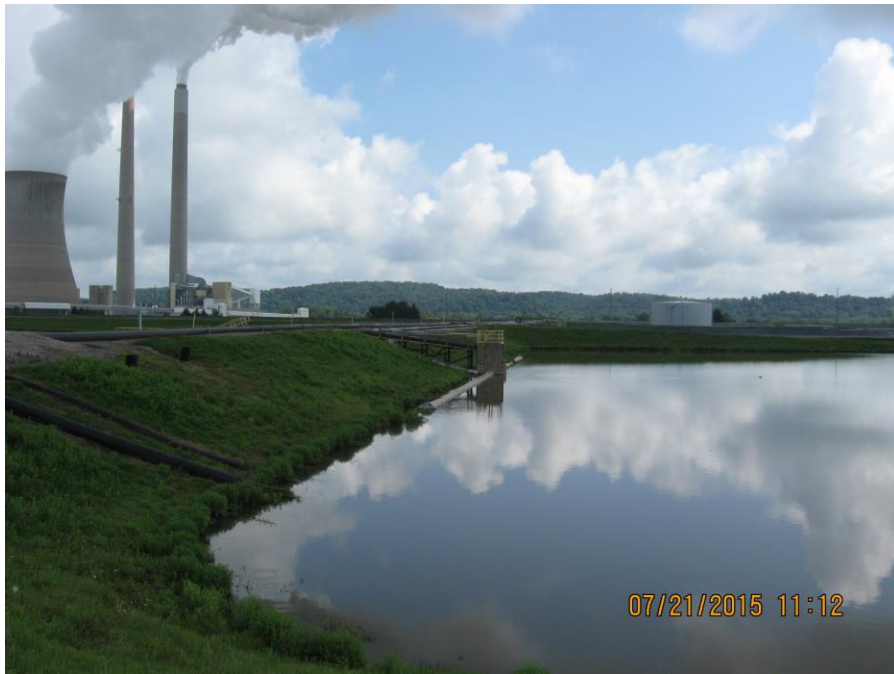
Photo 26: West Waste Water Pond, north dike.

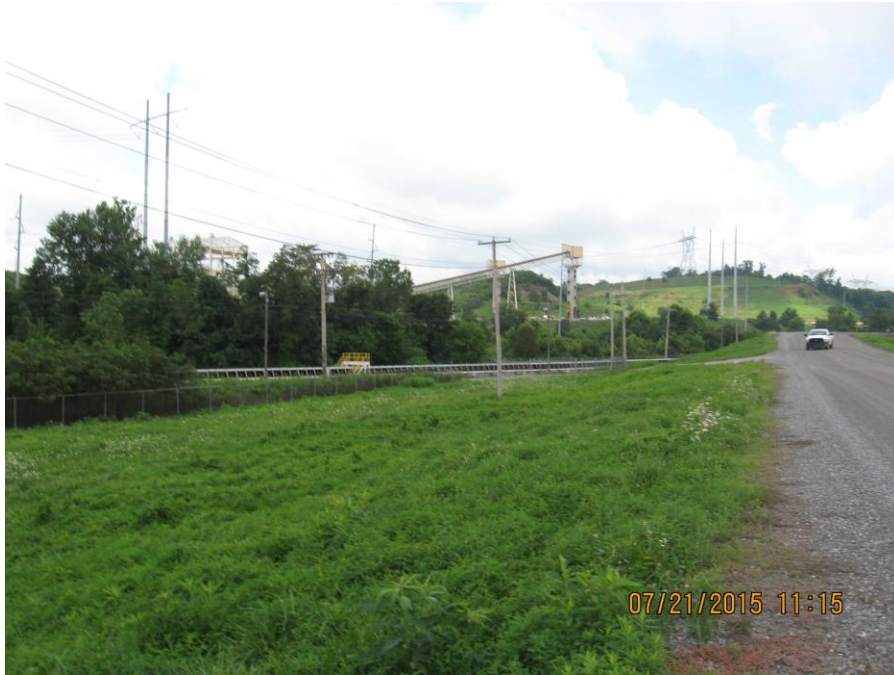
Photo 29: West Waste Water Pond, west dike.

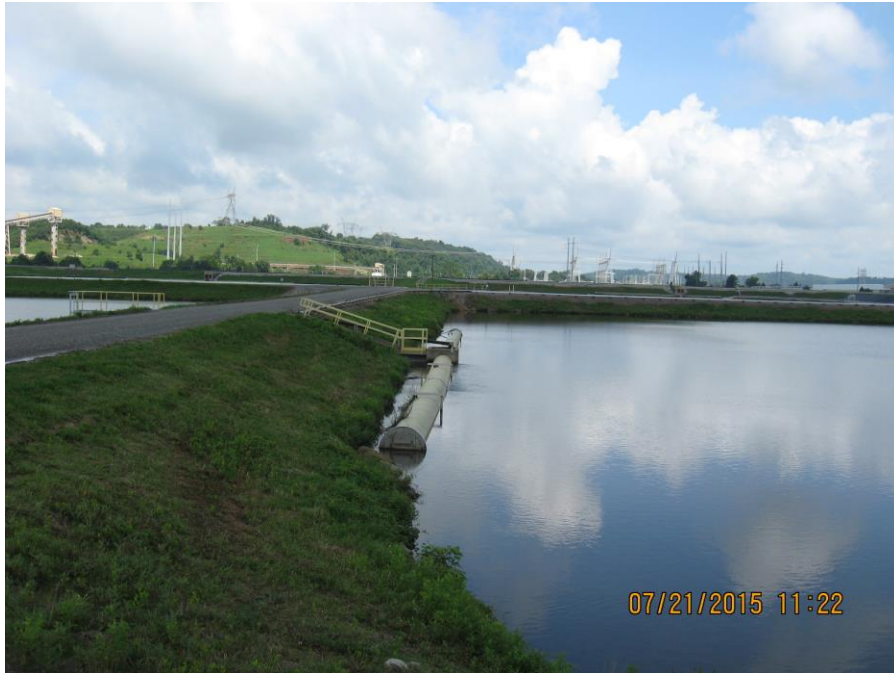
Photo 33: Clearwater Pond, west dike.

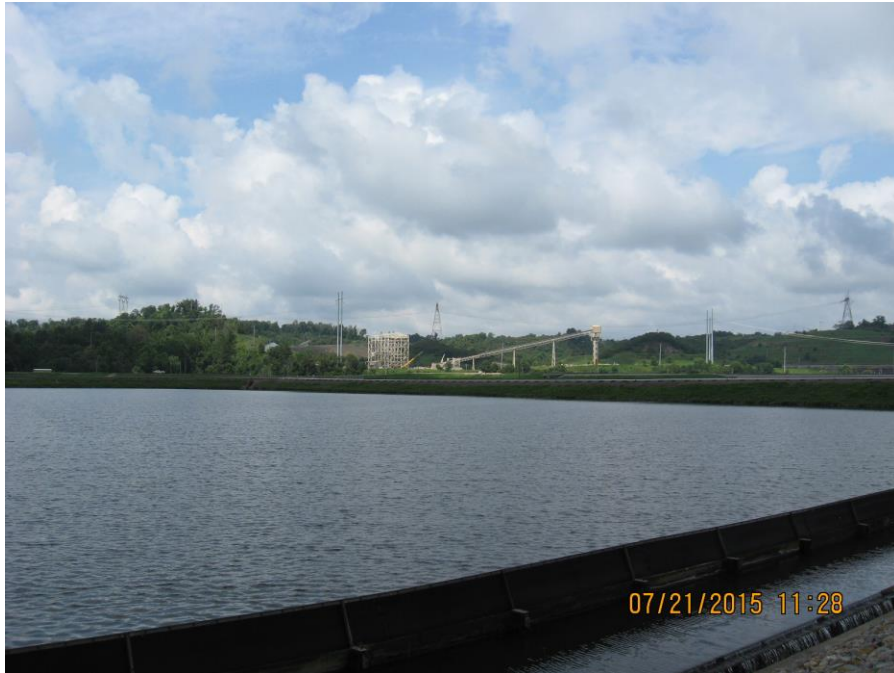
Photo 37: Clearwater Pond, north dike.

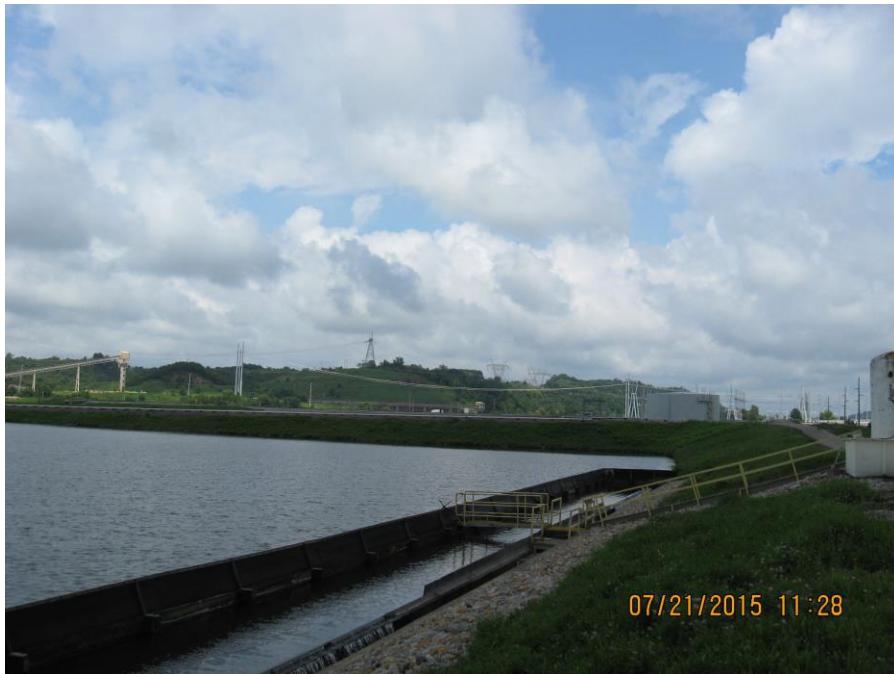
Photo 38: Clearwater Pond, east dike.

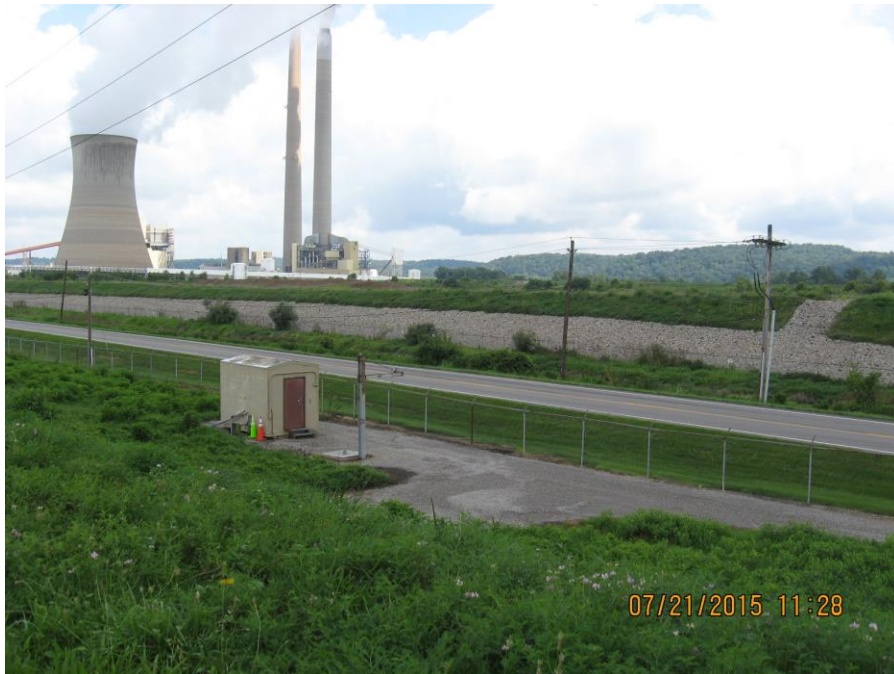
Photo 40: Clearwater Pond, east dike: exterior slope.

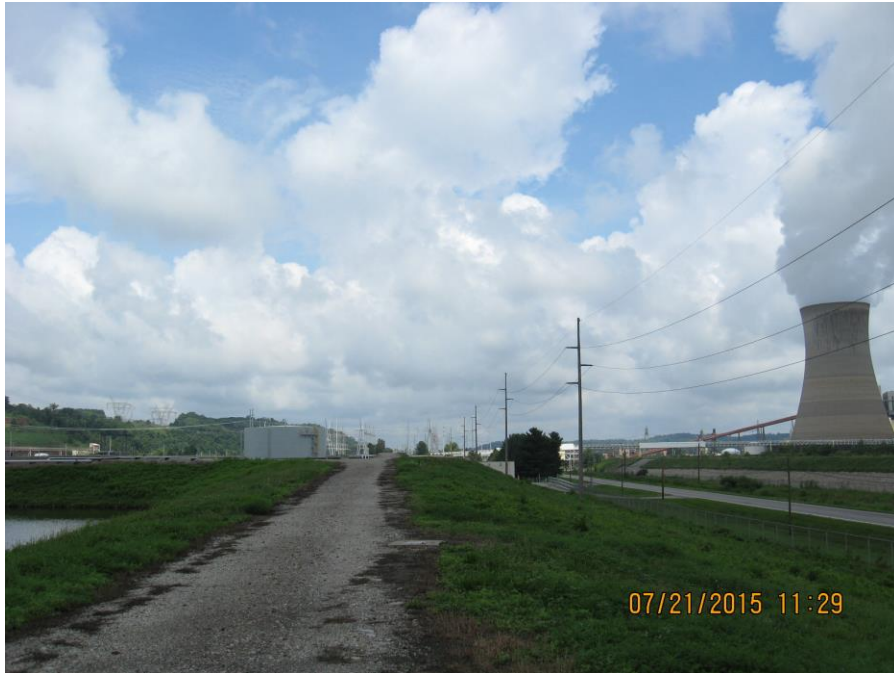
Photo 41: Clearwater Pond, east dike.

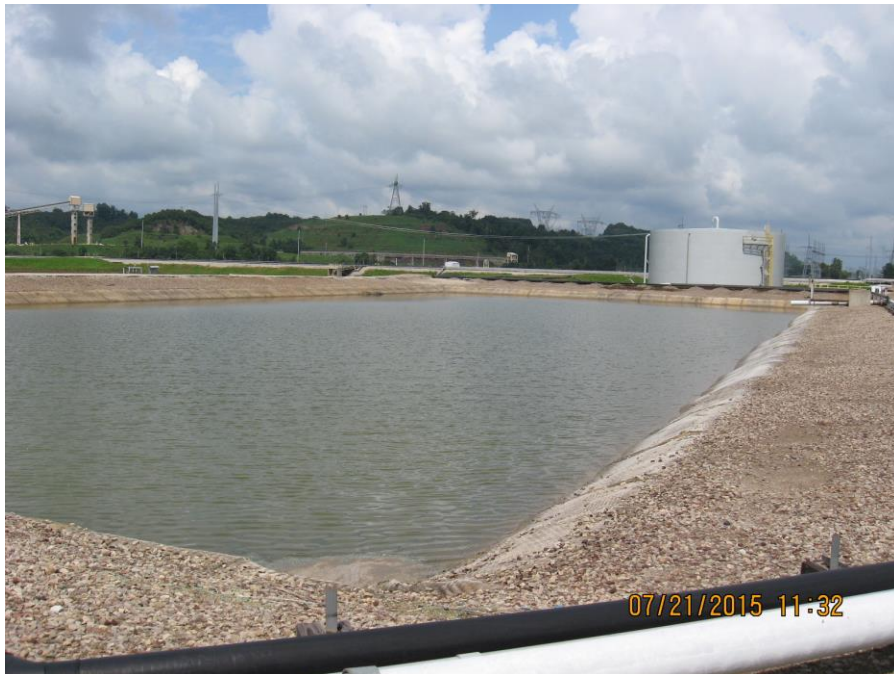
Photo 42: Leachate Surge Pond.

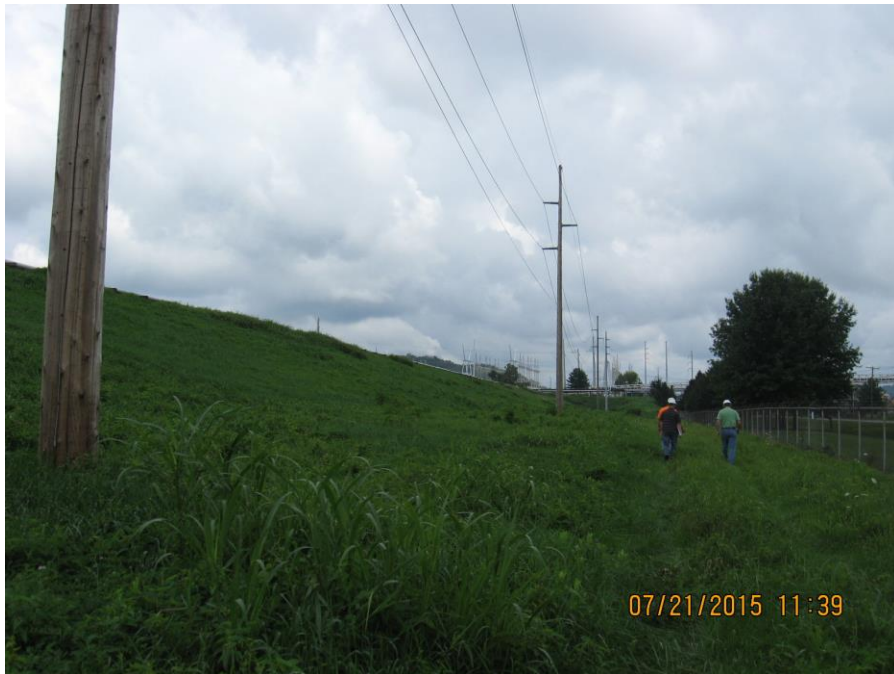
Photo 44: East Wastewater Pond, east dike.

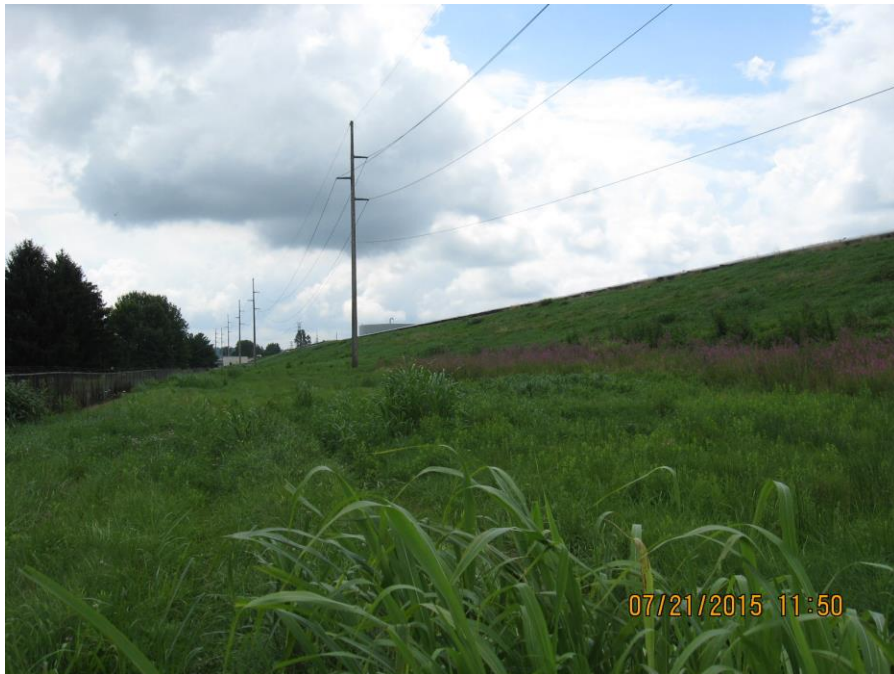
Photo 50: East Bottom Ash Pond, east dike: exterior slope.

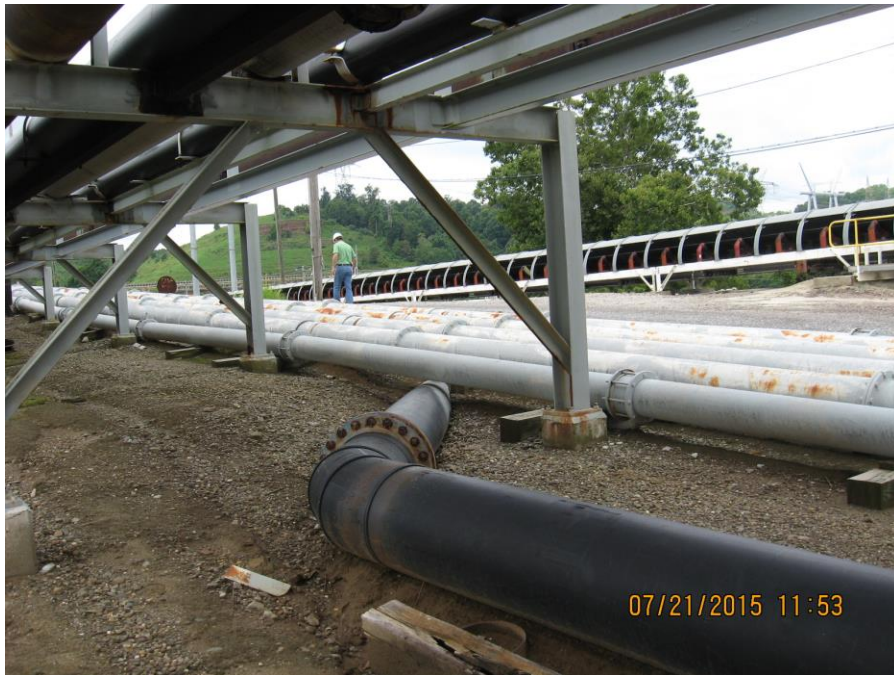
Photo 51: East Bottom Ash Pond, north dike: bottom ash inlet pipes.

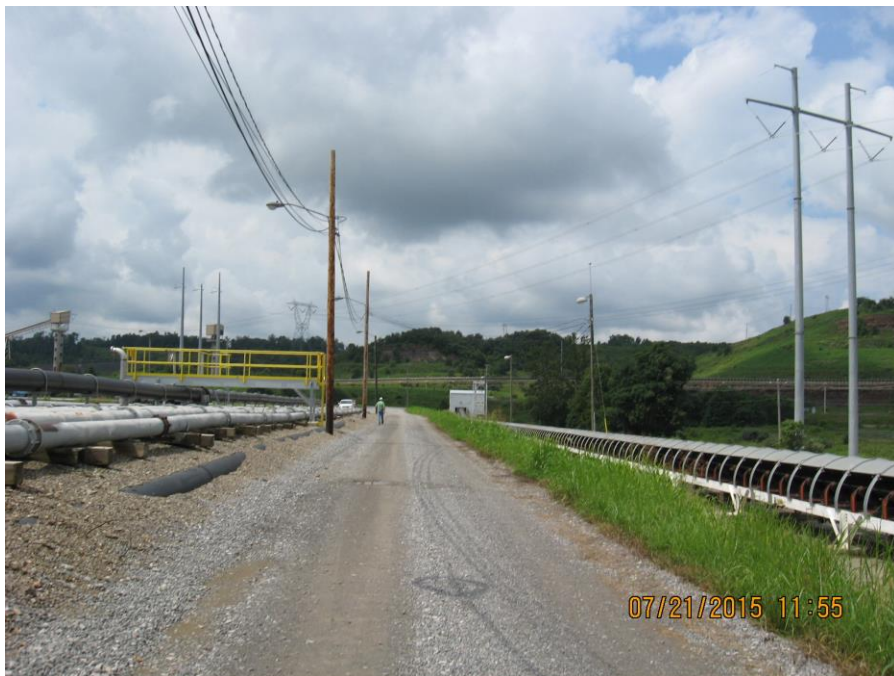
Photo 52: East Bottom Ash Pond, north dike.

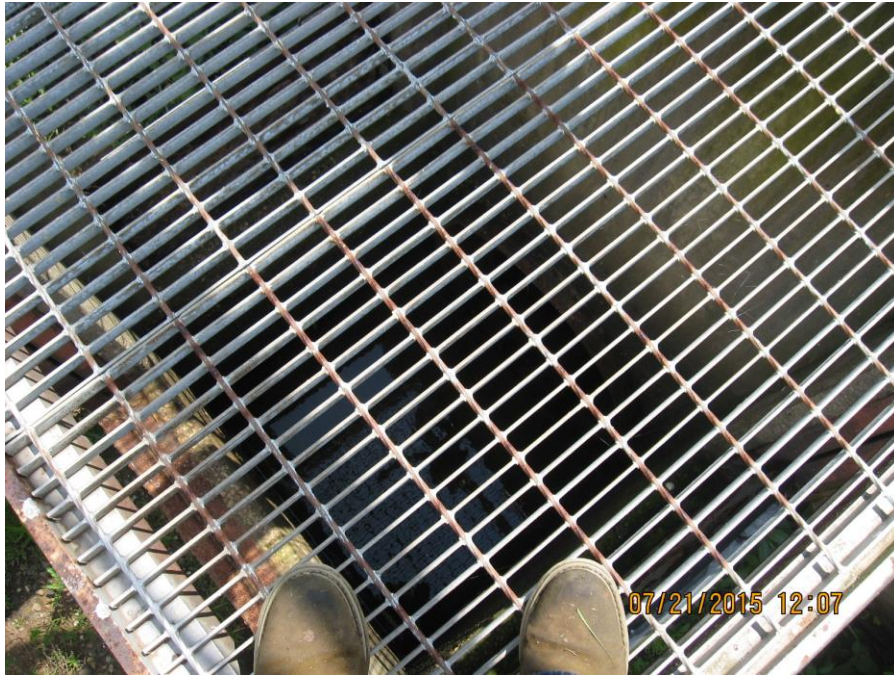
Photo 55: East Bottom Ash Pond, south dike: outlet structure.

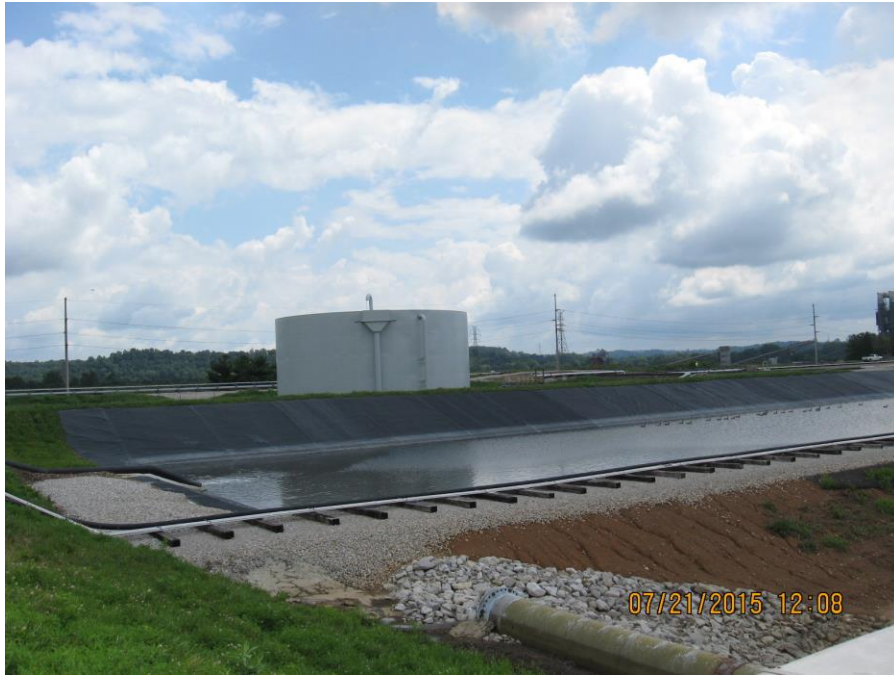
Photo 57: Leachate Surge Pond.

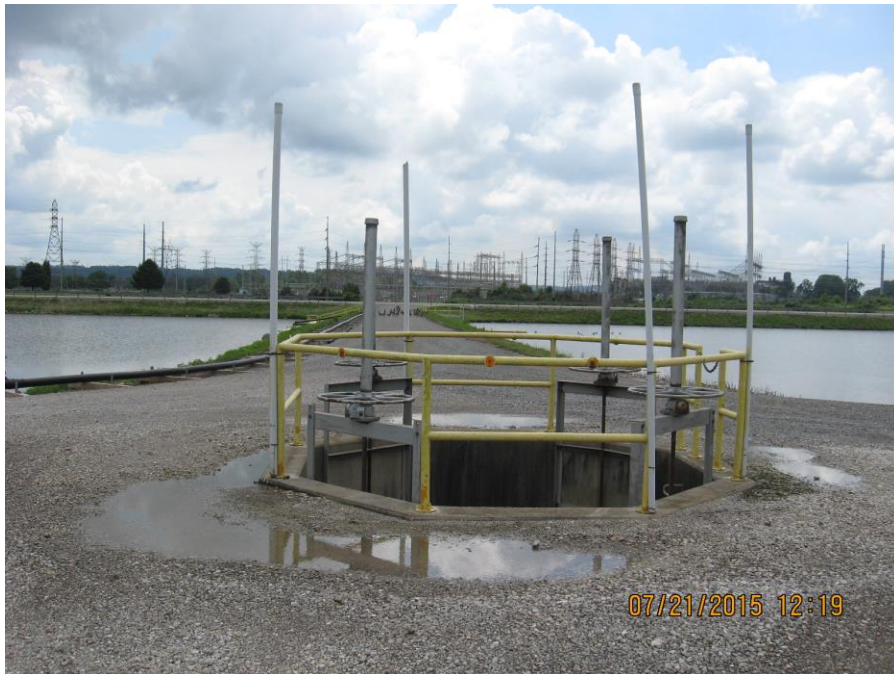
Photo 58: Waste Water Ponds: valve outlet structure.

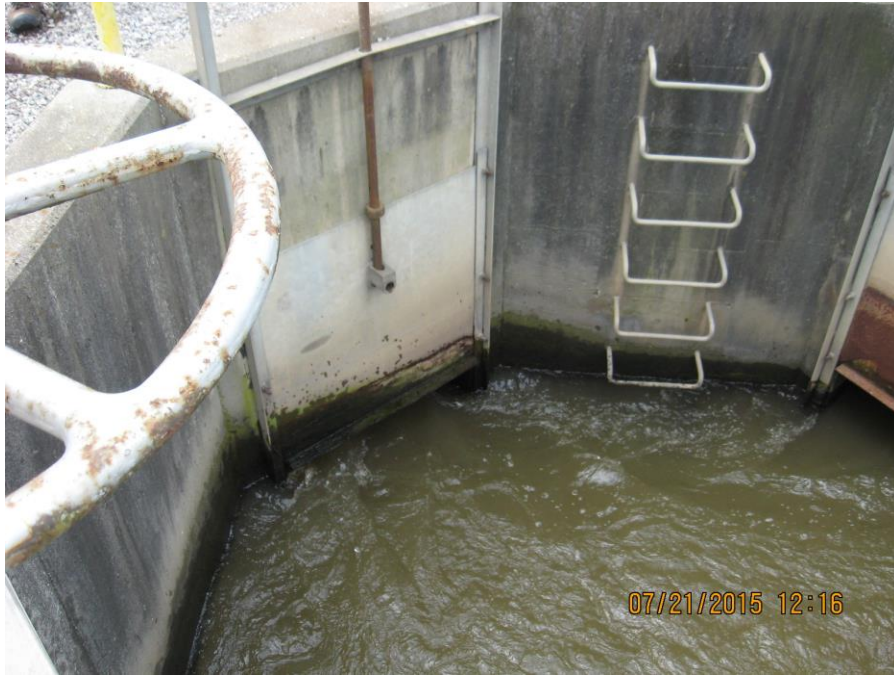
Photo 59: Waste Water Ponds: valve outlet structure.

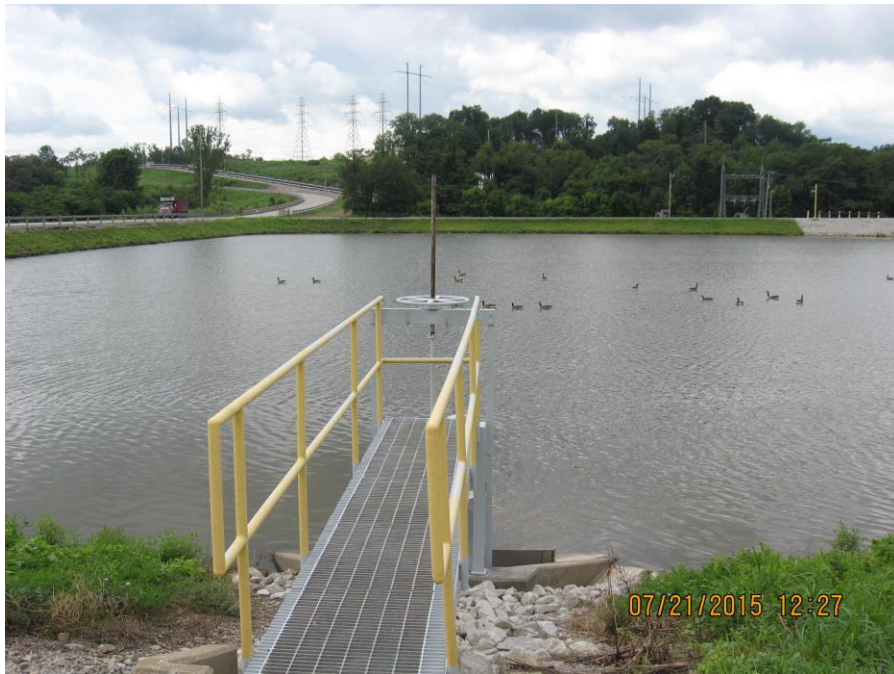
Photo 60: Clearwater Pond: outlet structure.

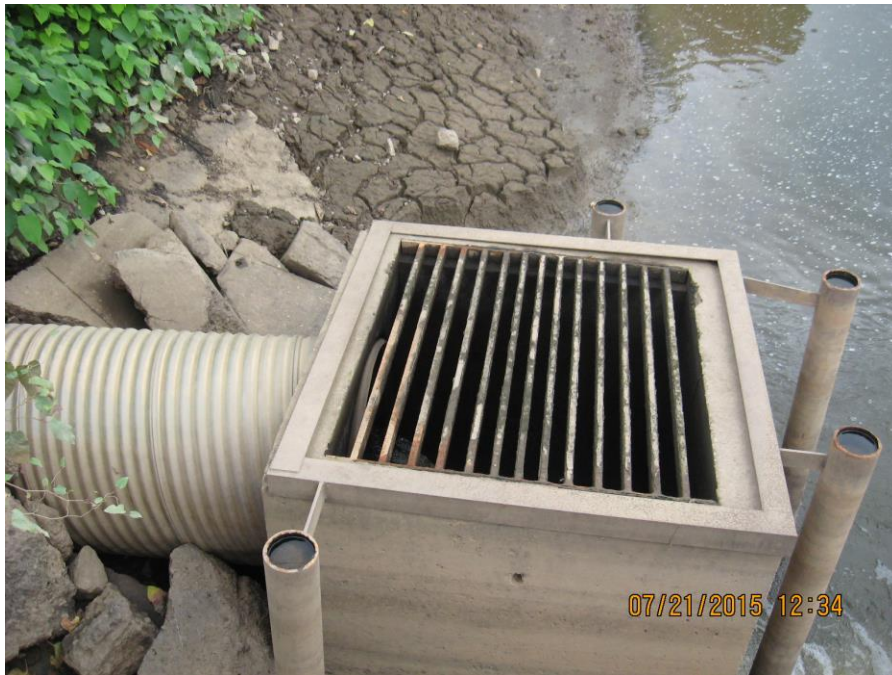
Photo 61: Ohio River outlet structure.
