2025 Annual Dam and Dike Inspection Report

**Wastewater Pond Dam
(Primary Bottom Ash Pond – CCR Unit)**

**Flint Creek Plant
Southwestern Electric Power Company
Gentry, Arkansas**

Document Number: GERS-25-038

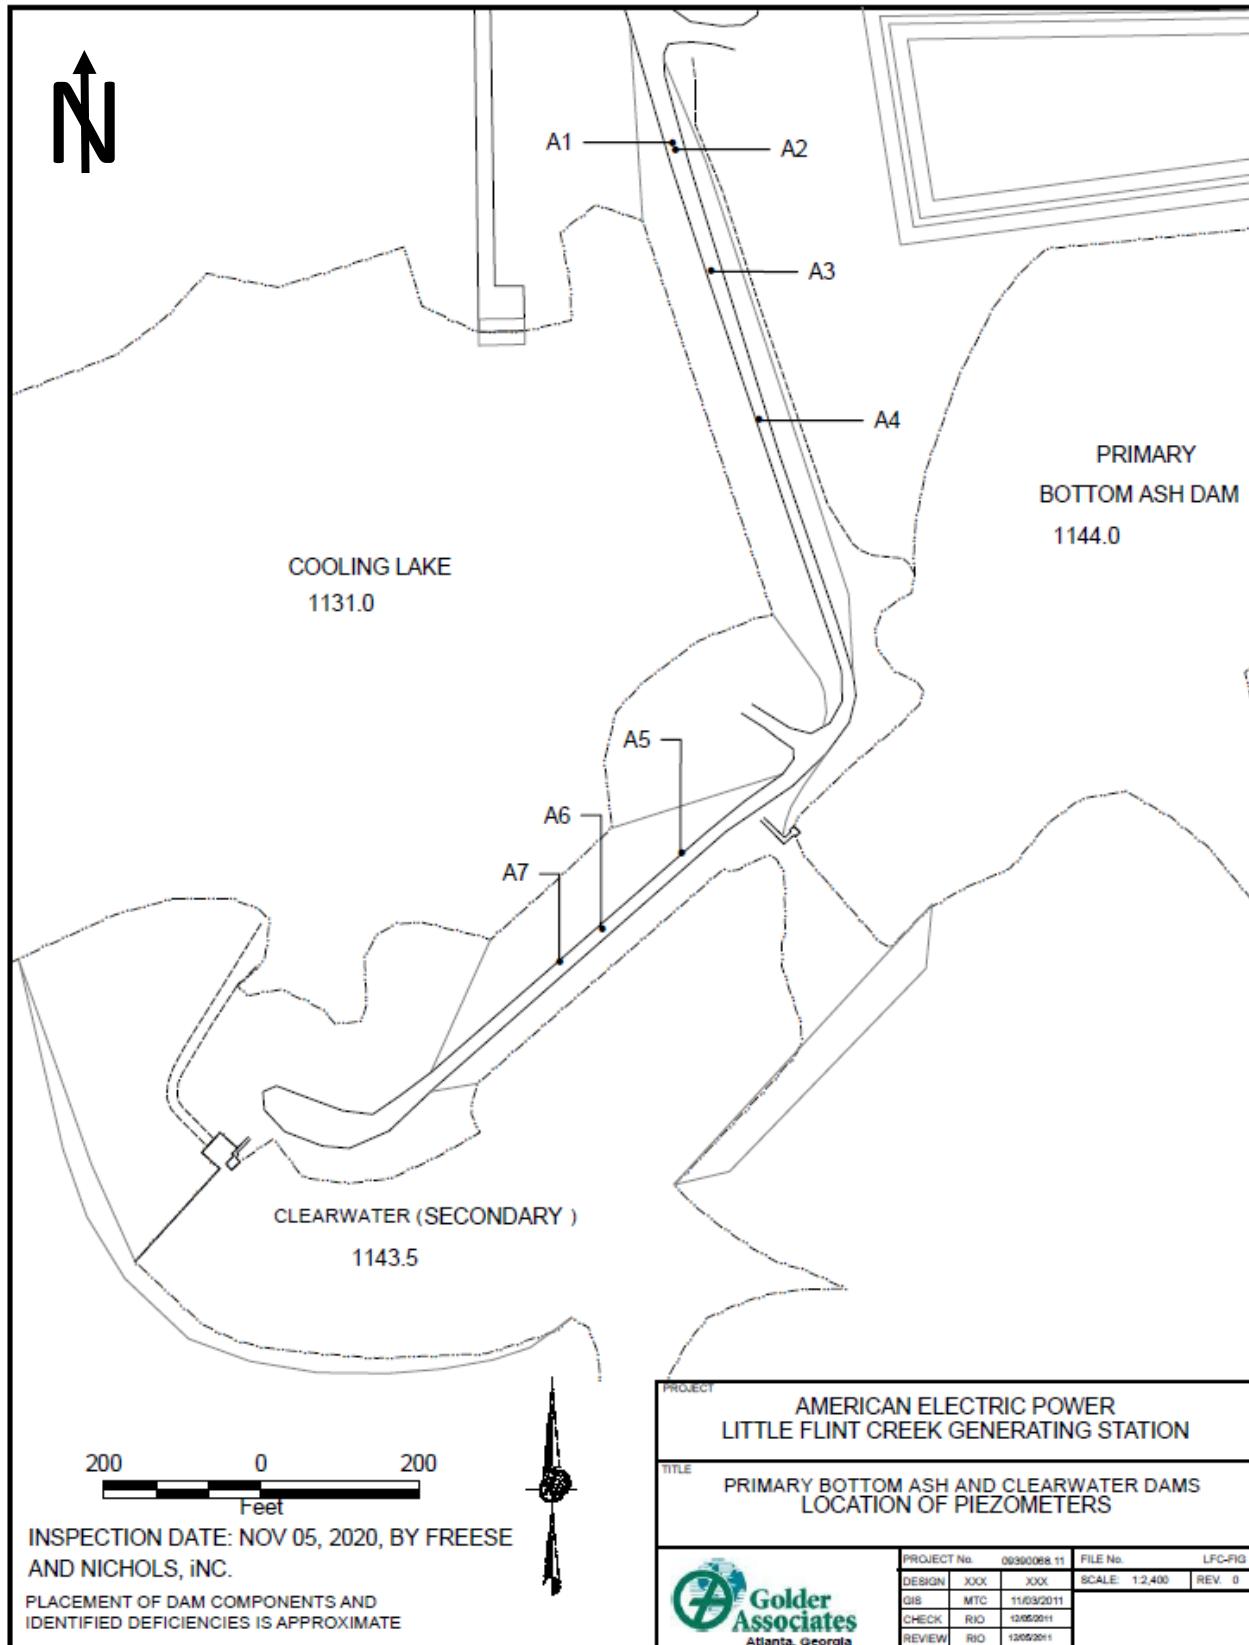
Figure 2 – Piezometer Location Map
Primary Bottom Ash Pond, Flint Creek Plant, Gentry, AR

There are four piezometers located along the crest of the dam as shown on Figure 2. These are the only instrumentation related to this facility. A review of readings since the last inspection and historical readings (2017-2025) indicate the levels are consistent and respond to the fluctuation of the cooling lake level. The piezometers are more influenced by the

level of the cooling lake than the elevation of the Wastewater Pond. A spike was noticed in Piezometers A1-A3 in April 2023 and A4 in August 2023. Piezometers A1-A3 were damaged by construction equipment and were replaced in June 2023. Typically, the trend in the historical data between the piezometers reading, lake level, and pond levels are consistent. Once the pond resume to its normal operating condition, the piezometer reading shall be checked and compared to its historical readings. Table 1 lists the maximum piezometer reading since the last annual inspection. Figure 3 provides historical data plot of the piezometer readings over the past several years.
