# **2025 Annual Landfill Inspection Report**

**Little Broad Run Landfill**

**Mountaineer Plant  
New Haven, West Virginia**

**Date of Inspection:** October 16, 2025

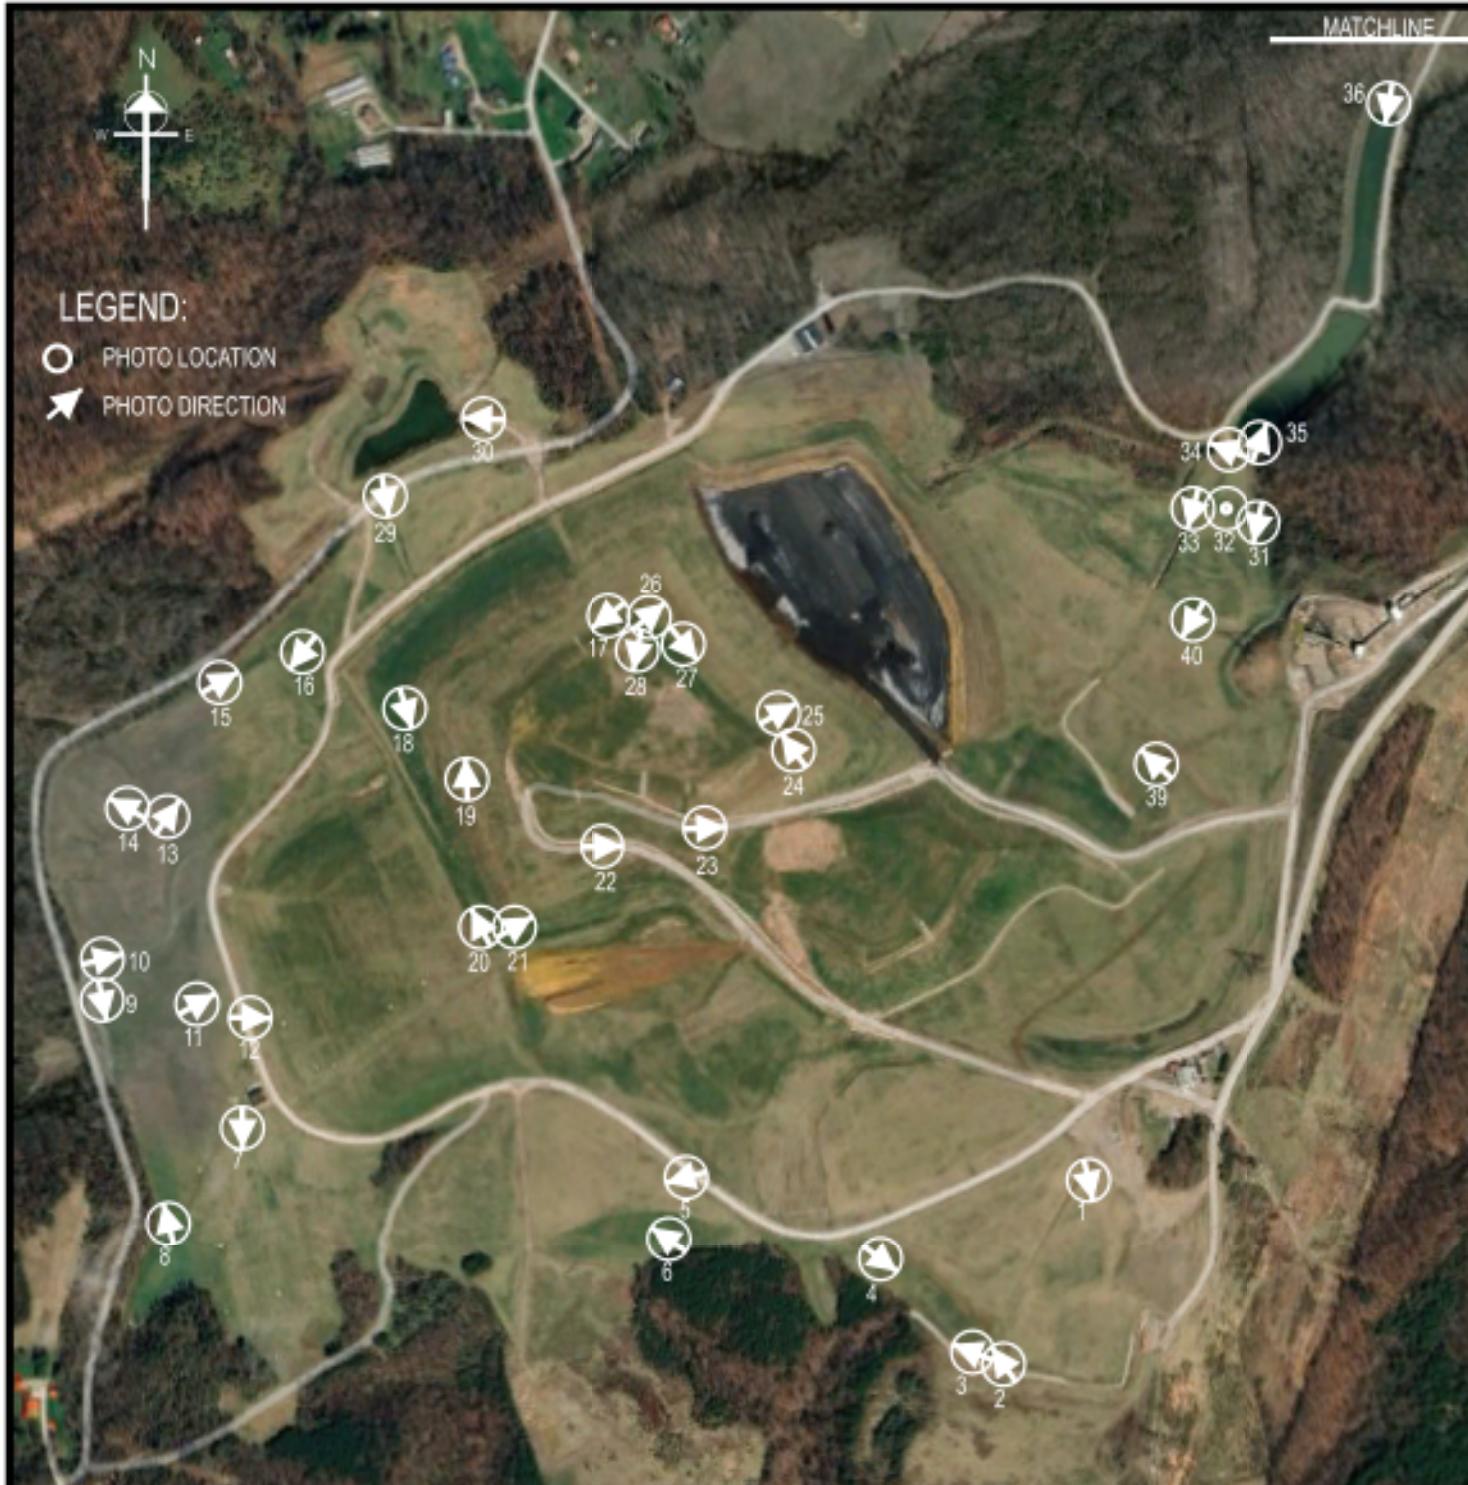
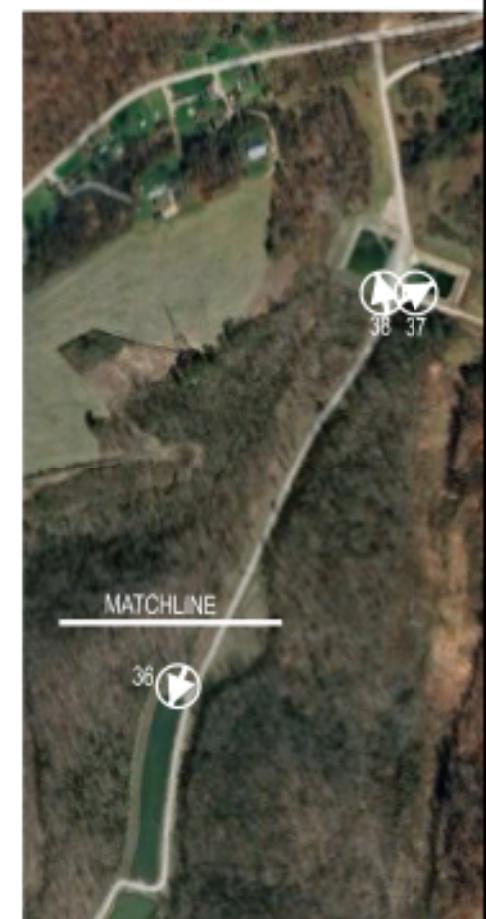
DRAWING NUMBER: FIGURE 3  
 POWER COMPANY: MOUNTAINEER PLANT  
 LANDFILL  
 PHOTO FIGURE

Overall, the facility is in satisfactory condition. The landfill is functioning as intended with no signs of potential structural weakness or conditions which are disrupting to the safe operation of the landfill. Inspection photos are included in Appendix A. Additional pictures taken during the inspection can be made available upon request. A site map presenting locations of the inspection observations is included in Figure 3.
