FGD Stackout Pad Area
2025 Annual Landfill Inspection
Report

H.W. Pirkey Power Plant, Hallsville, Texas

August 30, 2025
Project 2501323
AEP Document ID: GEVR-25-003

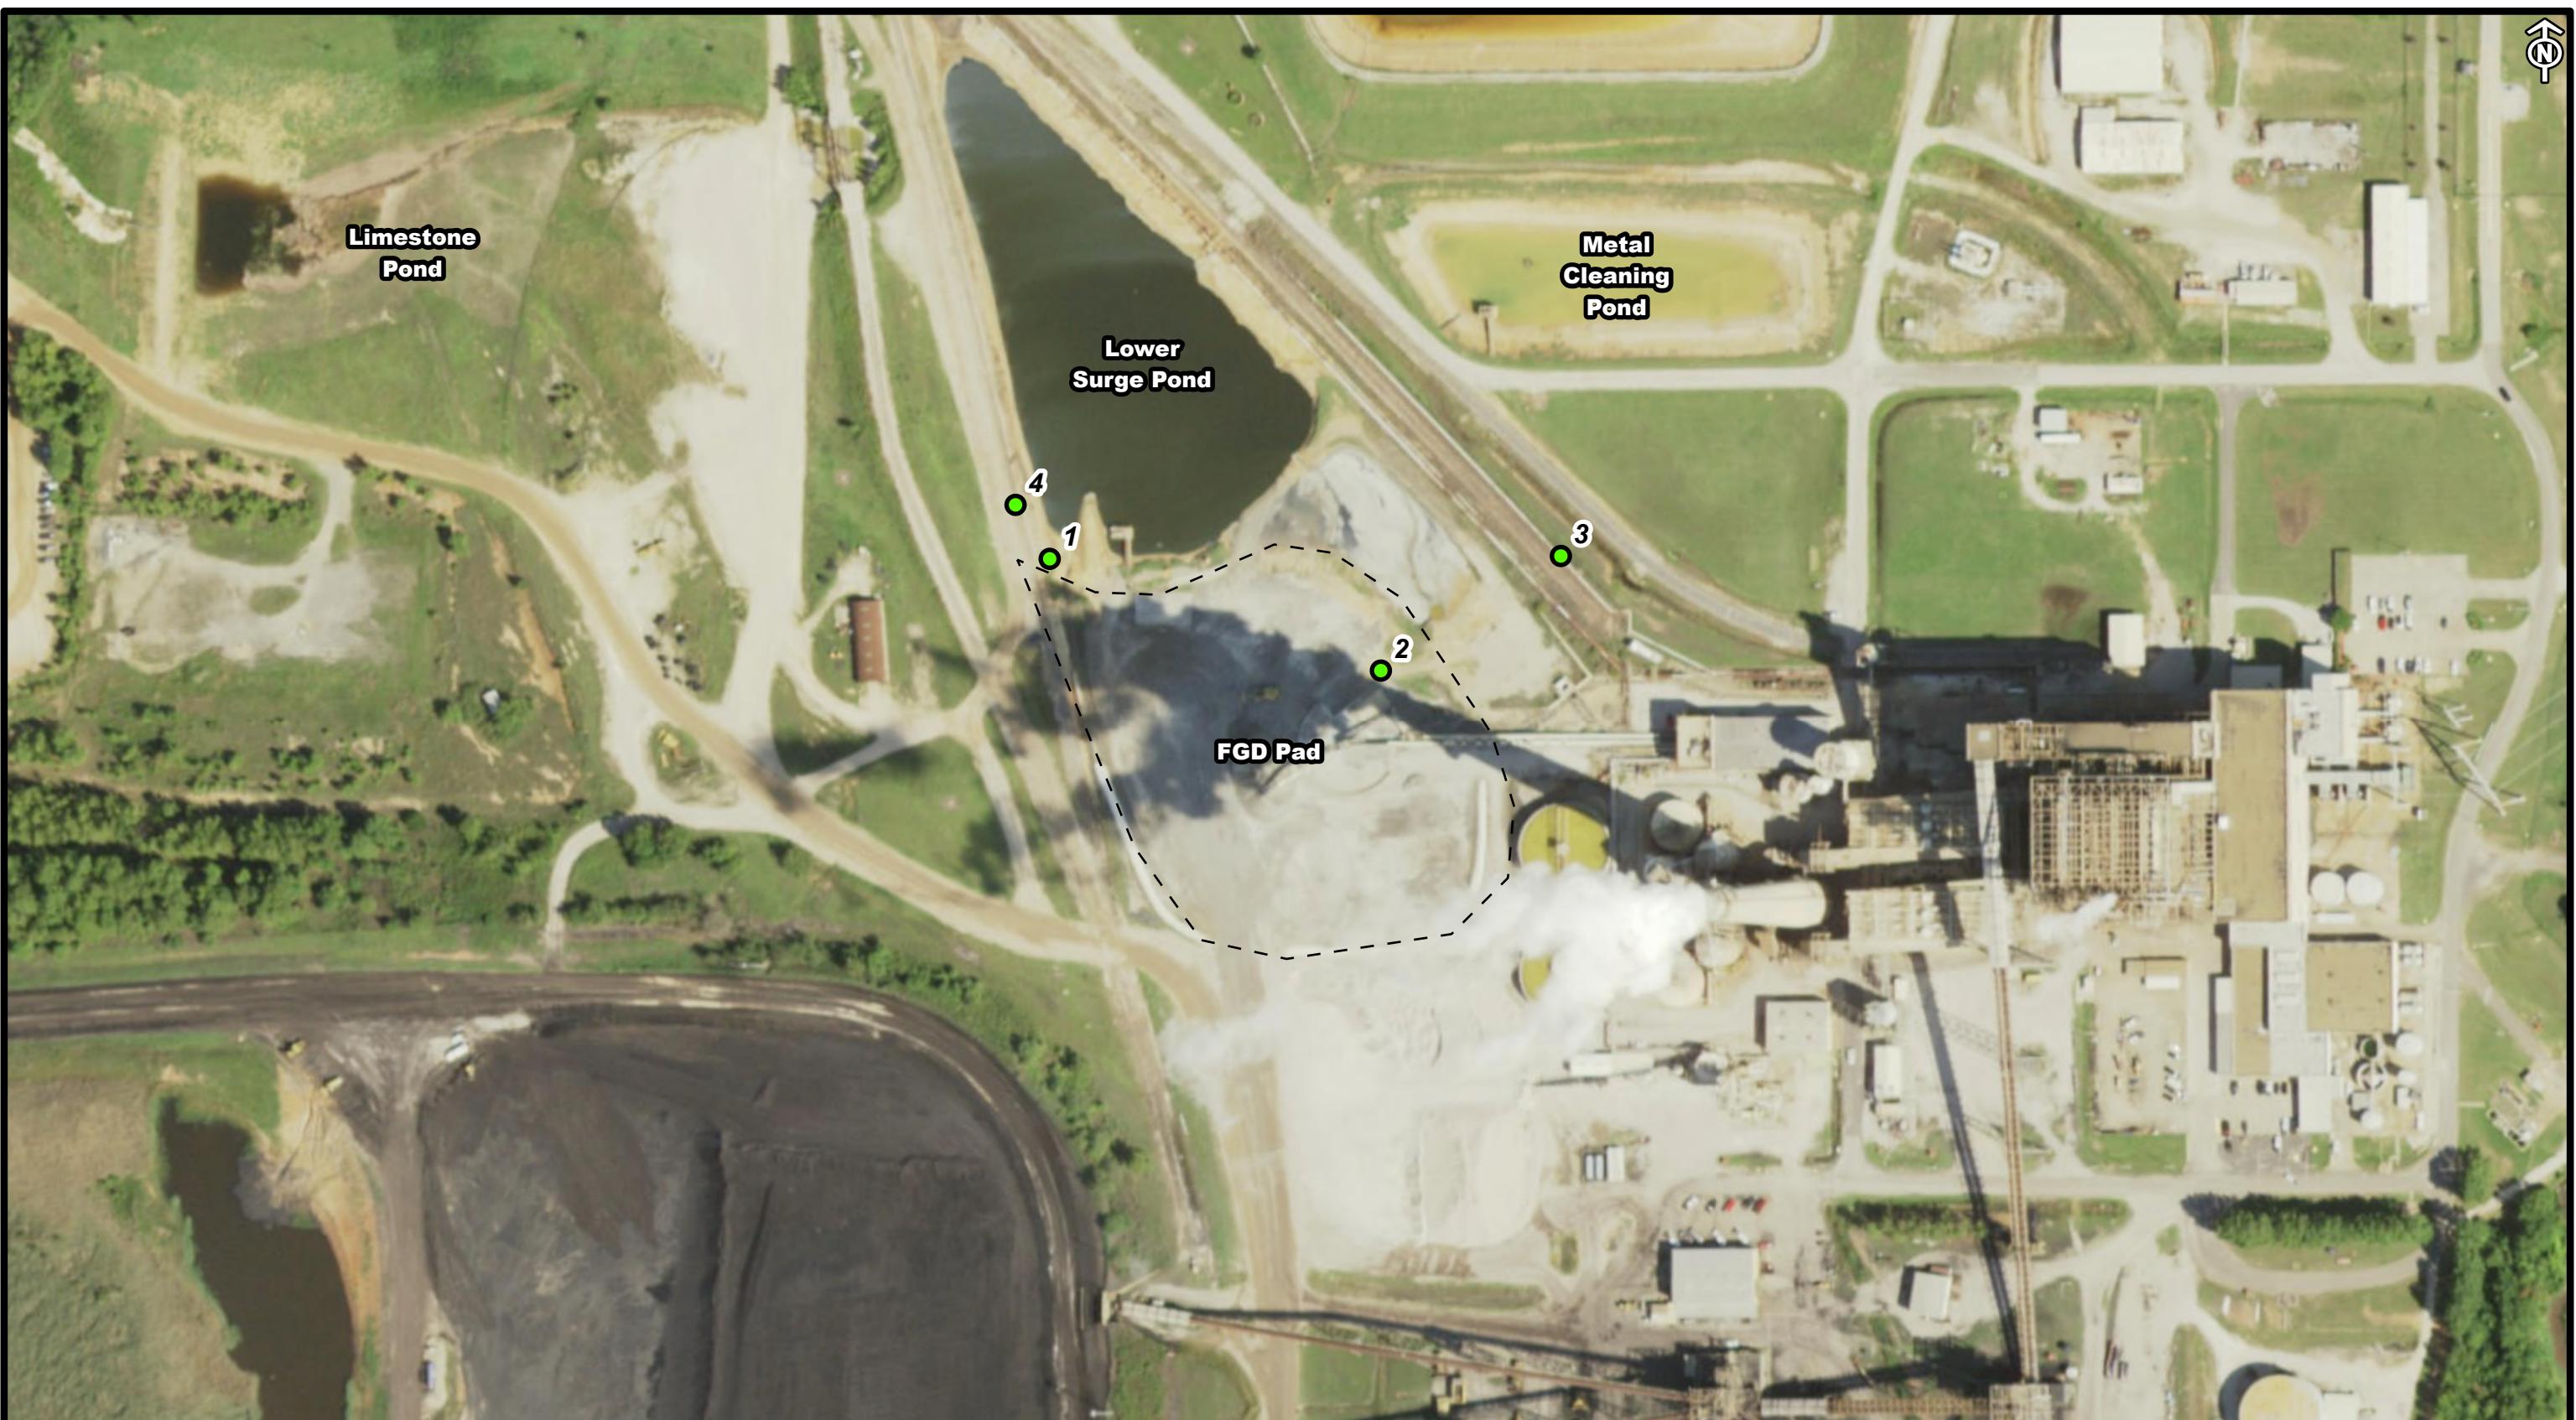
Figure 3 – Site Plan

Photographs taken during the inspection are included in Appendix A - Photolog. Each photograph that was captured during the inspection was tagged as either a general site observation, recommended for monitoring, or recommended as an item to be addressed. Our inspection did not identify any items to be monitored or addressed in the FGD Stackout Pad Area. The site observations are presented on Figure 3 – Site Plan.
