Bottom Ash Ponds
2025 Annual Dam and Dike
Inspection Report

H.W. Pirkey Power Plant, Hallsville, Texas

August 30, 2025
Project 2501323
AEP Document ID: GEVR-25-001

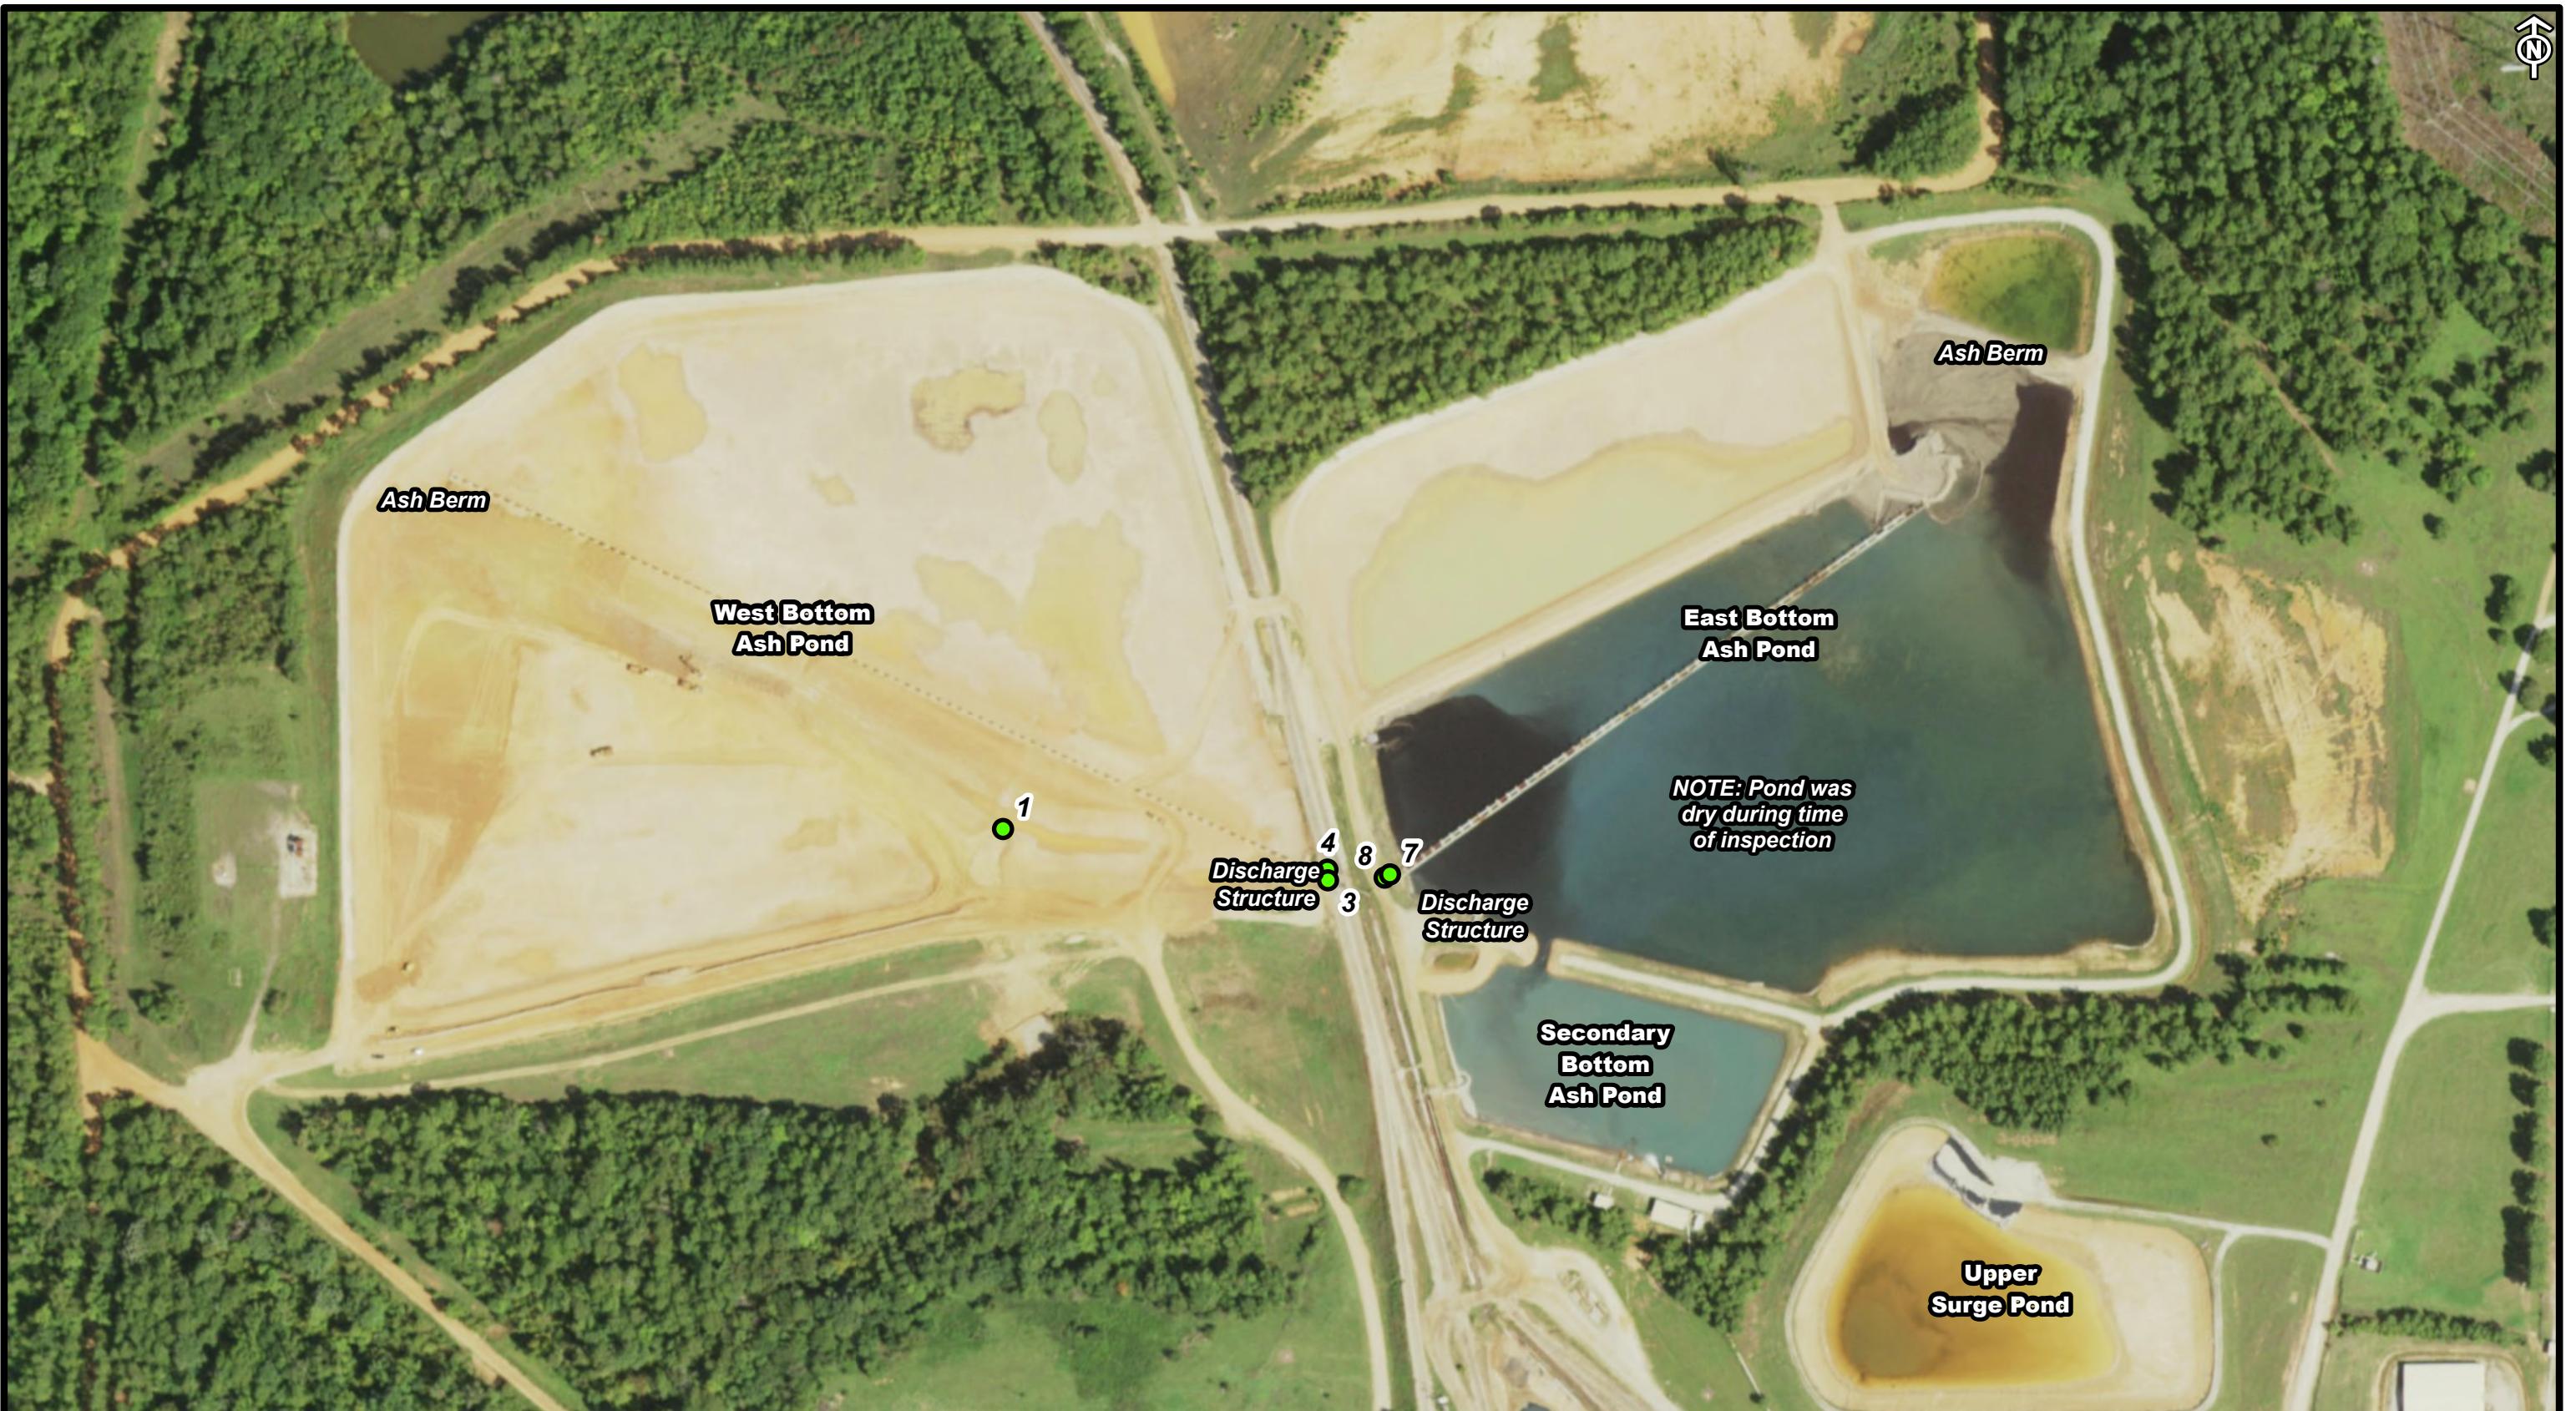
Photographs taken during the inspection are included in Appendix A - Photolog. Each photograph that was captured during the inspection was tagged as either a general site observation, recommended for monitoring, or recommended as an item to be addressed. Our inspection did not identify any items to be monitored in the Bottom Ash Pond Complex. The site observations are presented on Figure 3 – Site Plan and the items to be addressed are provided on Figure 4.
