2025 Rockport Landfill Annual Inspection Report

**Rockport Plant
Indiana Michigan Power Company
Rockport, Indiana**

October 2025

Document ID: GERS-25-018

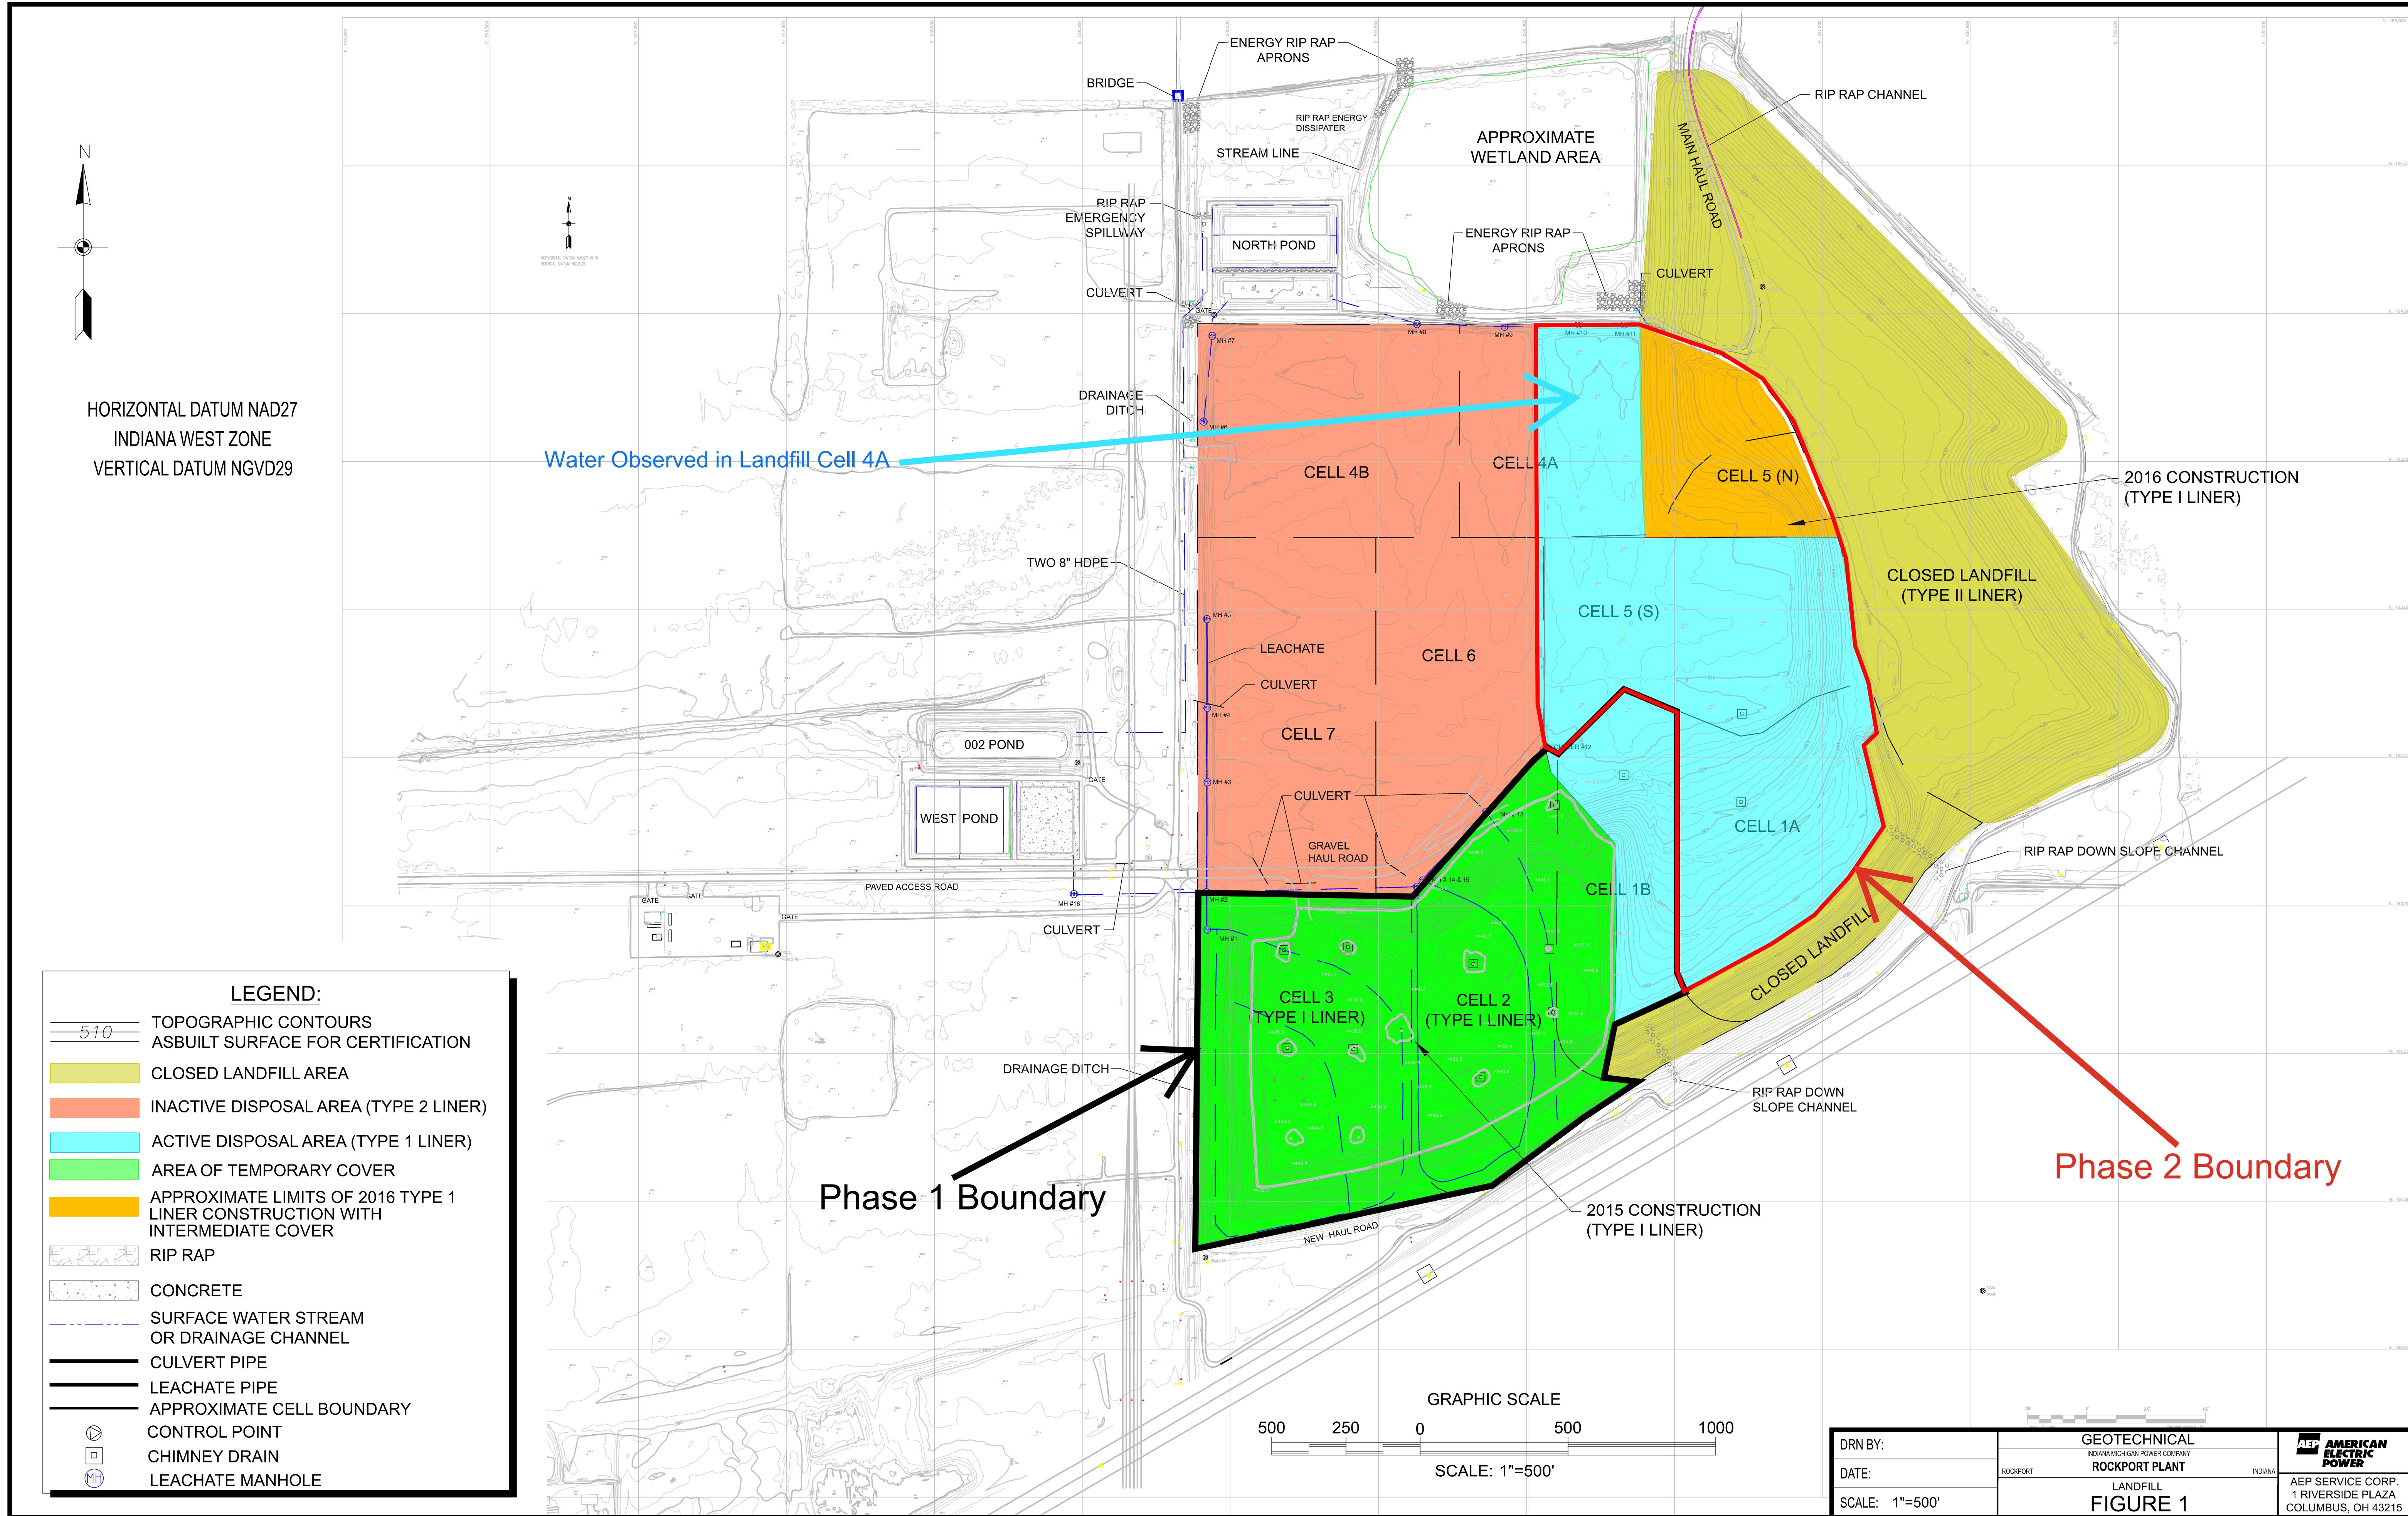
Figure 1 – Rockport Landfill Inspection Map 2025

These features, along with the approximate boundaries of each area, are illustrated in Figure 1.

The Closed Landfill Area is located on the east and south sides of the landfill as shown in Figure 1. This area of the landfill was constructed between 1985 and 1987 and was used for disposal of Type II ash. The area was closed and final cover was placed between 2000 and 2007. The final cover consists of twenty-four (24) inch thick compacted clay cover and a six (6) inch thick topsoil cover to support vegetation.

with drainage channel adjacent to the temporary containment berm. The channel directs stormwater flow to the west to a perimeter drainage channel. Phase 1 is presented on the attached Figure 1.
