### CCR Landfill

## 2025 Annual Landfill Inspection Report

Turk Power Plant, Fulton, Arkansas

May 1, 2025  
Project 2501323  
AEP Document ID: GEVR-25-009

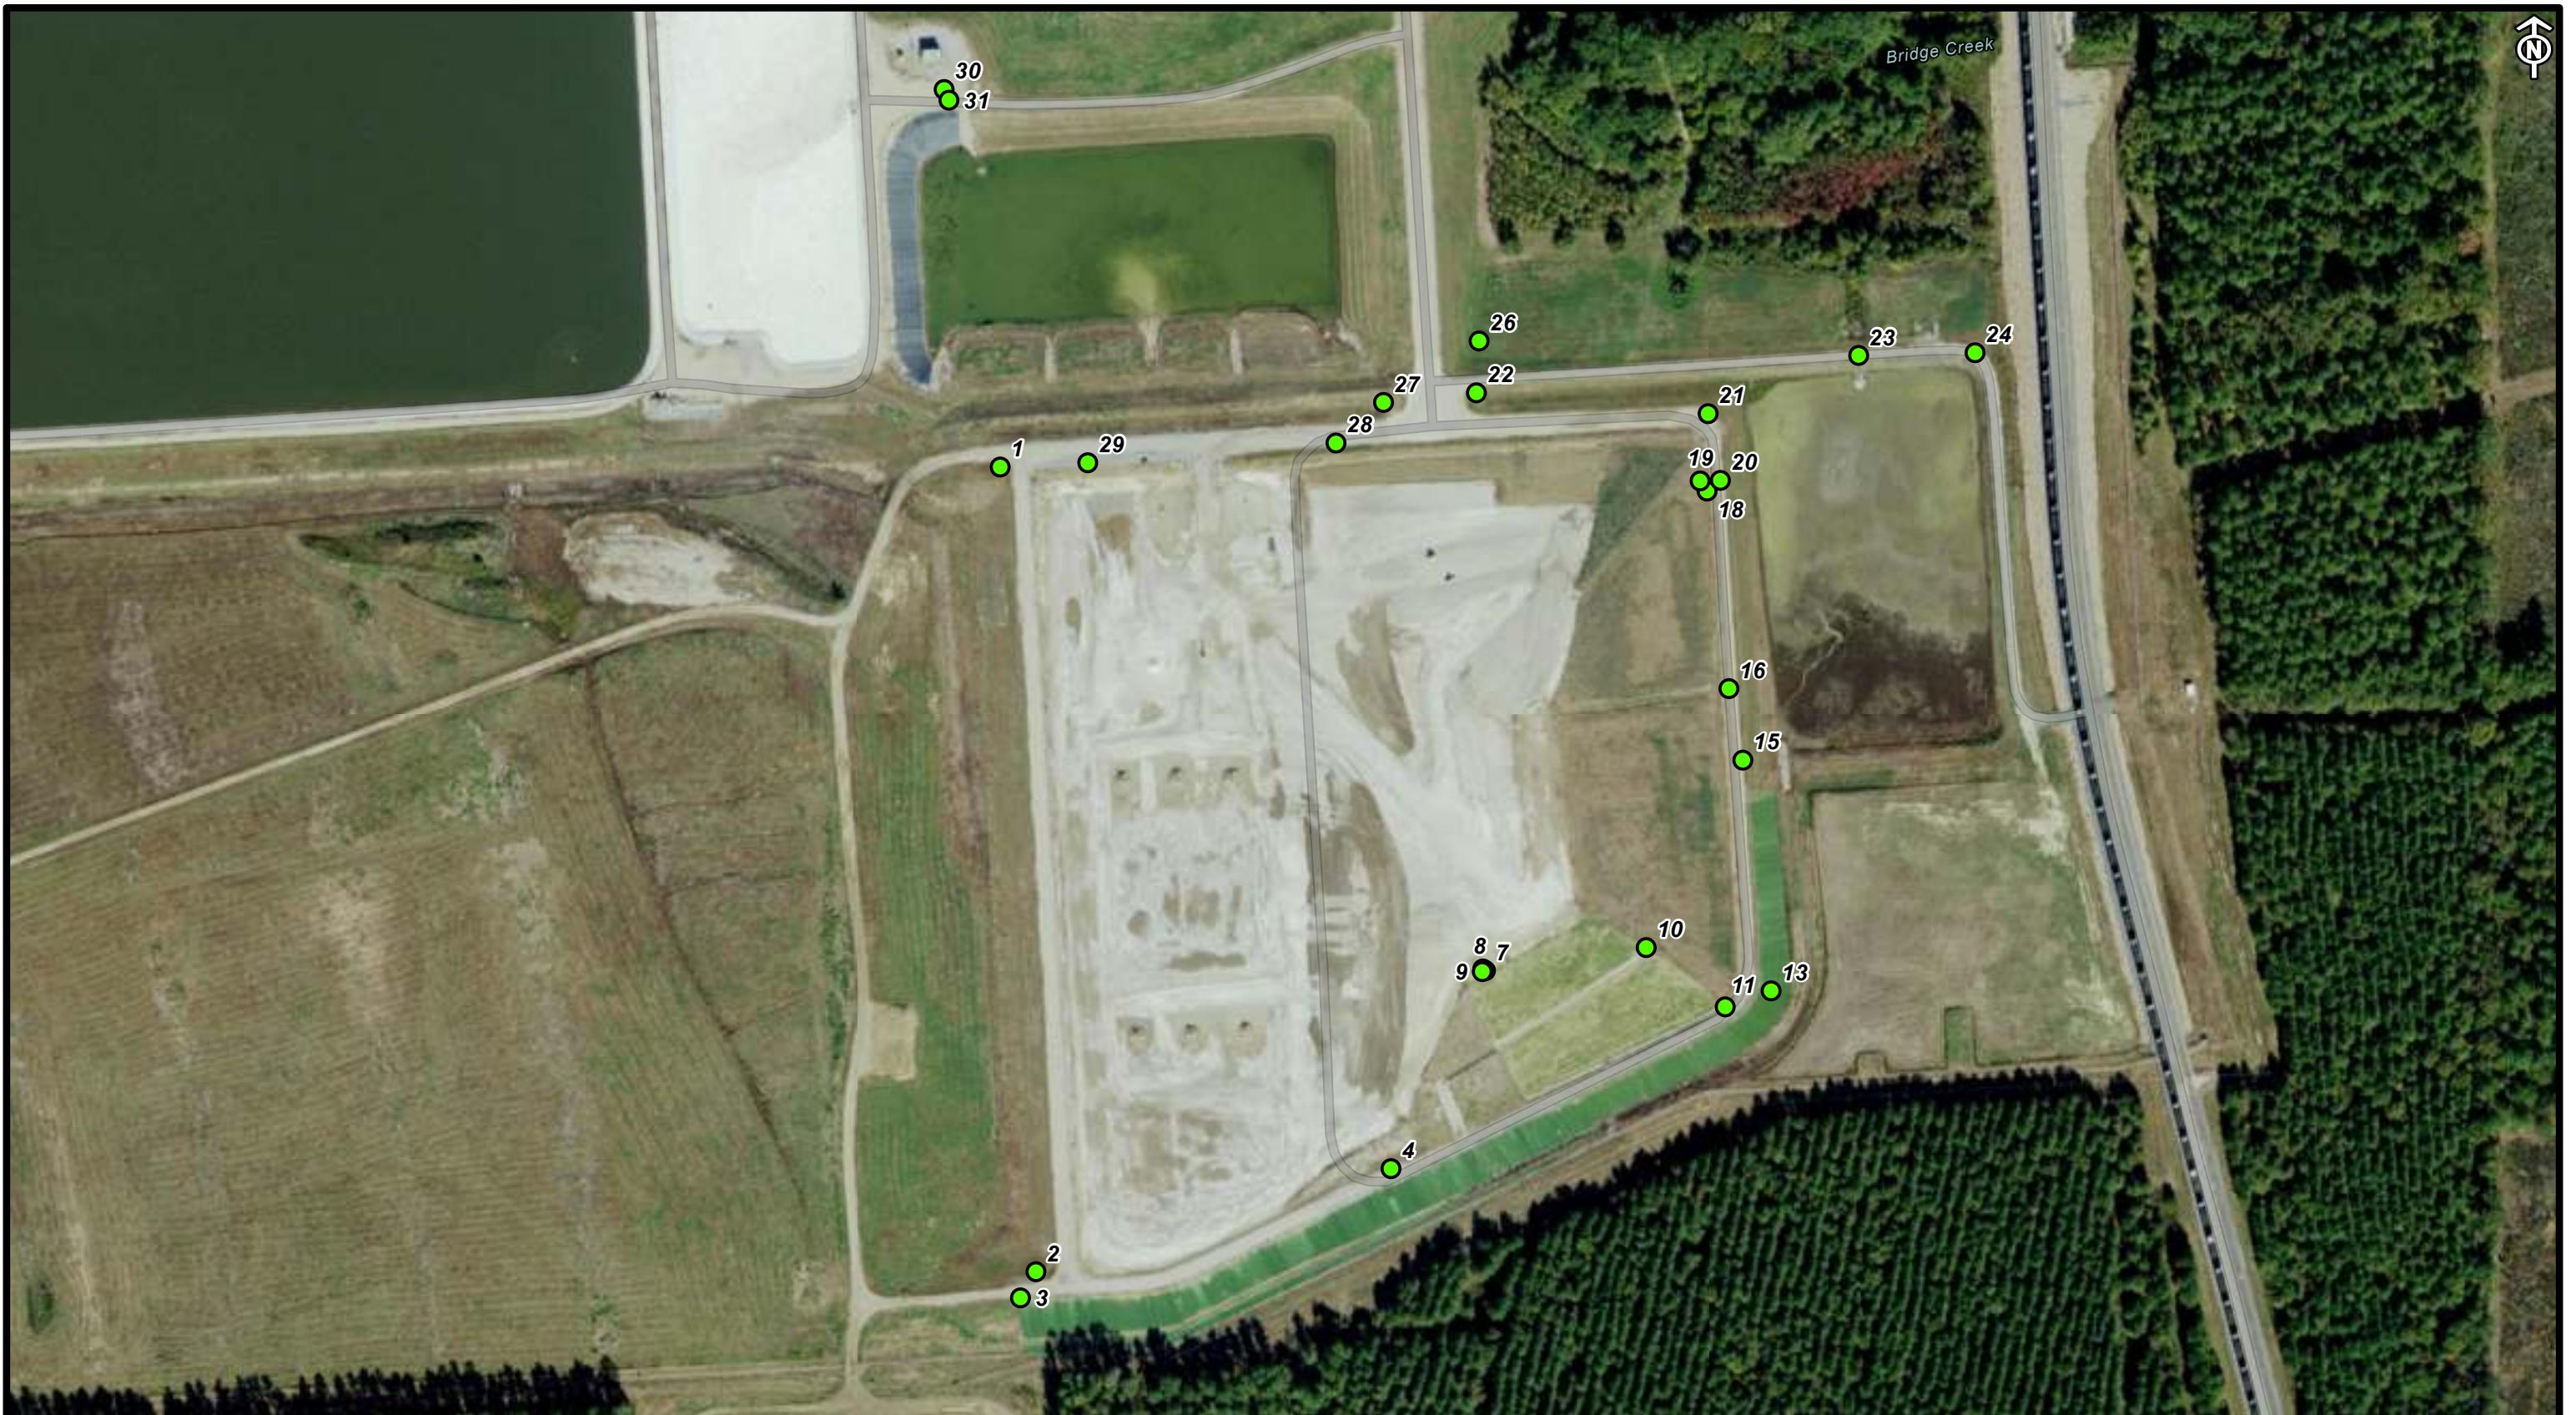
## **Figure 3 – Site Plan**

1. The overall condition of the CCR Landfill Cell 1 and Cell 2 was good. Photographs No. 1 and No. 2 were taken along the perimeter berm on the western side of the current landfill development. It also serves as the perimeter road in this section of the landfill. Cell 1 (Inactive) can be seen in the background of Photograph No. 29, while Cell 2 (Active) is depicted in the foreground. Cell 2 CCR fill has been raised to approximately 10 feet above the elevation of the perimeter road, shown in Photographs No. 4 and No. 7. Active Cell 2 fill area appeared in good condition. No significant erosion or ponded water was observed on the current CCR surface.

3. The south slope of the berm consists of Versacap (artificial turf alternate to the natural grass cover) and appeared in good and stable condition. Few isolated spots indicated weeds protruding through the artificial turf. Overall, the Closureturf® cover and perimeter toe channel are functioning as designed. An area at the southeast corner appears to have some ponding water as a result of overgrown vegetation in the bottom of the channel. Minor overgrown vegetation was observed along the toe into the channel to the stormwater pond (Photograph No. 12) that should be monitored and addressed as needed. Overall, the toe ditch and the berm are functioning as designed. Photographs No. 3, No. 5, No. 12, and No. 13 provide general conditions of these areas observed during the inspection.

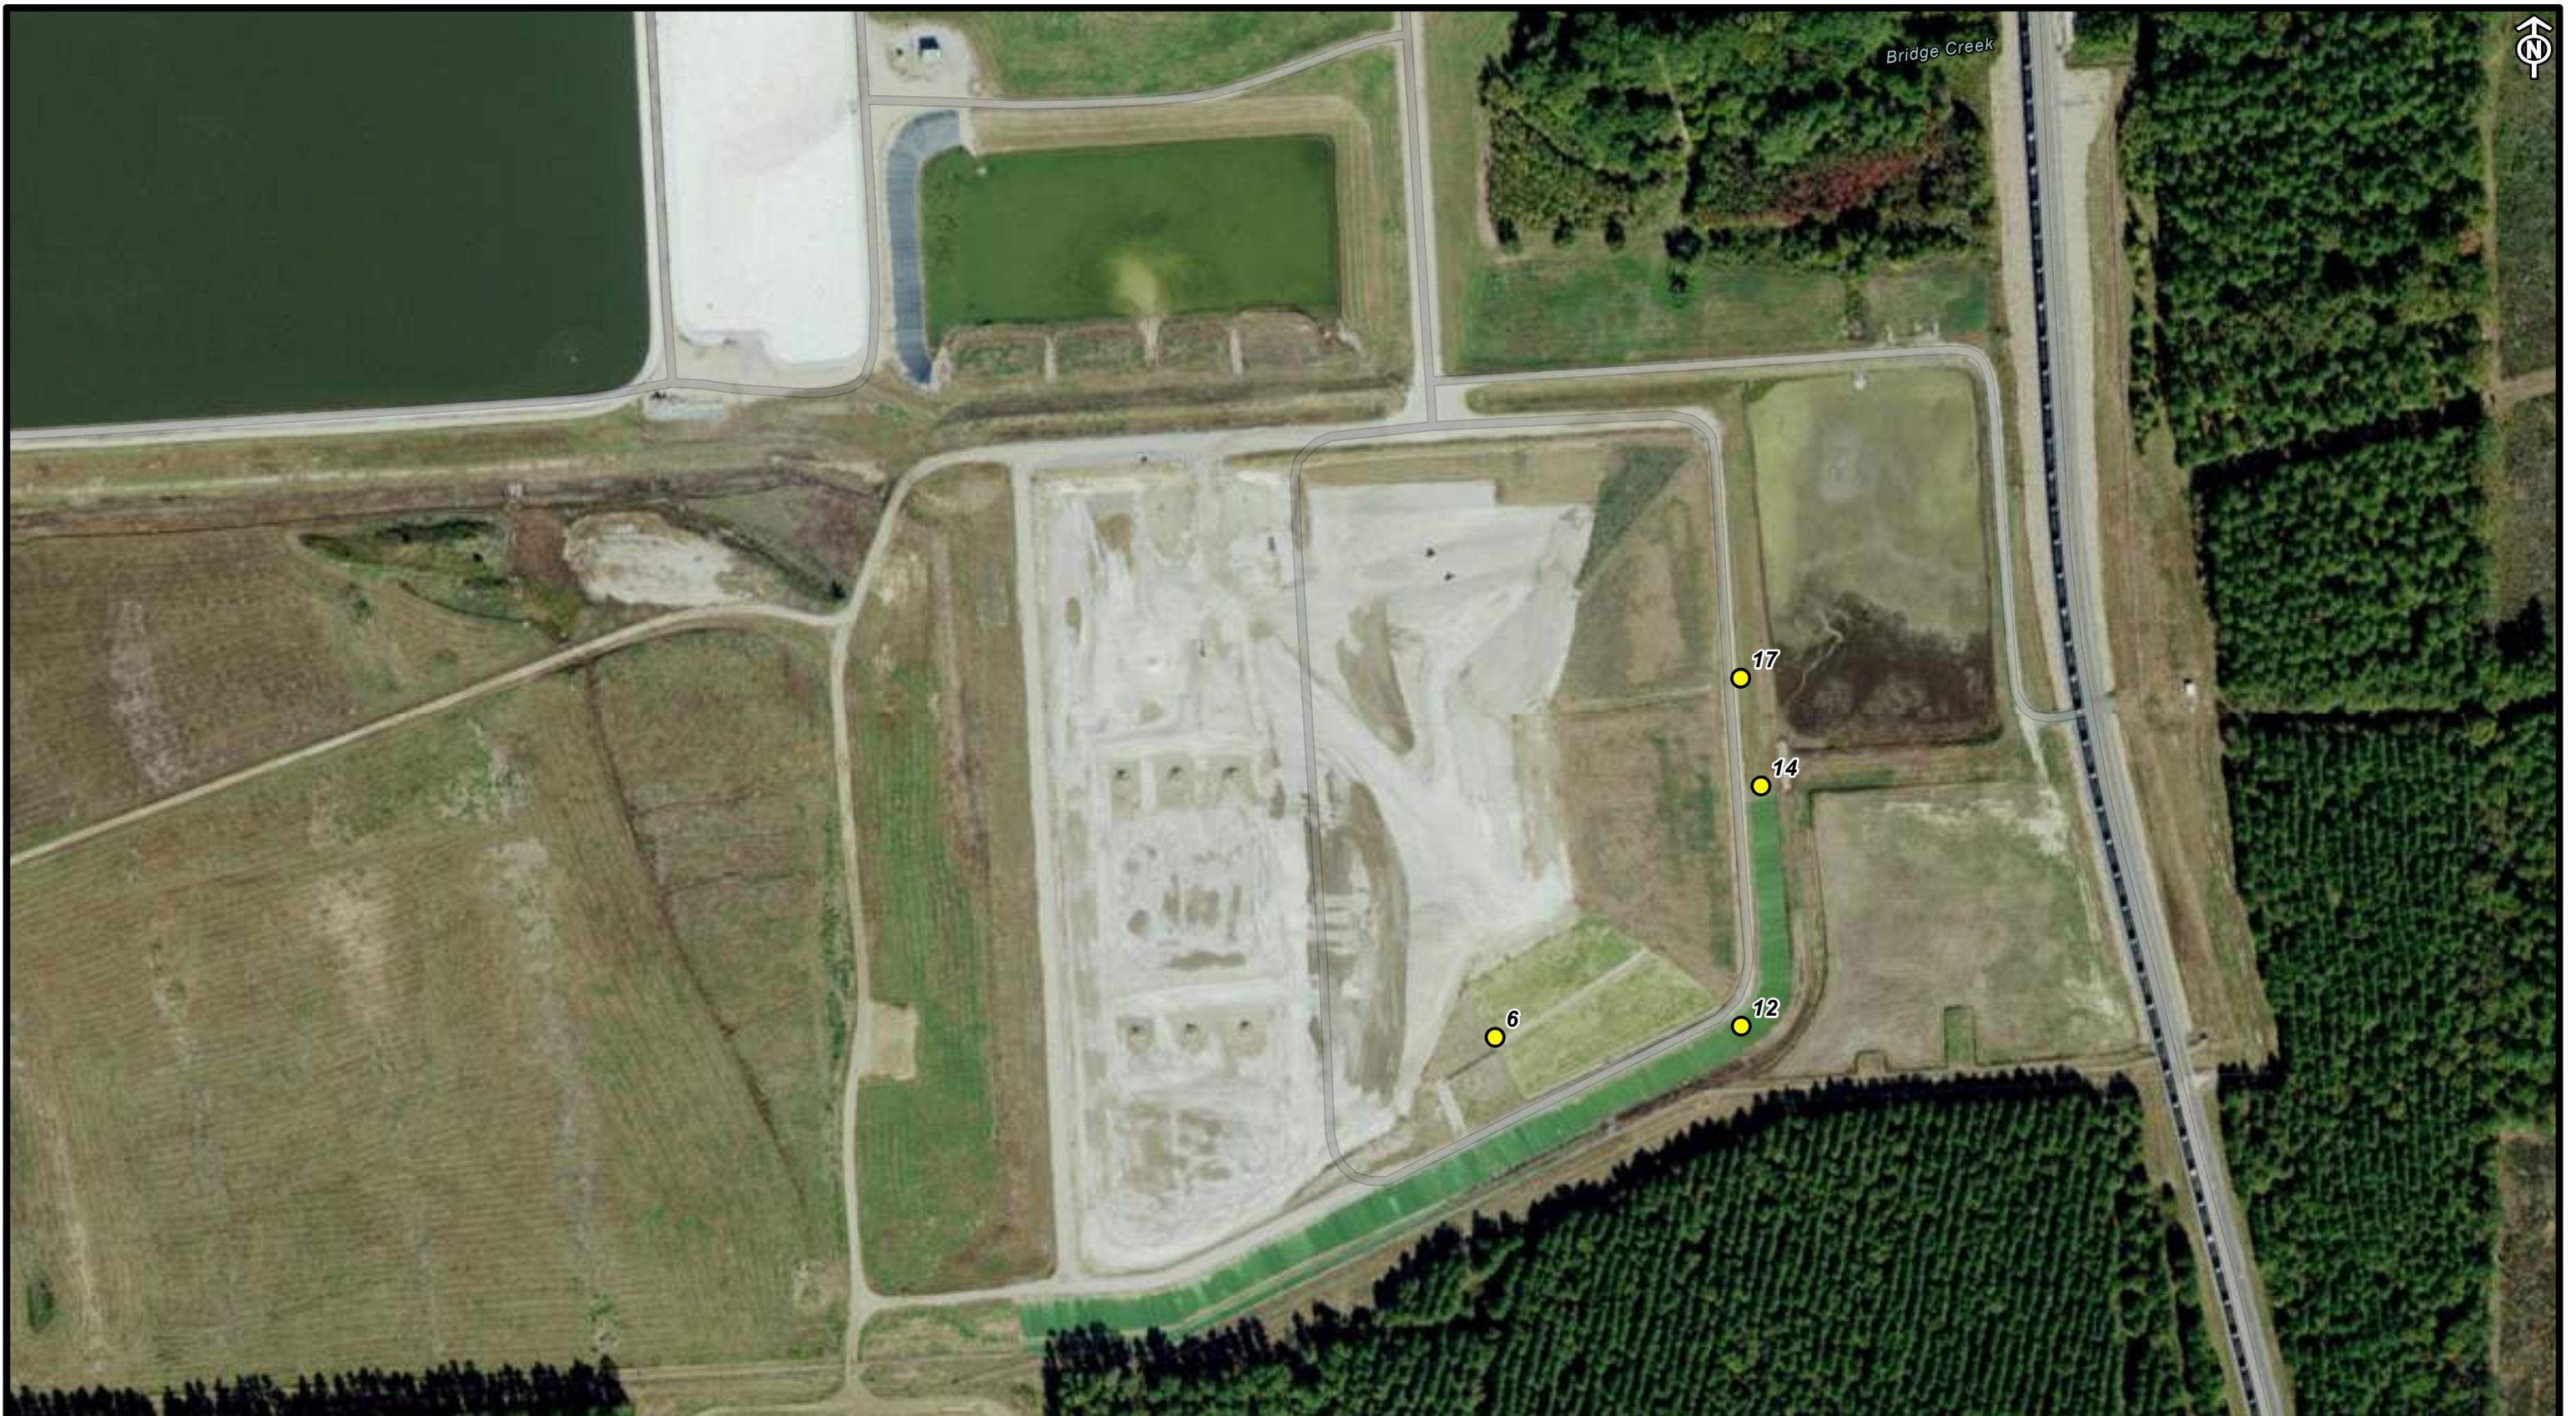
## **Figure 4 – Items to be Monitored**

Photo 14 – Monitor surface crack in interim cover on Cell 1 exterior slope.

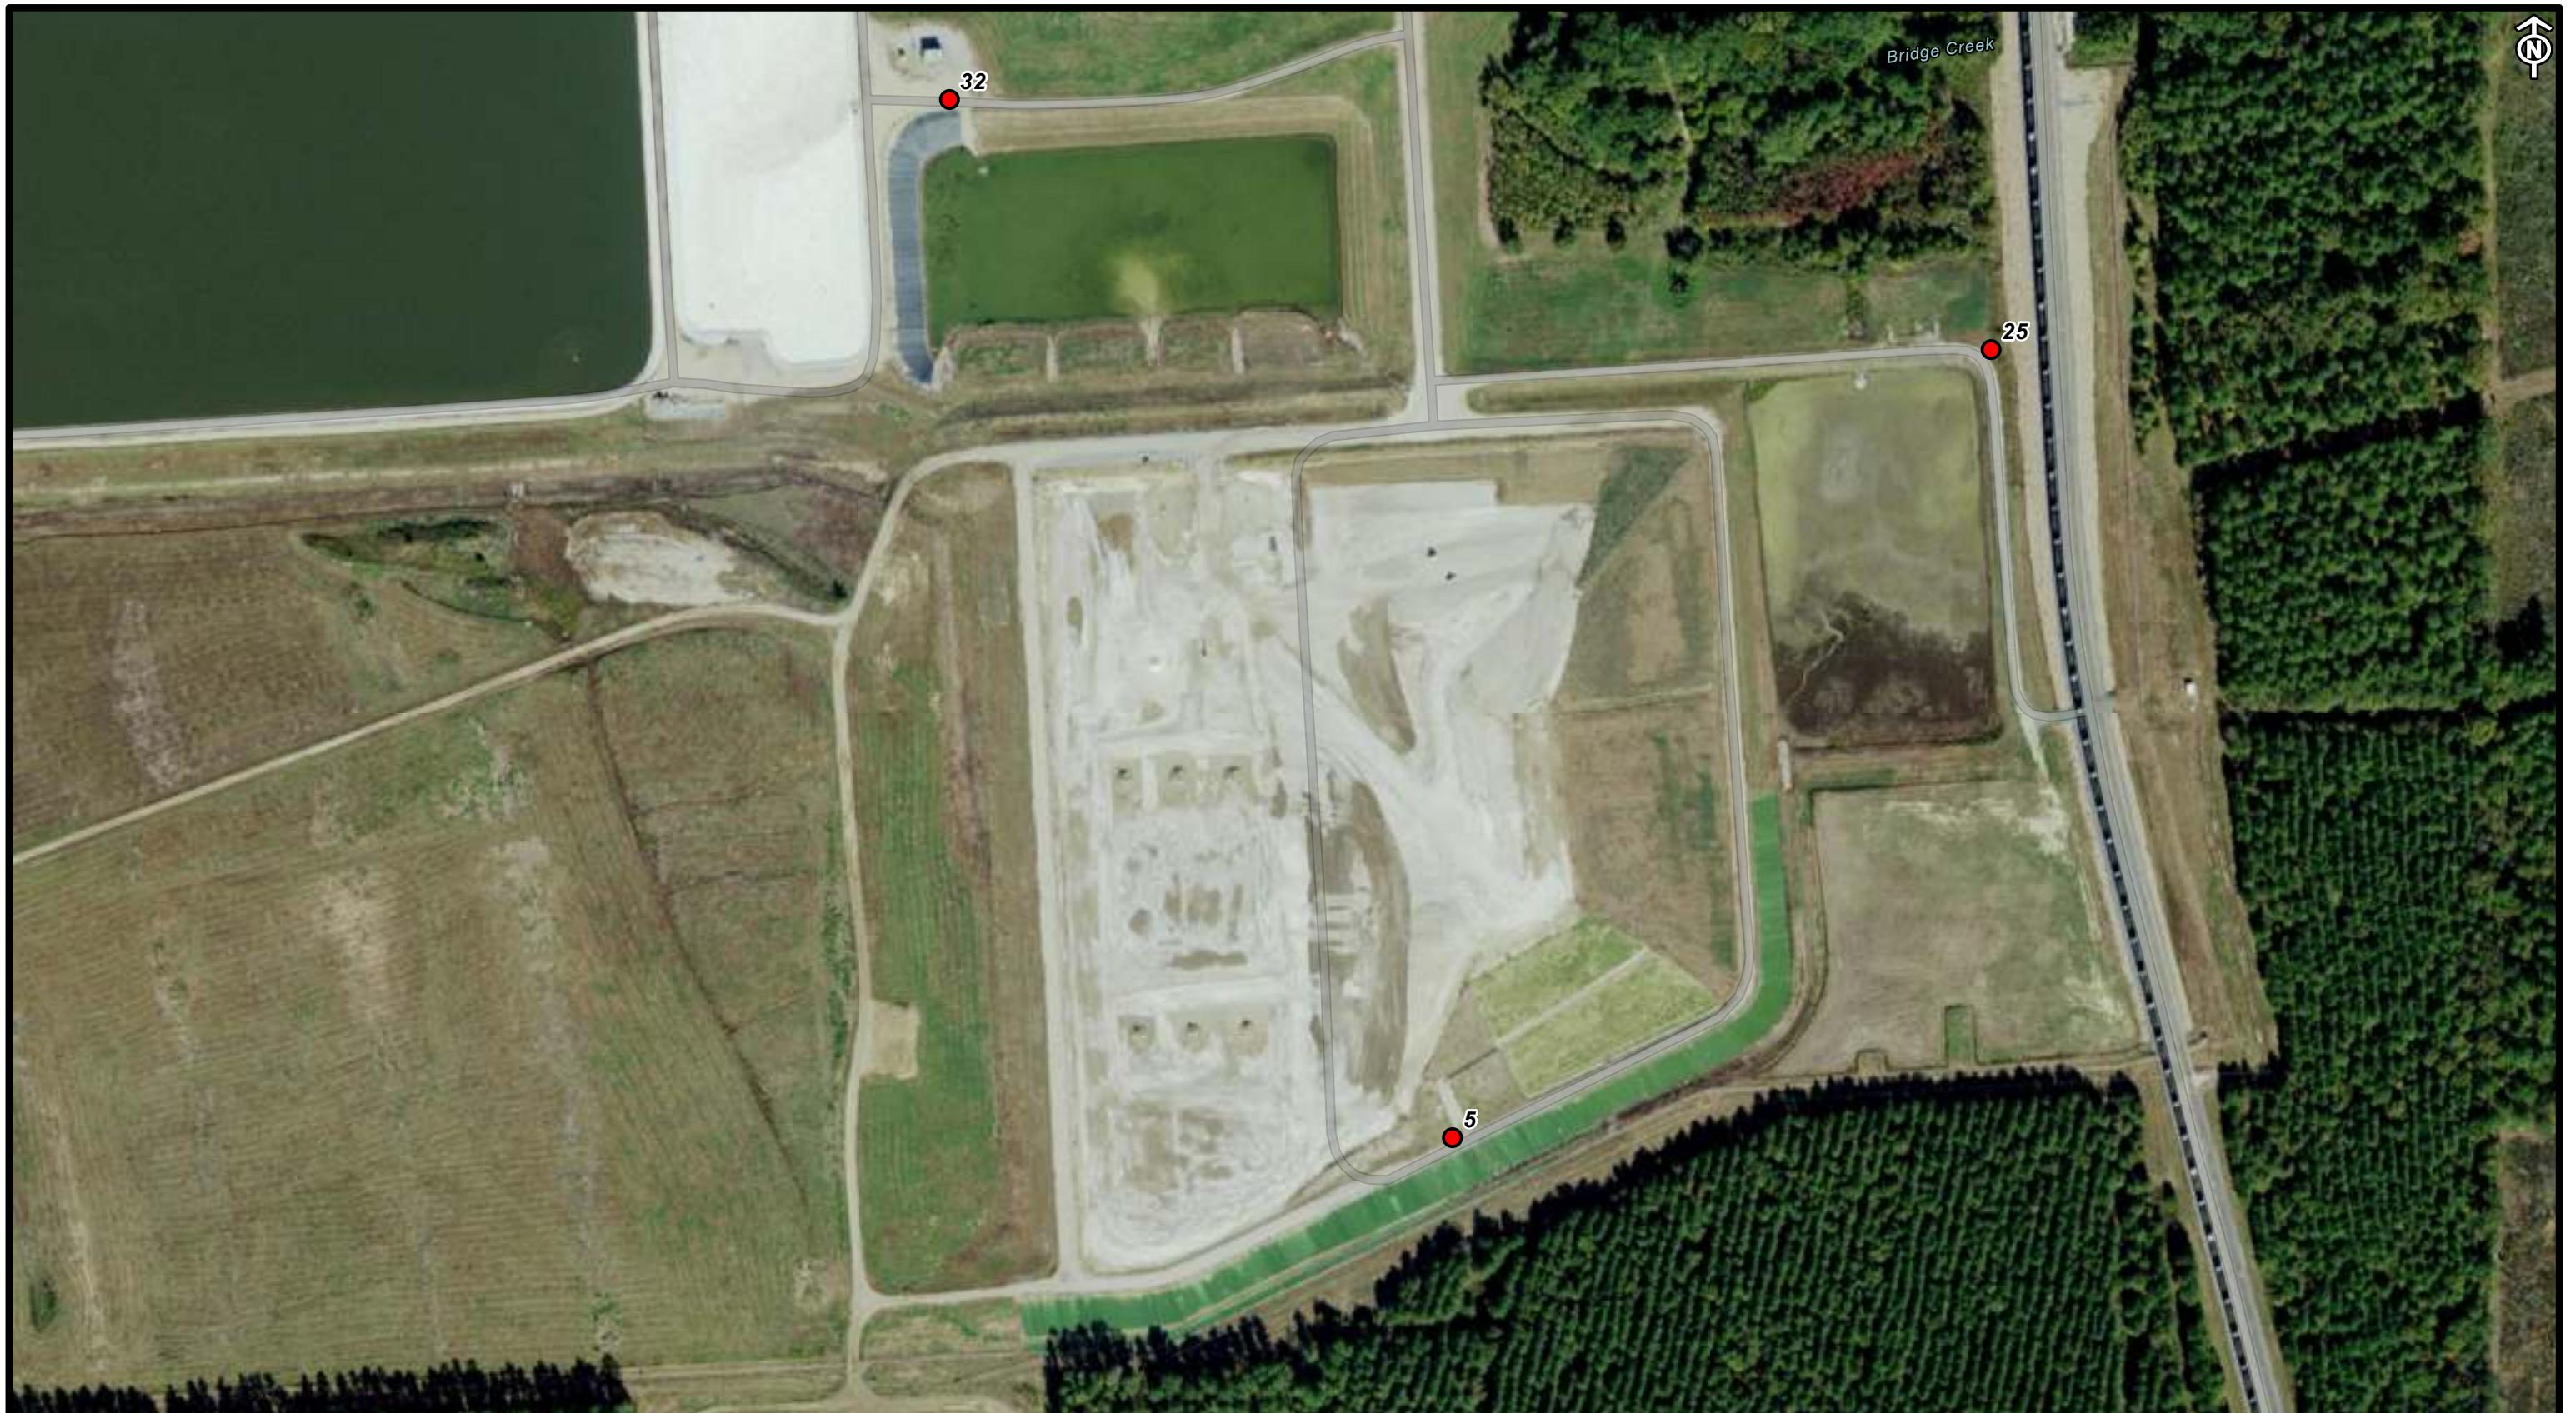
## **Figure 5 – Items to be Addressed**

Photo 5 – Address isolated vegetation growing through artificial turf cover on Cell 1 perimeter berm exterior slope.
