CCR Bottom Ash Storage Pond 2025 Annual Dam and Dike Inspection Report

Welsh Power Plant, Cason, Texas

August 14, 2025
Project 2501323
AEP Document ID: GEVR-25-015

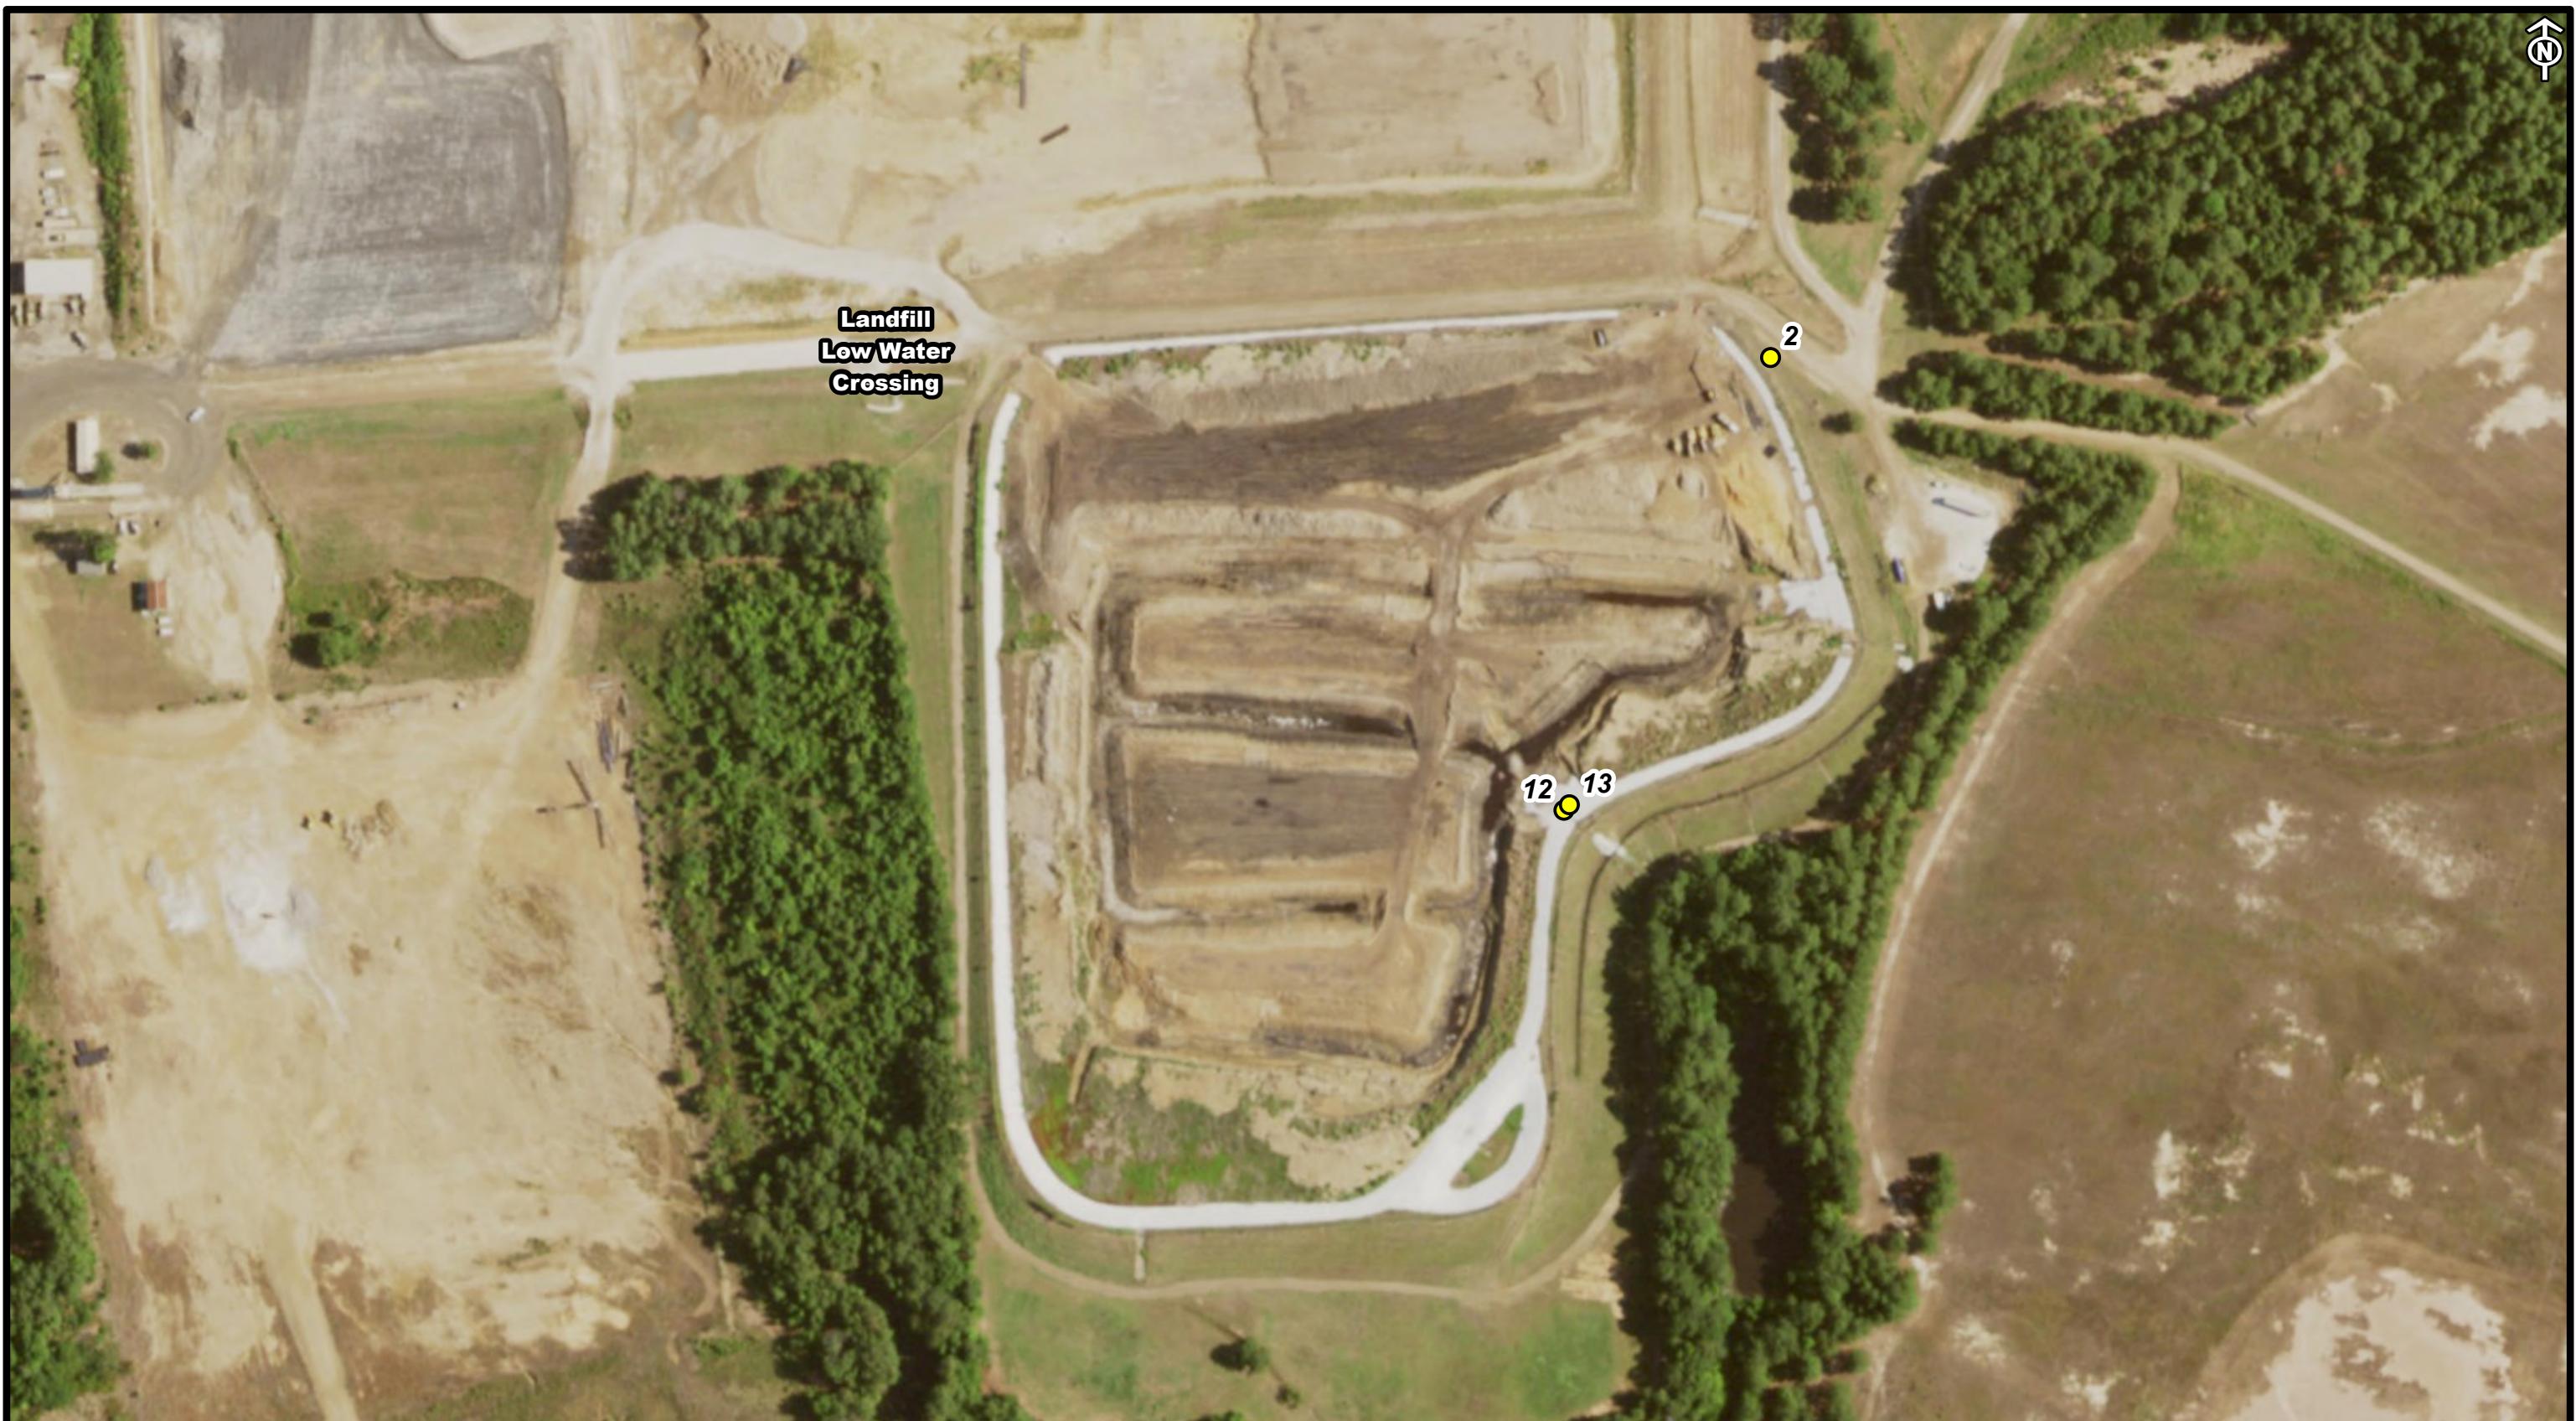
Figure 4 – Items to be Monitored

1. The upstream slopes are in satisfactory condition with healthy vegetation establishment on most areas as shown on Photo No. 1, 3, 4, 8, 9, and 10. Some minor erosion was observed in isolated areas and should be monitored as shown in Photo No. 2. Isolated areas of major erosion should be graded and reseeded as shown in Photo No. 5, 6, and 7.
