# STRUCTURAL STABILITY ASSESSMENT

**40 CFR 257.73 (d)**

Ash Pond

Cabin Creek Site

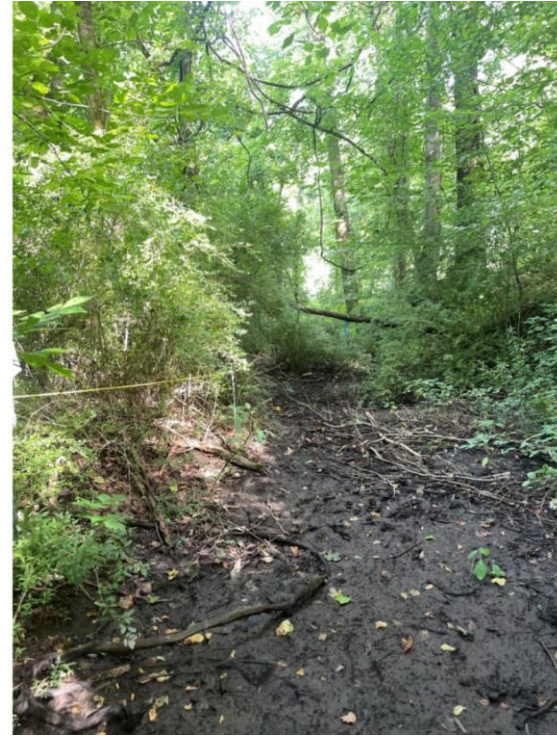
Media 4: Drainage way near perimeter dike

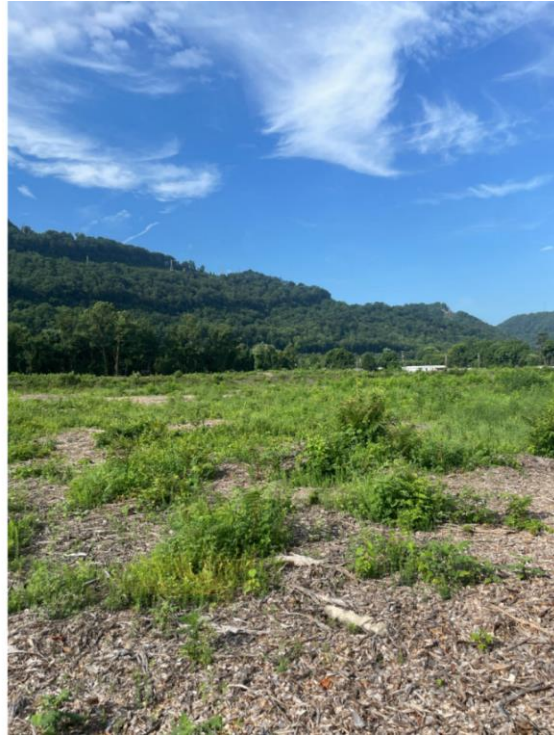
Media 12: Top of ash pond looking southwest

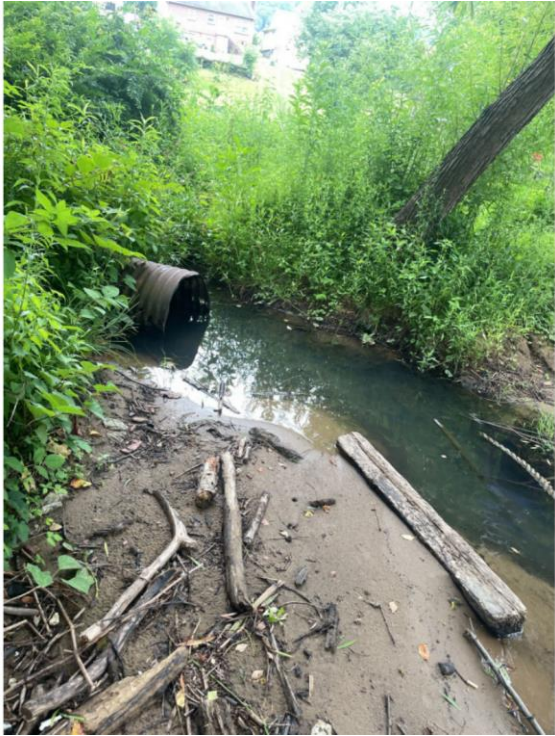
Media 29: Corrugated metal storm drain outlet
