# Emergency Action Plan

Ash Pond

Cabin Creek Site

# Cabin Creek Site – Ash Pond Emergency Action Plan

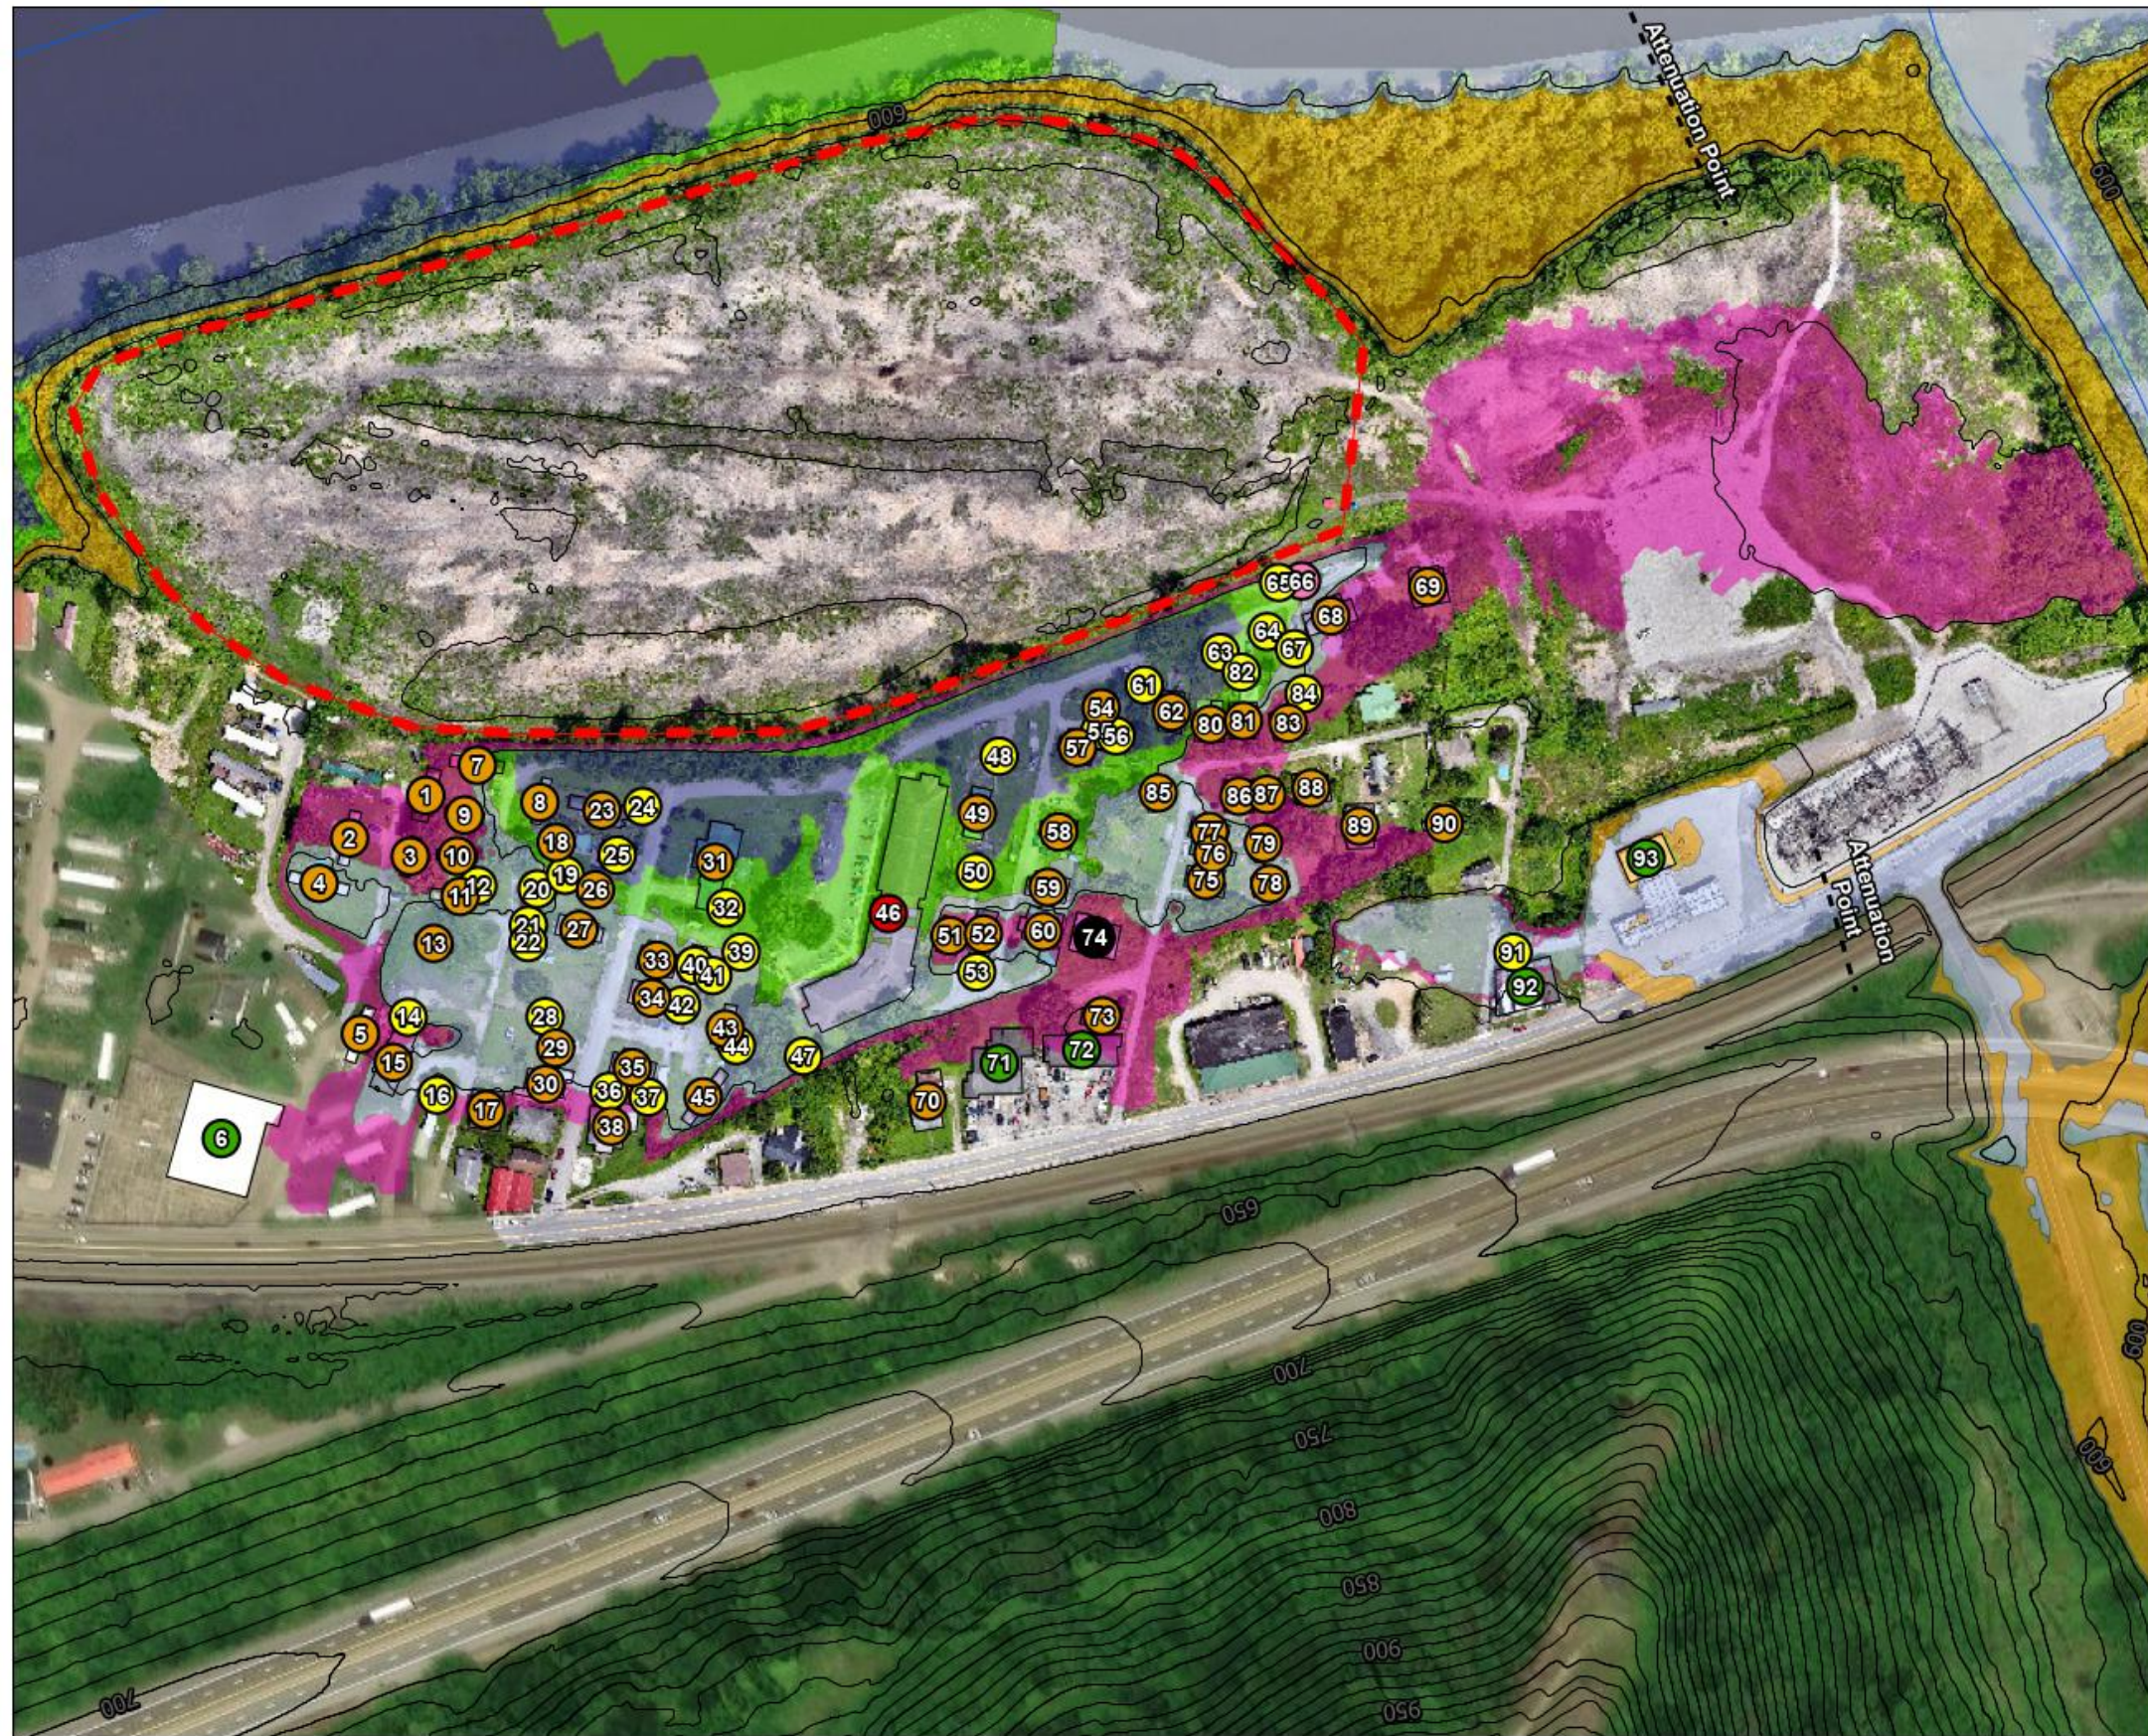
**CABIN CREEK DAM  
DAM FAILURE MAPPING  
KANAWHA COUNTY, WV**  
Panel 2 of 2

Refer to Breach Model Report tables for detailed results at pertinent locations/road crossings.

The methods used to develop inundation zones and flood wave arrival times are approximate and should only be used as guidance for establishing evacuation zones. Actual areas inundated will depend on actual failure and pre-failure hydrologic conditions and may differ significantly from information shown on maps.

See appendix A for inundation map. The Cabin Creek Ash Pond consists of dry ash that is bounded on the north by the Kanawha River, and the south by the town of Chelyan. The breach model assumes that the ash is saturated, flowable, and develops a full breach of the north or south dams. Inundation areas vary based on potential flow characteristics of the ash, resulting in different potential inundation areas. Model assumes no flood tailwater conditions.
