Closure Completion Notification for Closure by Removal

Mountaineer Plant

Bottom Ash Pond Complex

AEP Mountaineer Plant Bottom Ash Complex

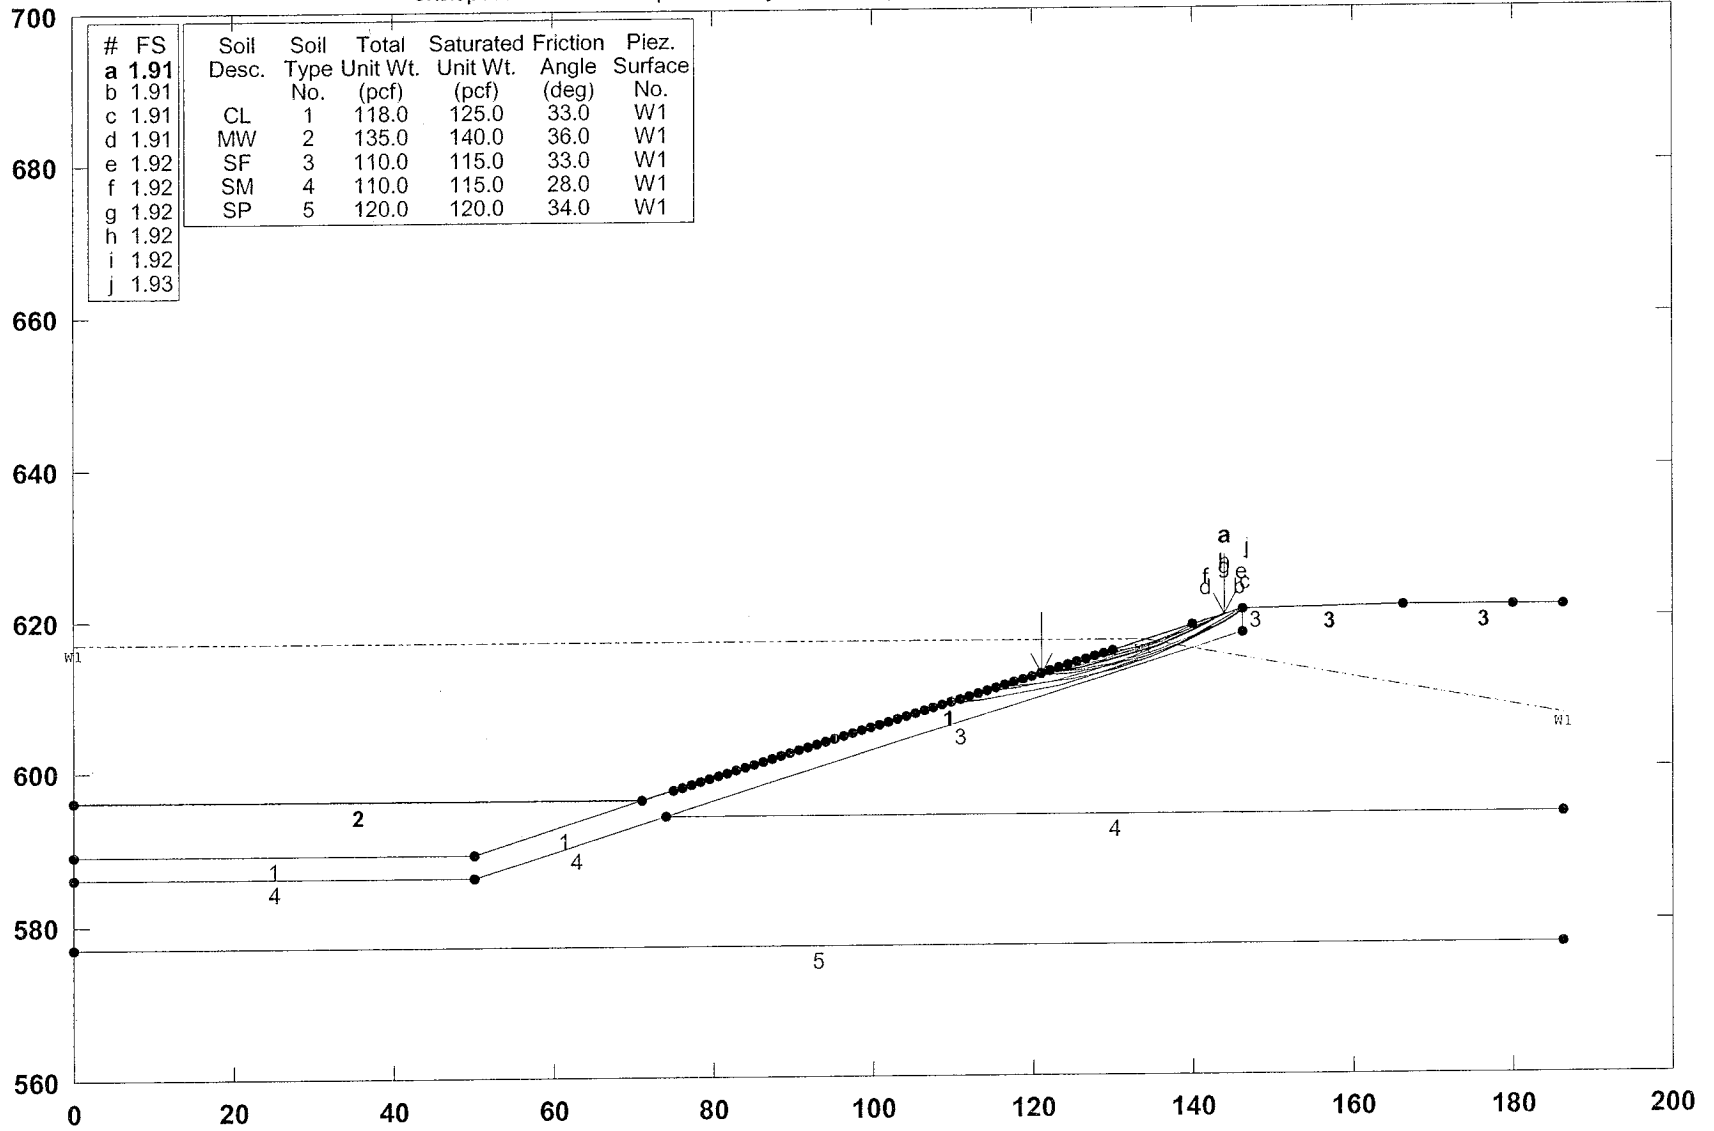
AEP / Mountaineer BAP Complex, C/S A-A', Upstream Slope, Long term Local

PCSTABL7 FSmin=1.91

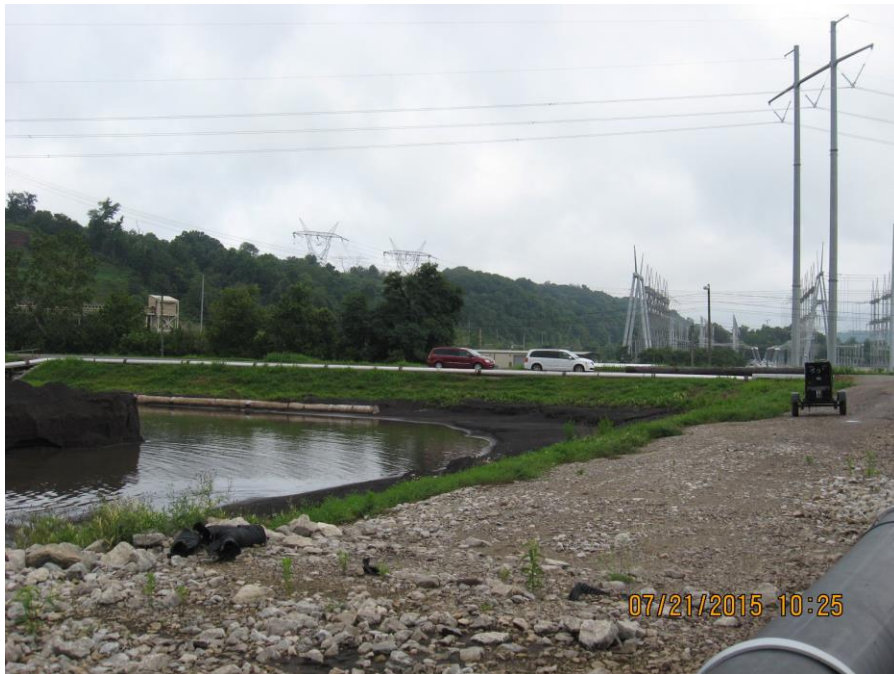
Photo 2: West Bottom Ash Pond, north dike.

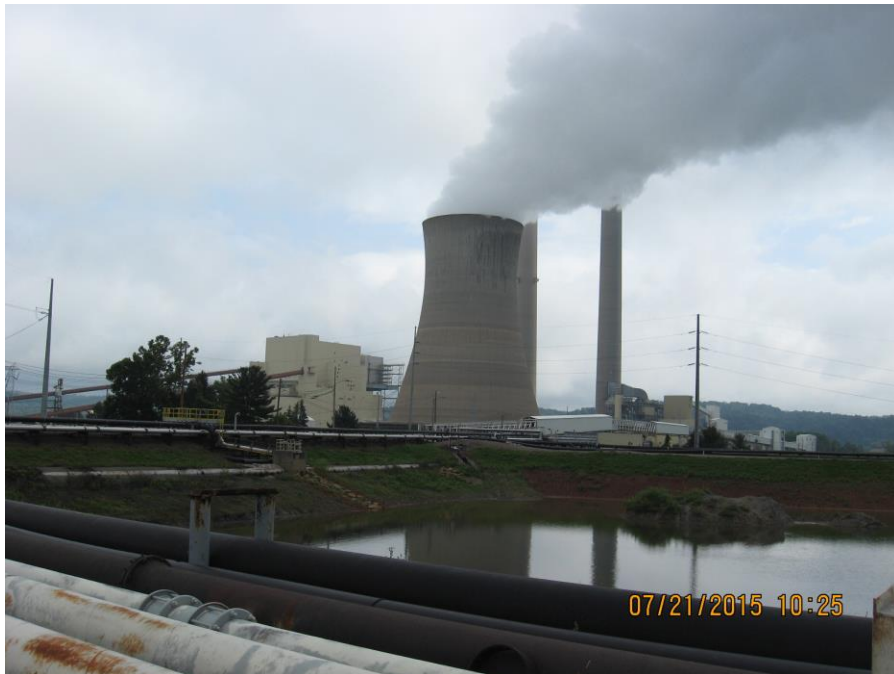
Photo 4: East Bottom Ash Pond, north/east dikes.

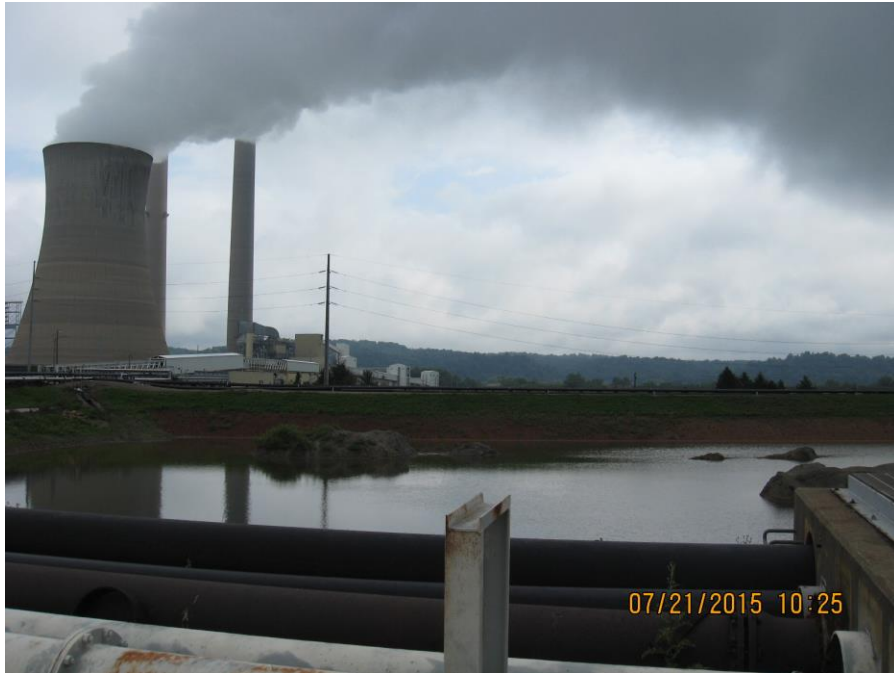
Photo 5: East Bottom Ash Pond, north/east dikes.

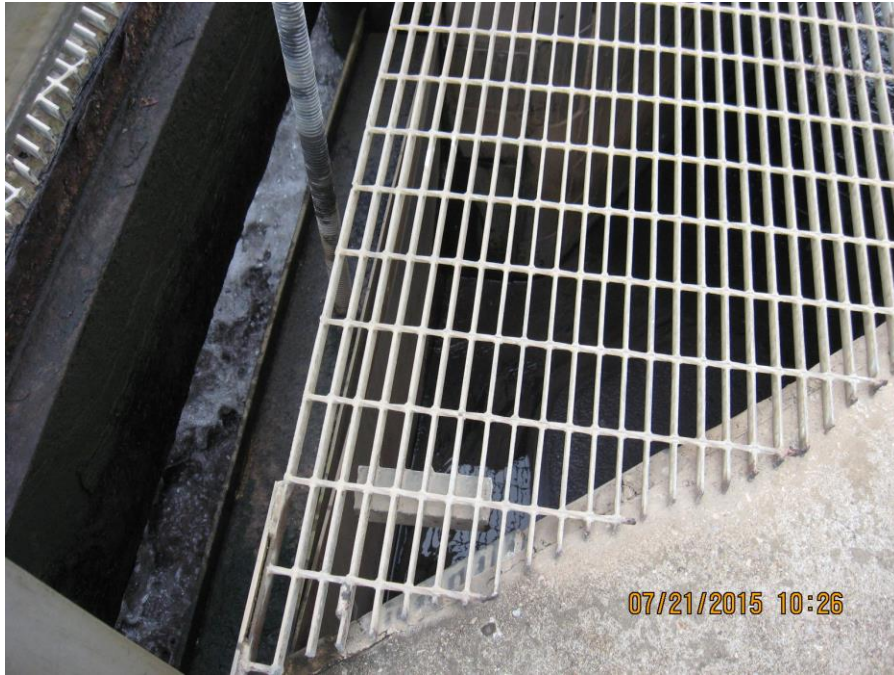
Photo 7: West Bottom Ash Pond: inlet structure sluice gate.

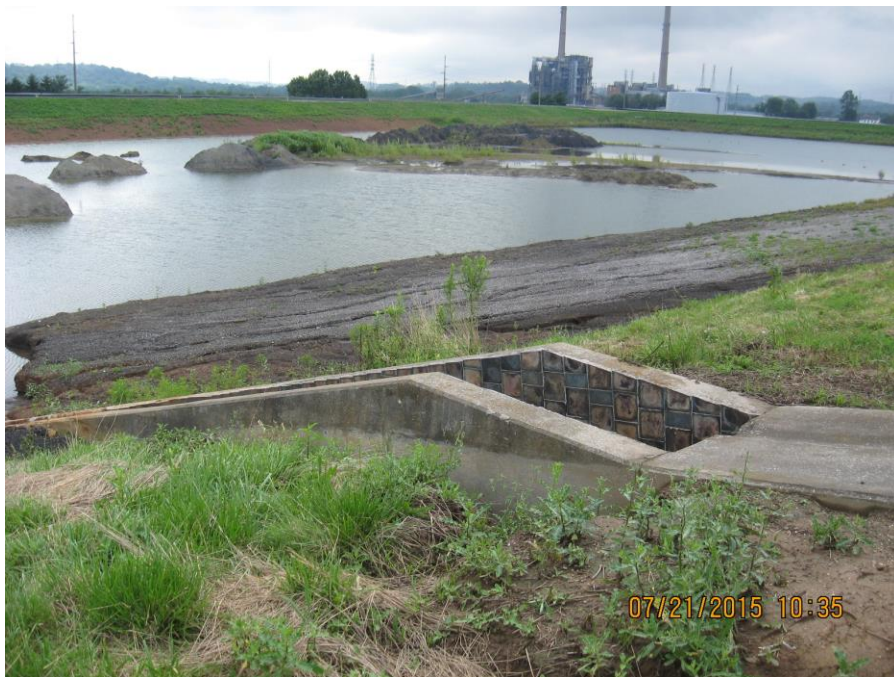
Photo 10: East Bottom Ash Pond: inlet structure.

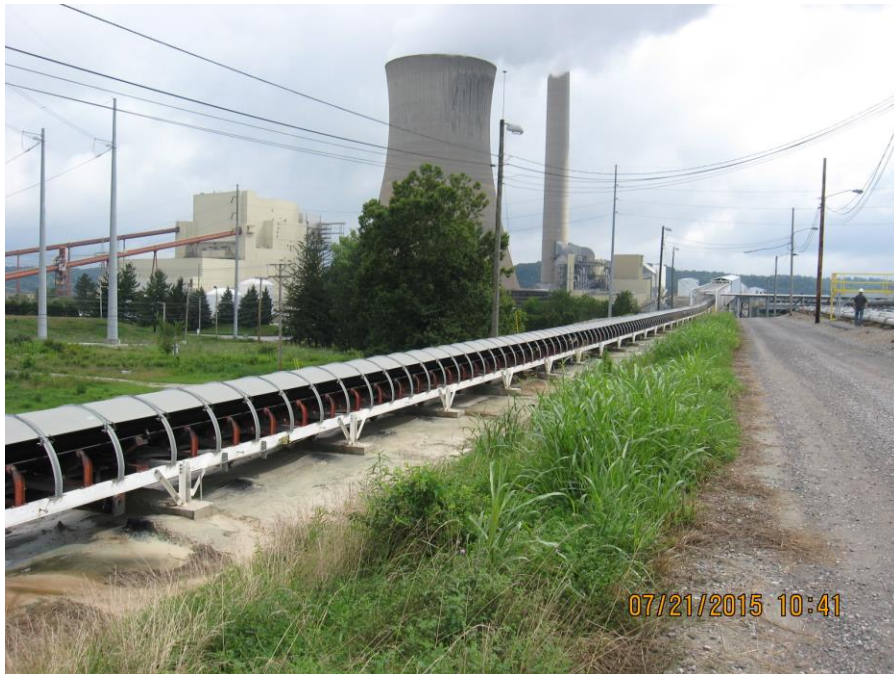
Photo 12: Bottom Ash Ponds, north dike: gypsum conveyor.

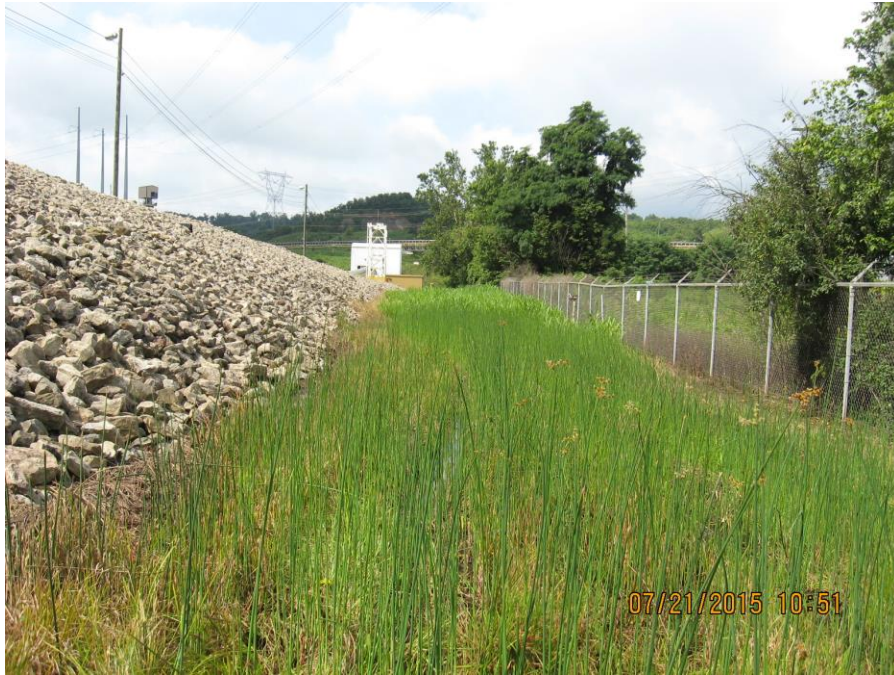
Photo 15: Bottom Ash Ponds, north dike: exterior slope.

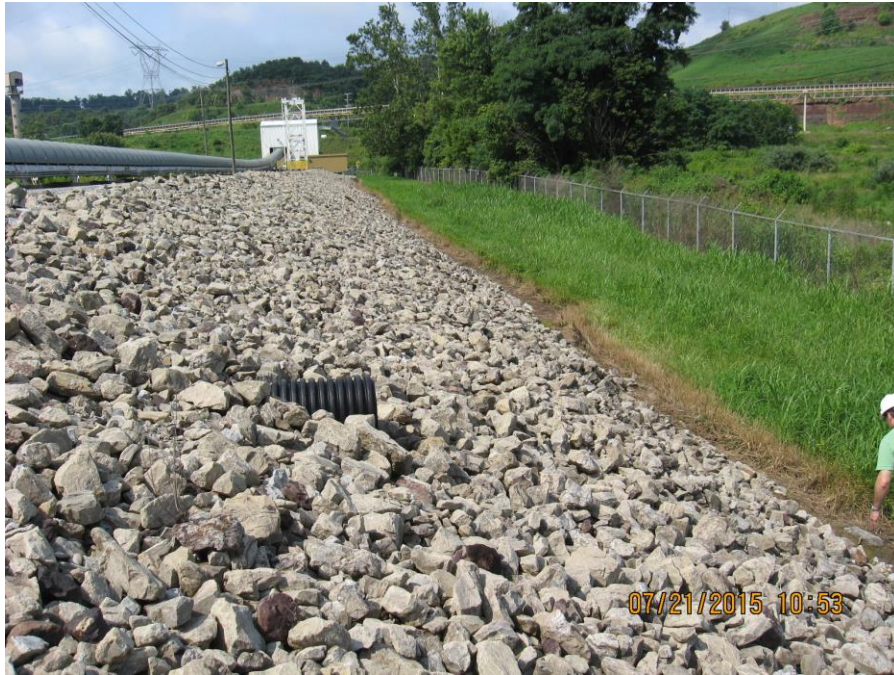
Photo 19: Bottom Ash Ponds, north dike: exterior slope.

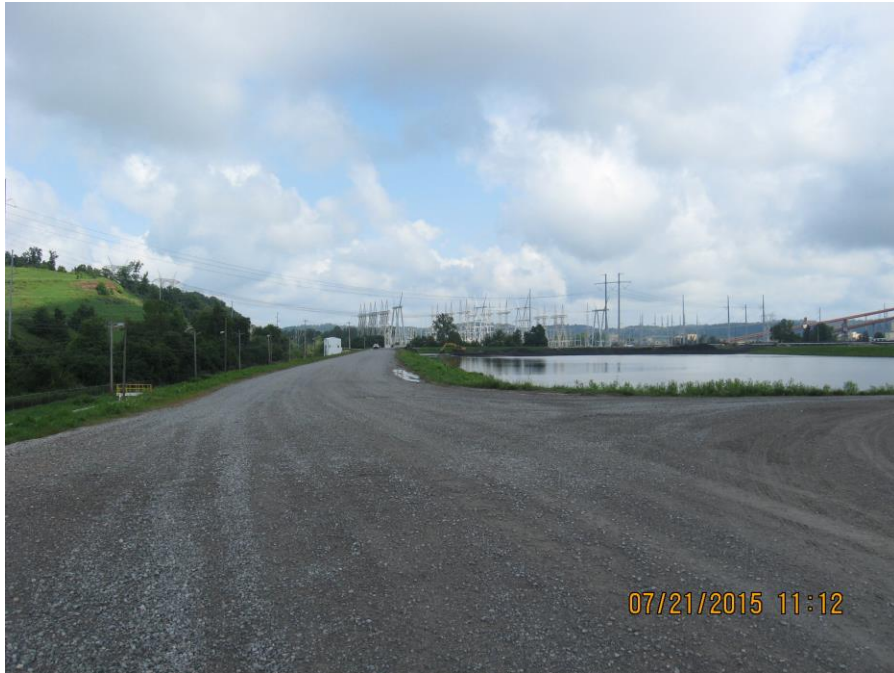
Photo 25: West Bottom Ash Pond, west dike.

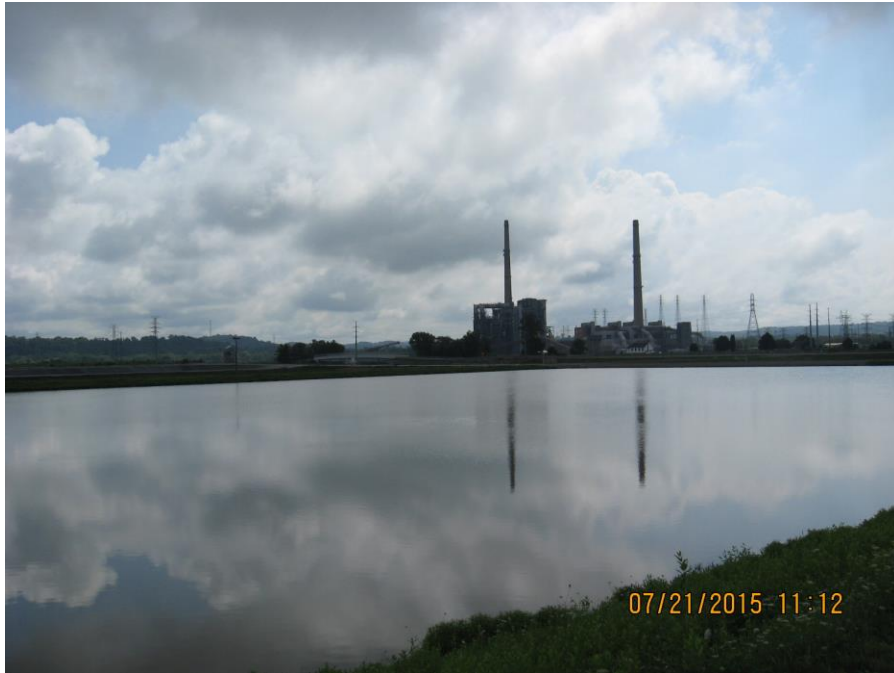
Photo 27: West Waste Water Pond, east dike.

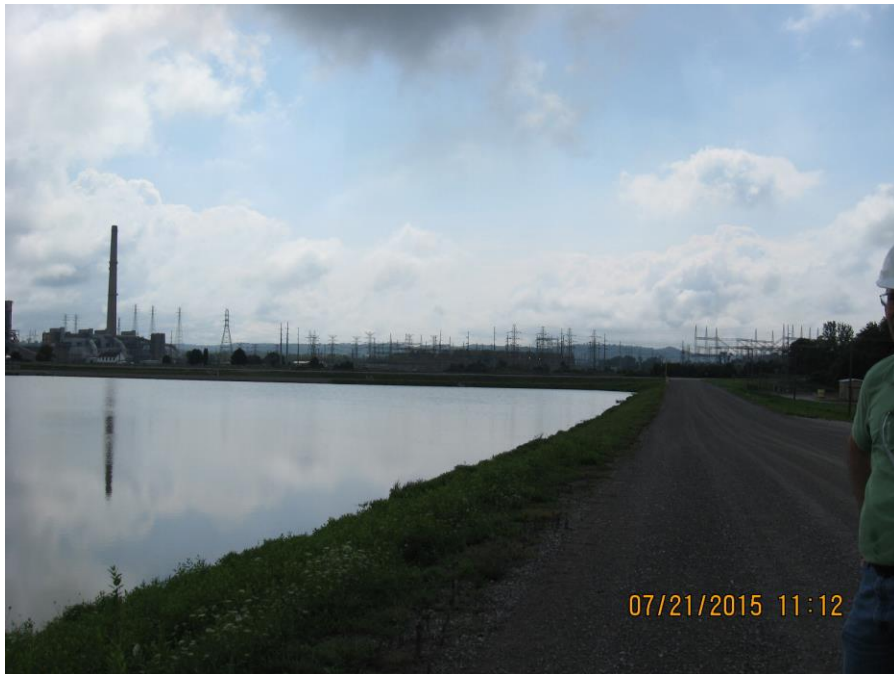
Photo 28: West Waste Water Pond, west dike.

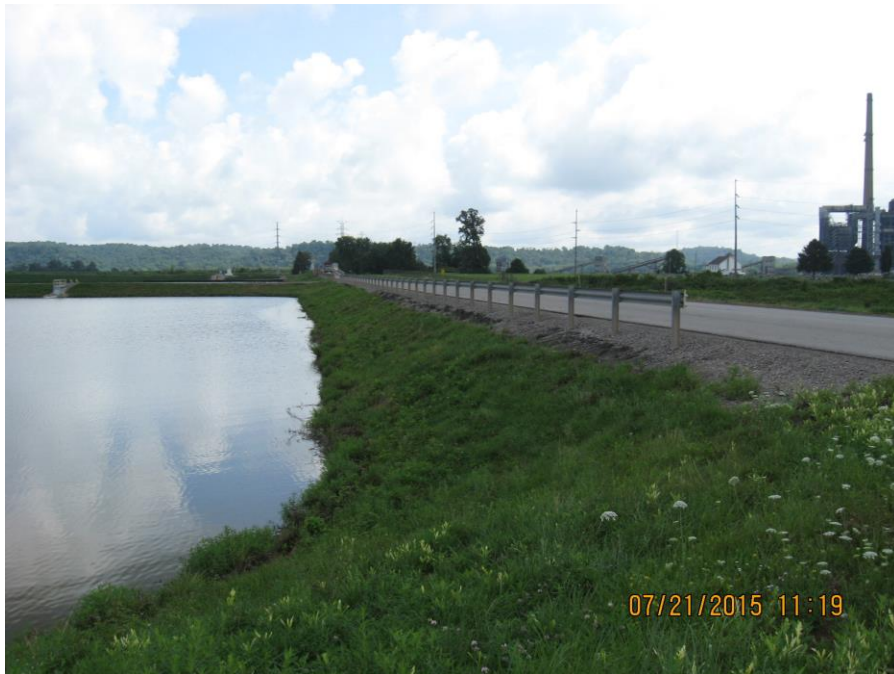
Photo 30: Reclaim Water Pond, south dike.

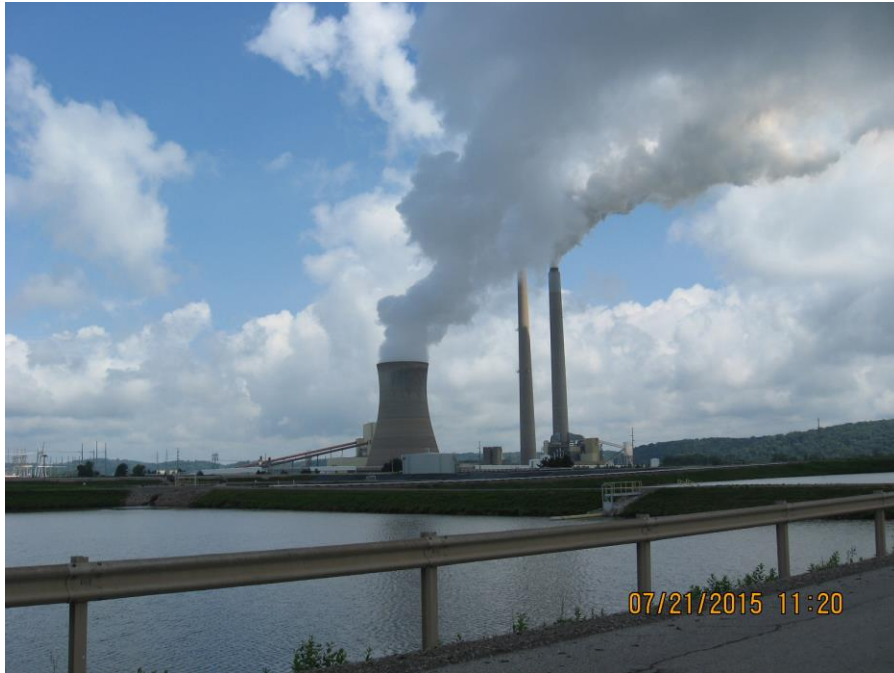
Photo 31: Reclaim Water Pond, east dike.

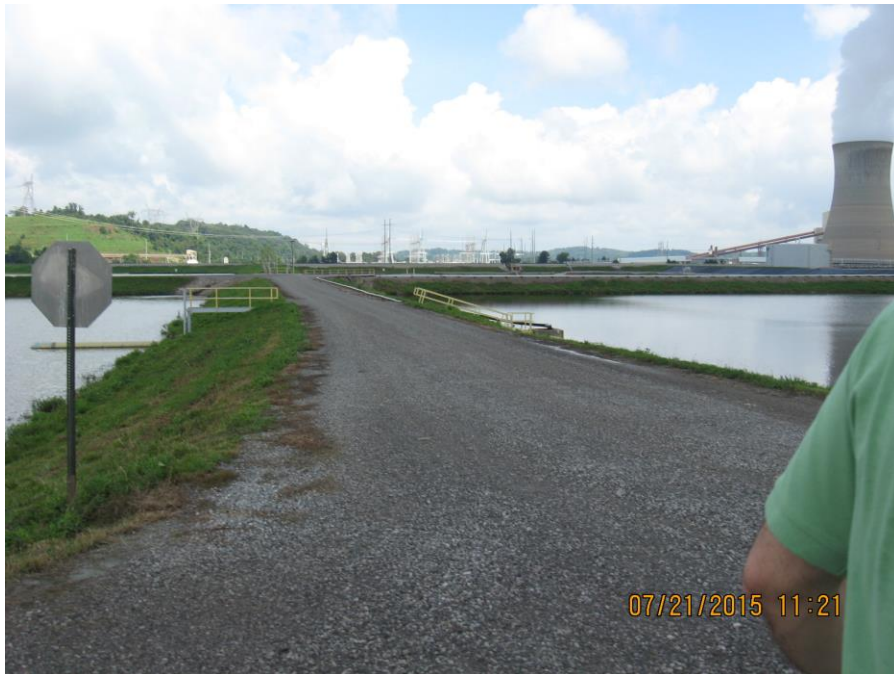
Photo 32: Reclaim Water Pond, east dike.

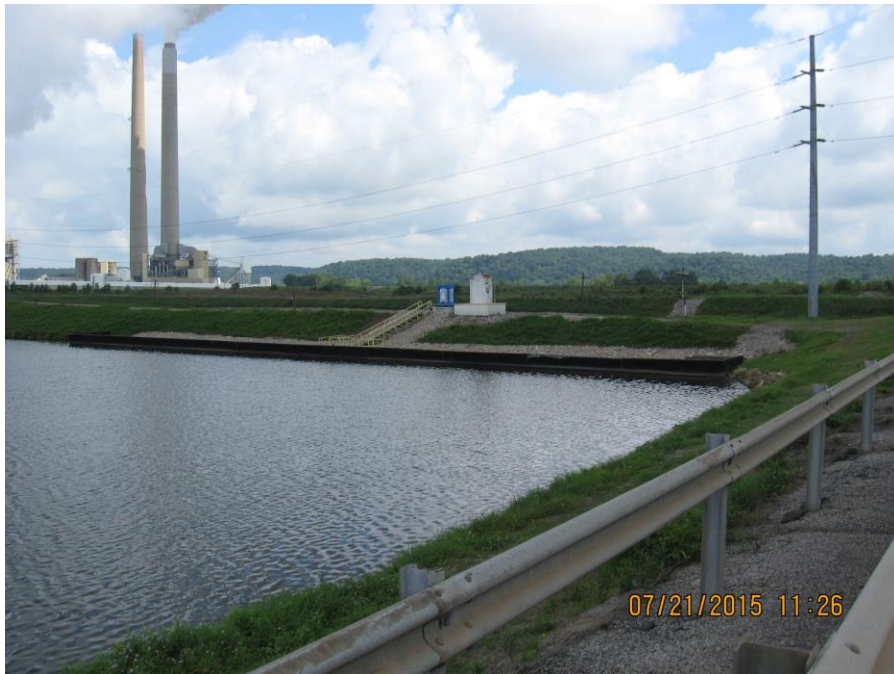
Photo 34: Clearwater Pond, outlet weir.

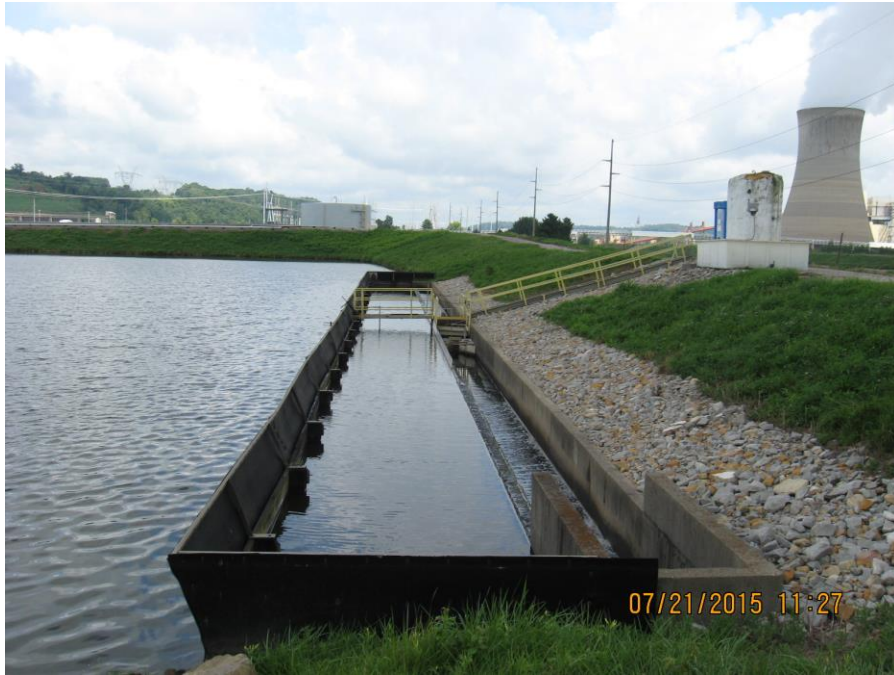
Photo 35: Clearwater Pond, outlet weir.

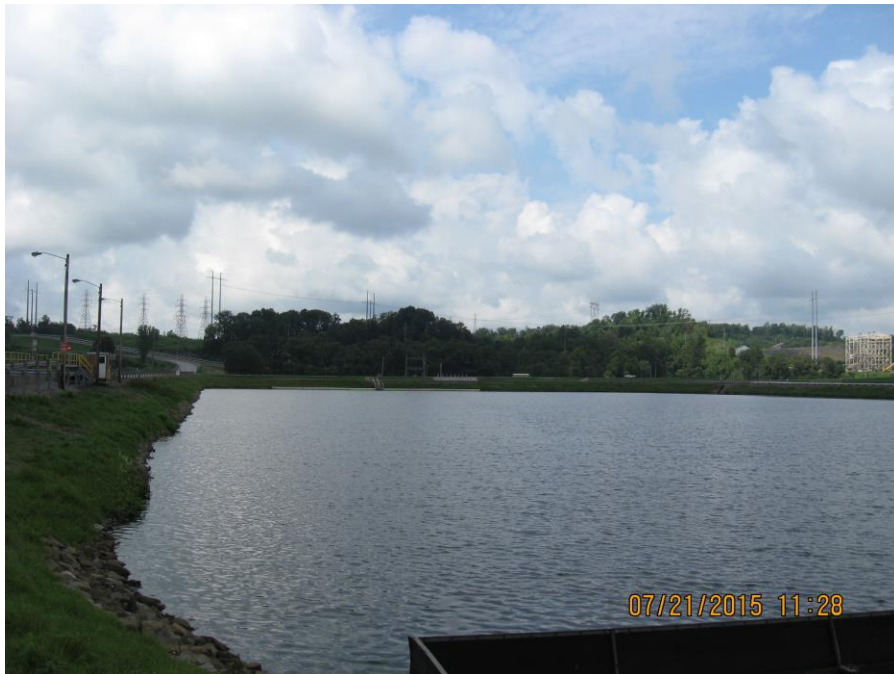
Photo 36: Clearwater Pond, west dike.

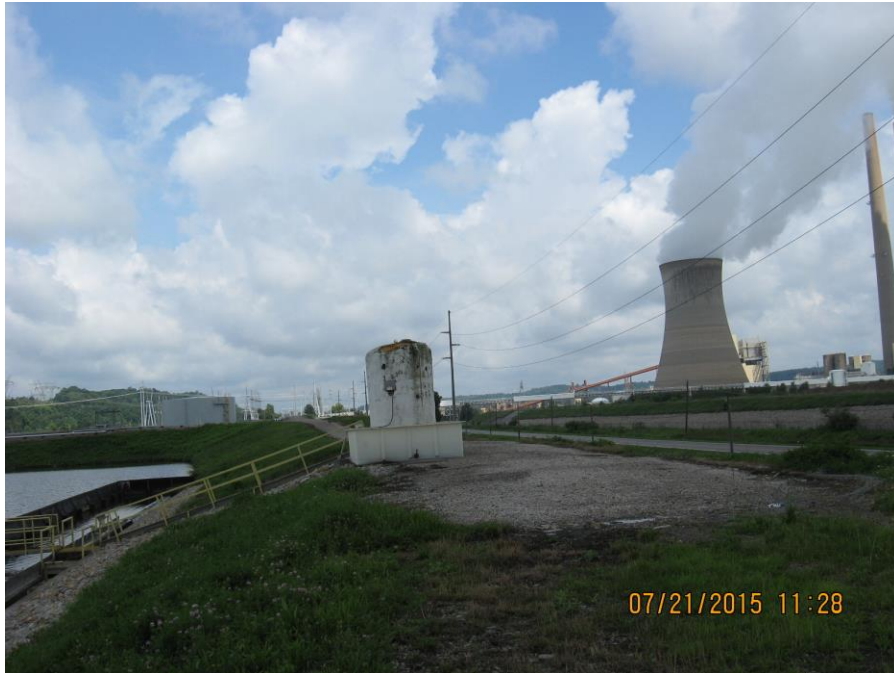
Photo 39: Clearwater Pond, east dike.

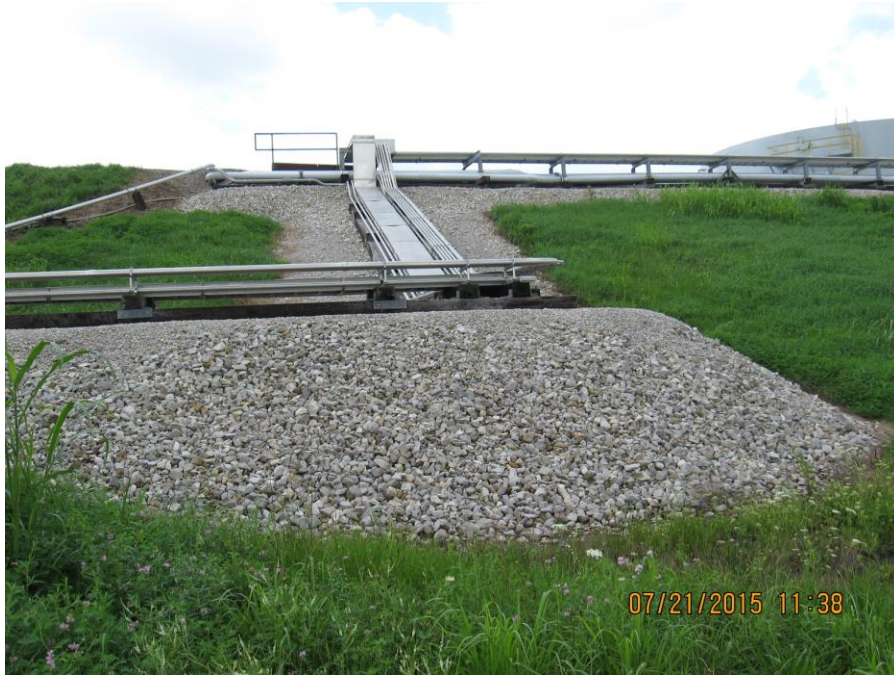
Photo 45: East Wastewater Pond, east dike: piping along exterior slope.
