# STRUCTURAL STABILITY ASSESSMENT

**40 CFR 257.73 (d)**

Ash Pond

Cabin Creek Site

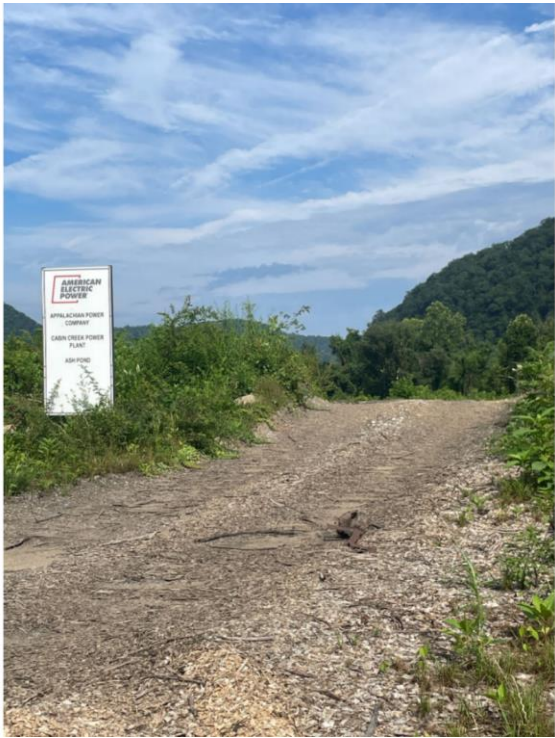
Media 1: Road adjacent to the ash pond

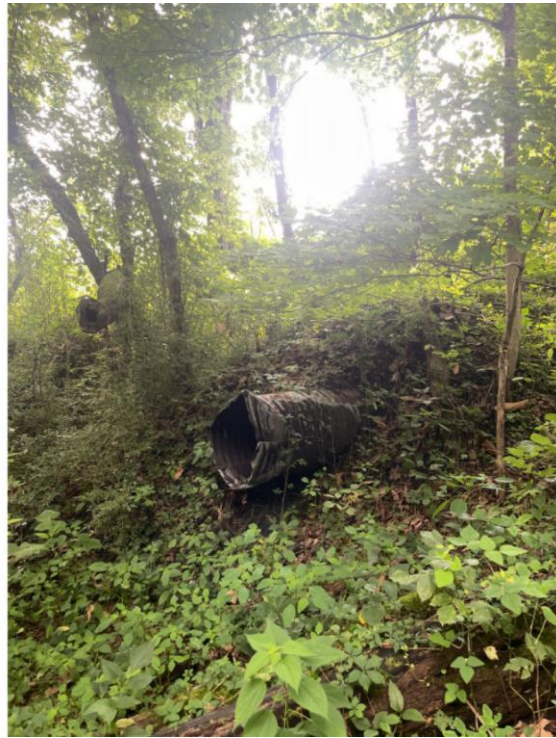
Media 2: Drainage pipe from the former power plant area

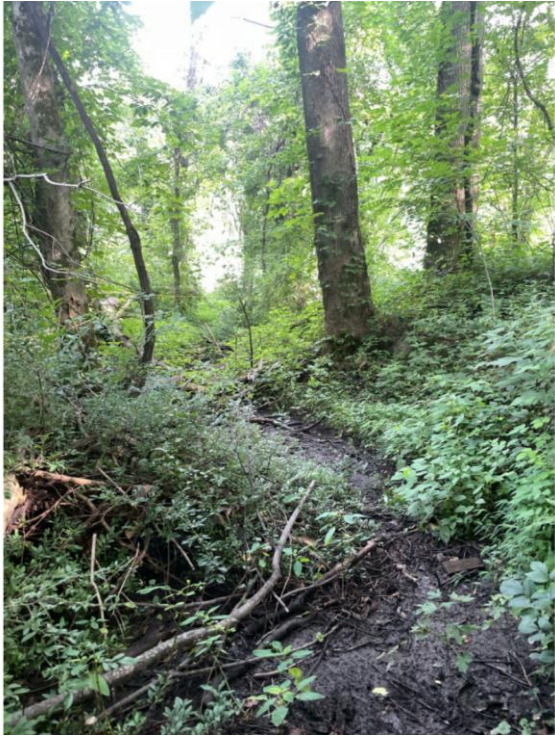
Media 5: Floodplain area located to the east of the ash pond near the perimeter dike toe of slope

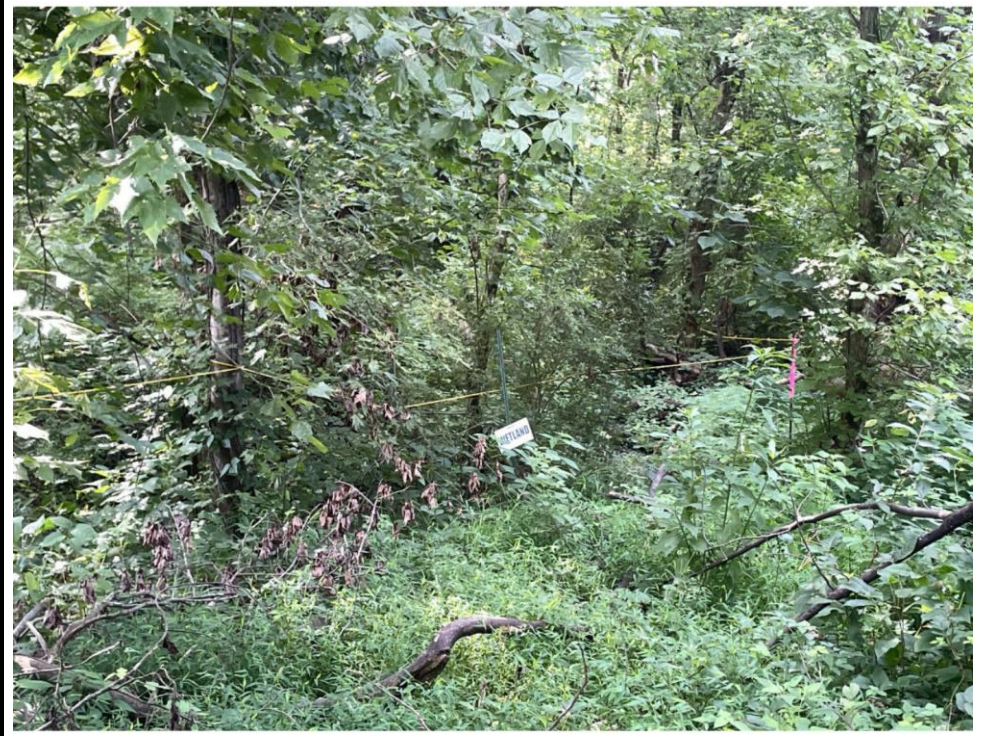
Media 6: Floodplain area located to the east of the ash pond near the perimeter dike toe of slope

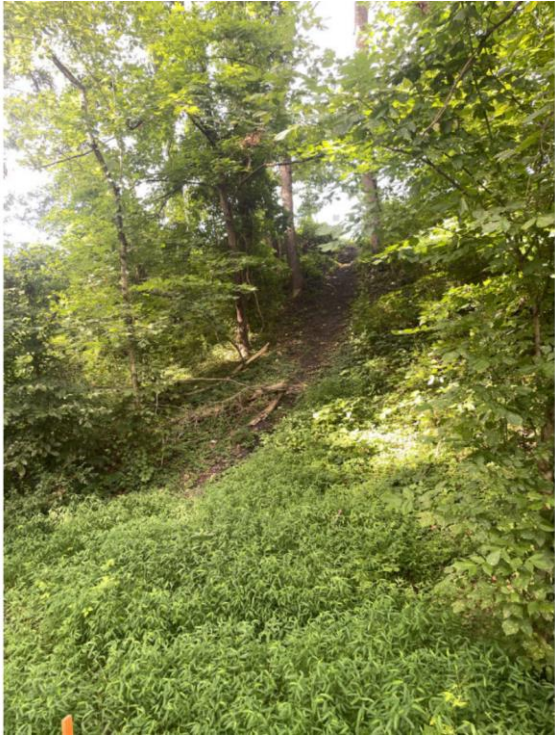
Media 7: Perimeter dike at the northeast corner of the ash pond

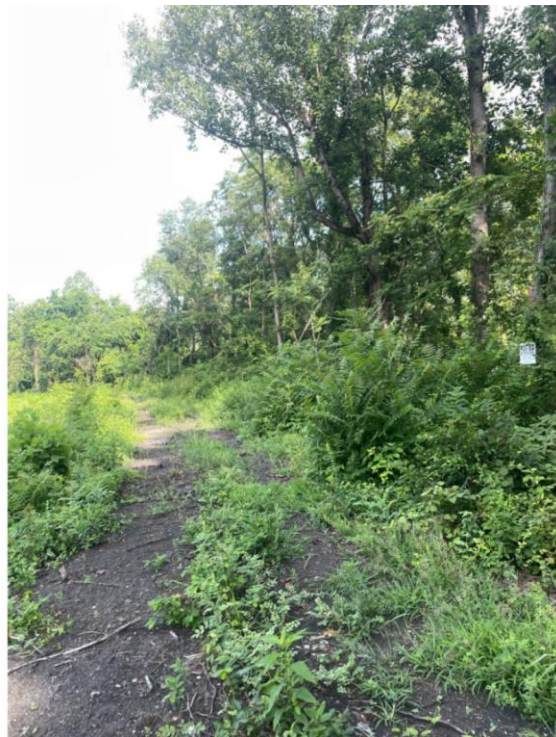
Media 10: Access road on the north side of the ash pond (top of ash pond)

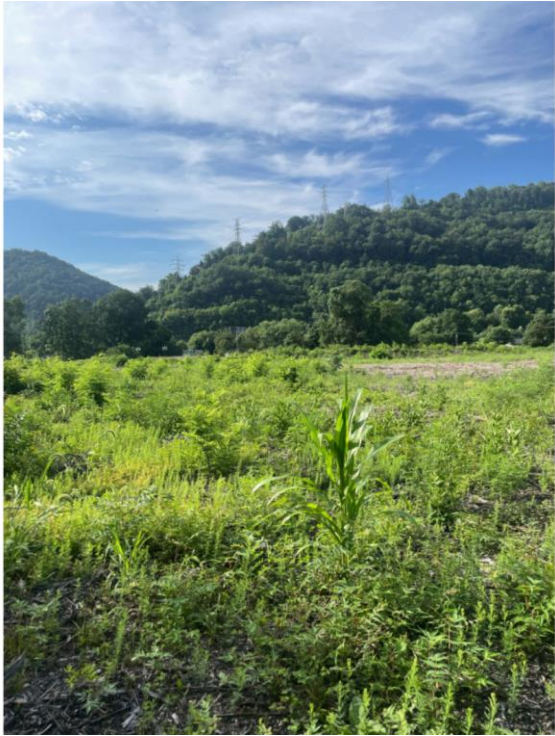
Media 11: Top of ash pond looking from north to south

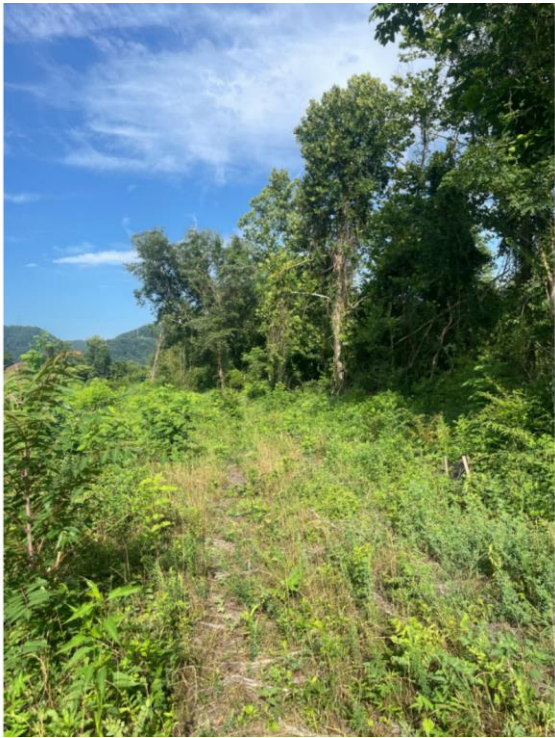
Media 13: Access road along the north side of the ash pond (top of ash pond)

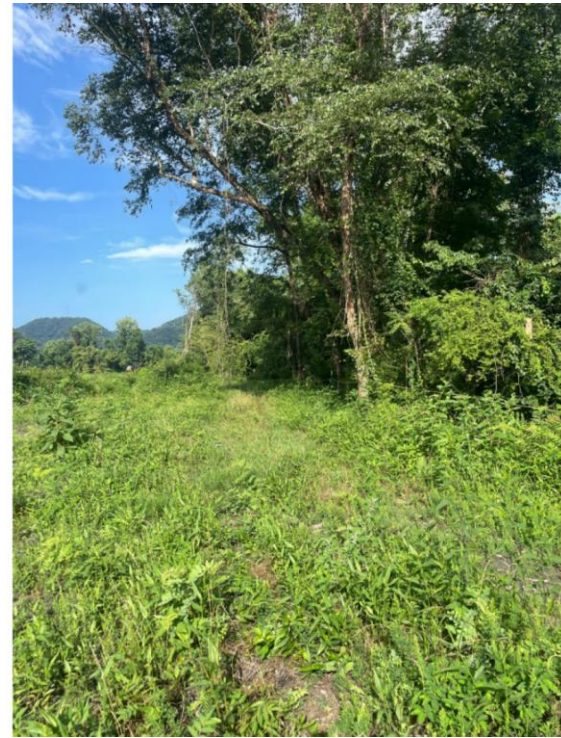
Media 14: Access road along north side of ash pond (top of ash pond)

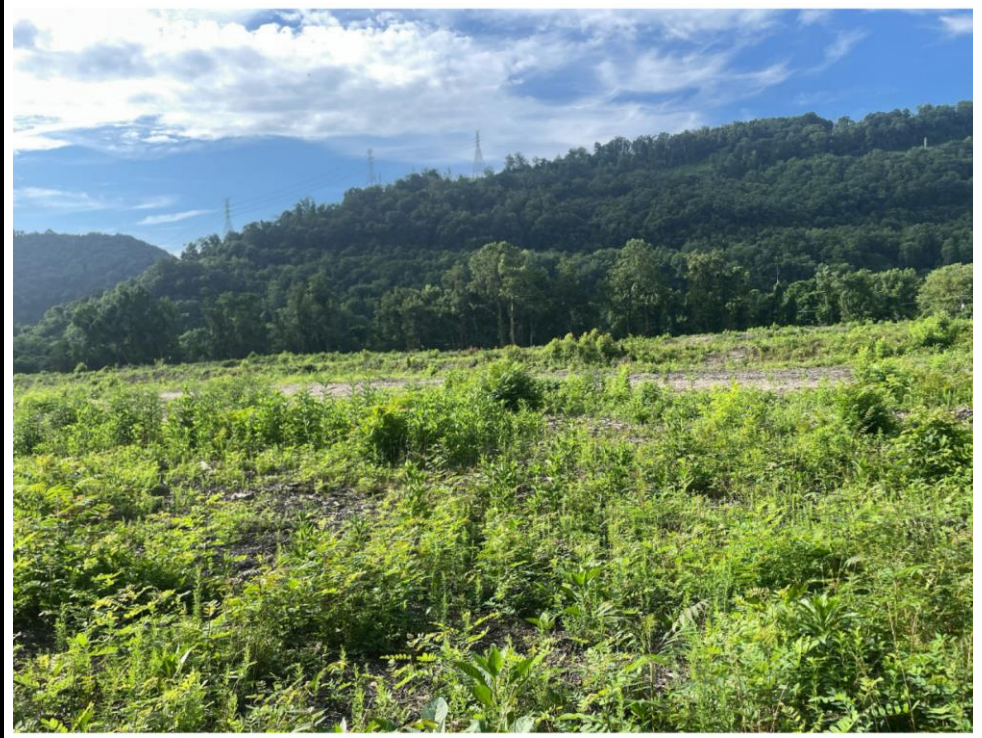
Media 16: Top of ash pond looking from north to south

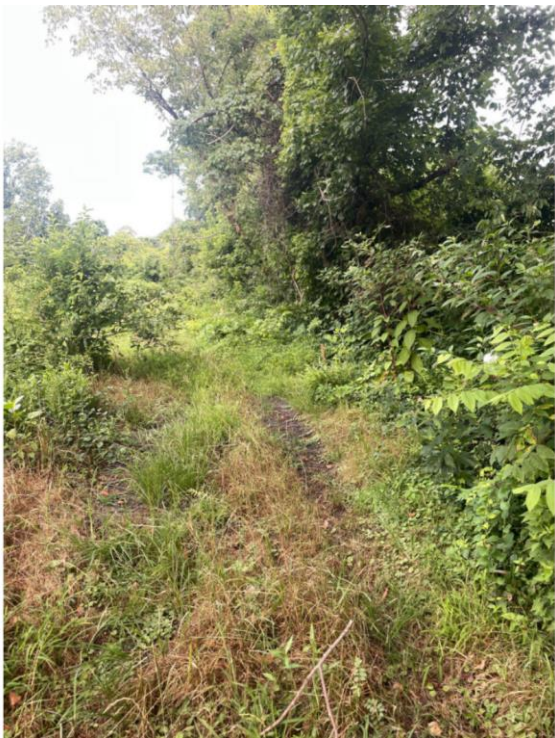
Media 19: Access road along the north side of the ash pond (top of ash pond)

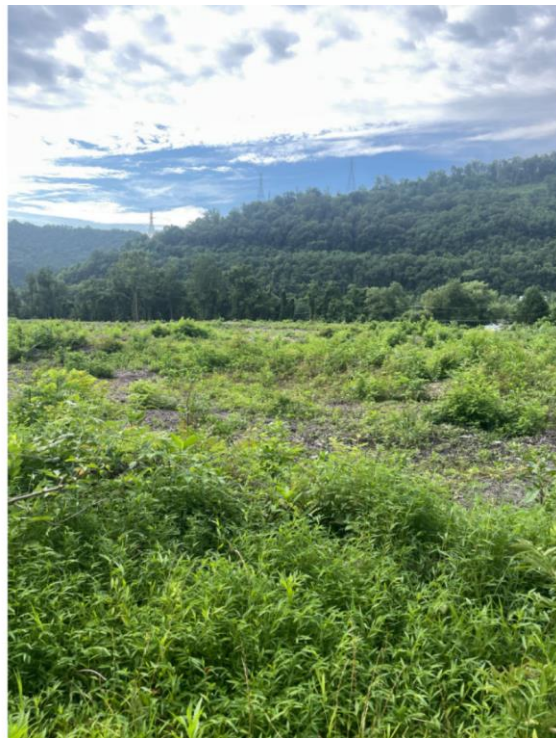
Media 20: Top of ash pond looking from north to south

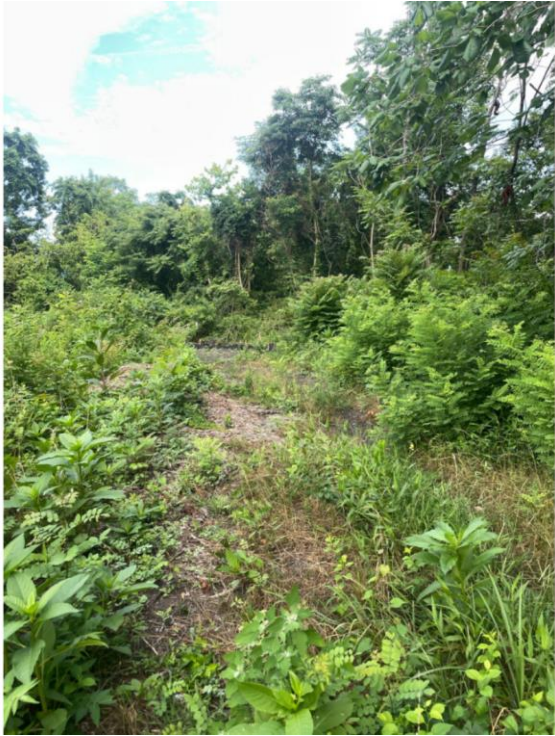
Media 21: Access road along the north side of the ash pond (top of ash pond)

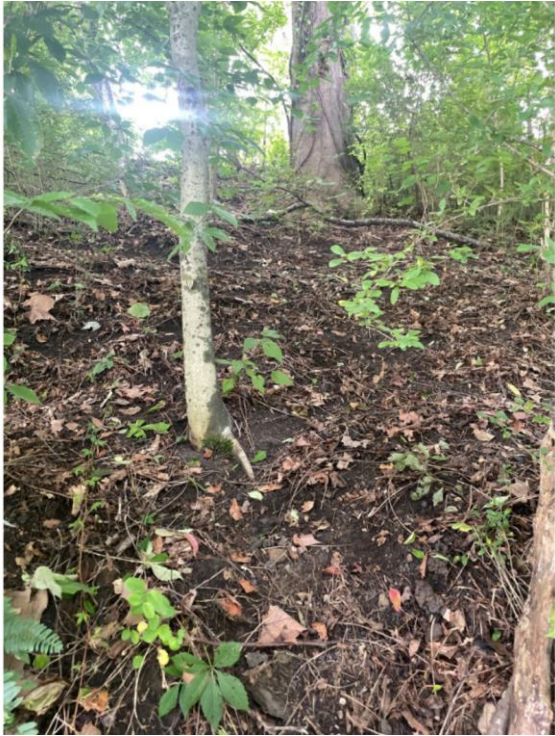
Media 23: Perimeter dike at the northwest end of the ash pond

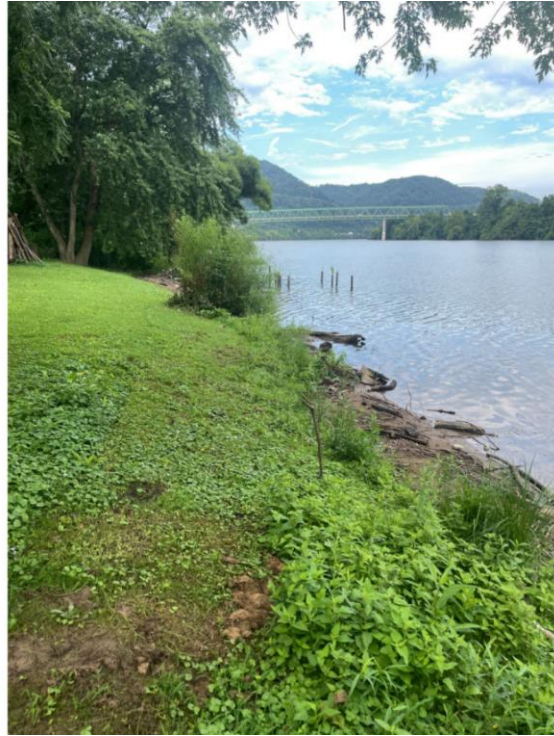
Media 26: Floodplain area shown to the northwest of the ash pond

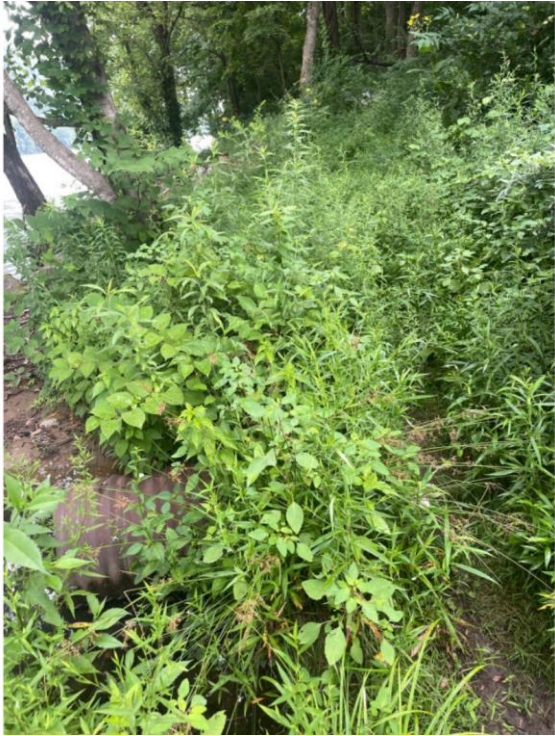
Media 27: Corrugated metal storm water pipe by the concrete outlet pipe

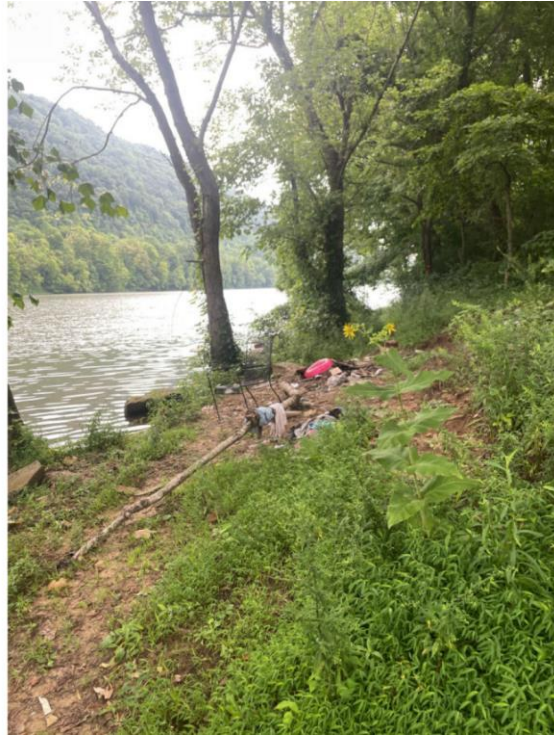
Media 30: View of perimeter dike adjacent to the Kanawha River

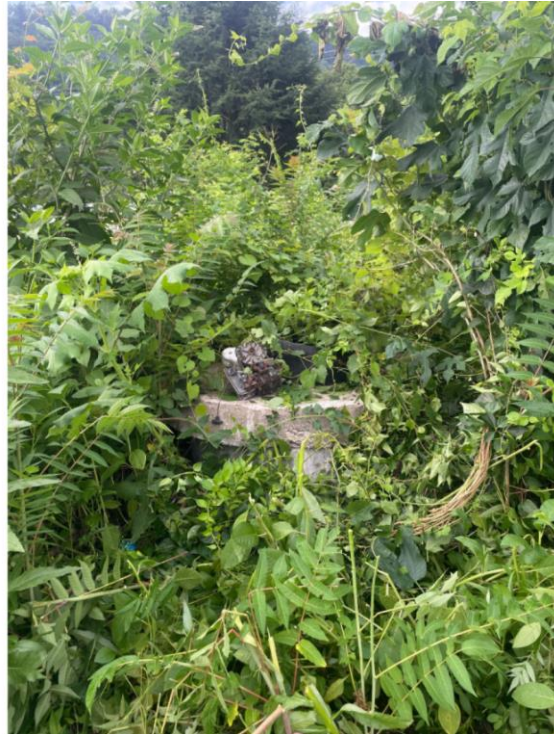
Media 42: Top of concrete stormwater manhole. Access point for stormwater drainage pipes that traverse the ash pond

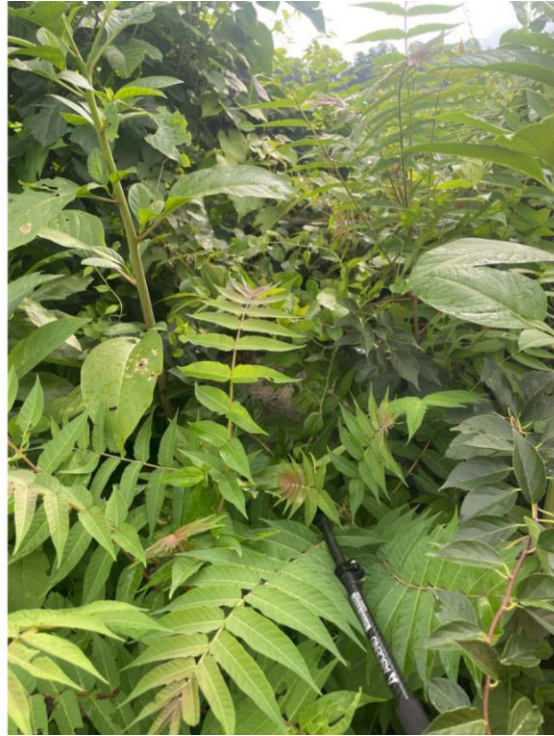
Media 44: Top of concrete stormwater manhole. Access point for stormwater drainage pipes that traverse the ash pond

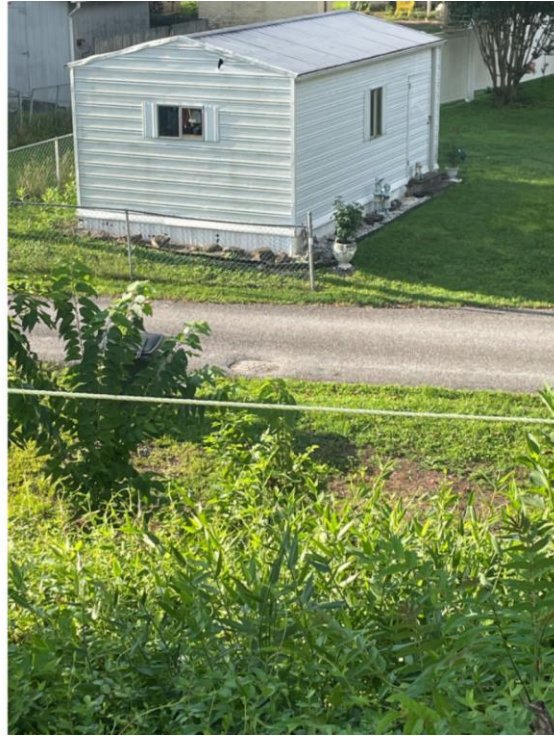
Media 50: Looking south from the top of the perimeter dike, showing manhole location in the adjacent street

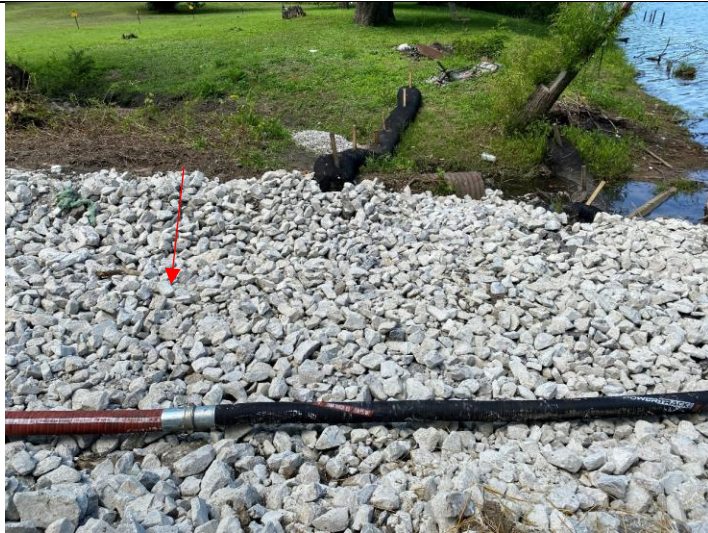
Note the pipe outlet is not visible, but its location is approximated by the red arrow.

Photograph 6.  
View showing the stabilized outlet area for the new storm drainpipe.

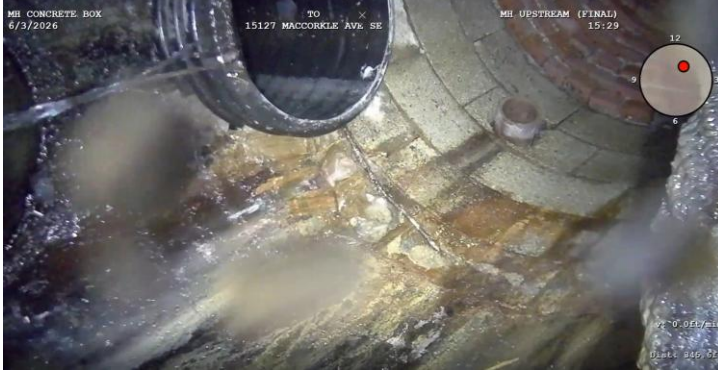
Photograph 14. View inside the closed lid manhole near the intersection of Grady Steet and Appalachian Street.

This is the location where the 18" CPP storm drain belonging to the WVDOH discharges into ApCo's pipe.
